Investigation report

Involved	
Teams T-2 T-F	Approved by/date 28 May 2021
Members of the investigation team Roar Sognnes Øyvind Tuntland Vebjørn Nygaard	Investigation leader Eigil Sørensen

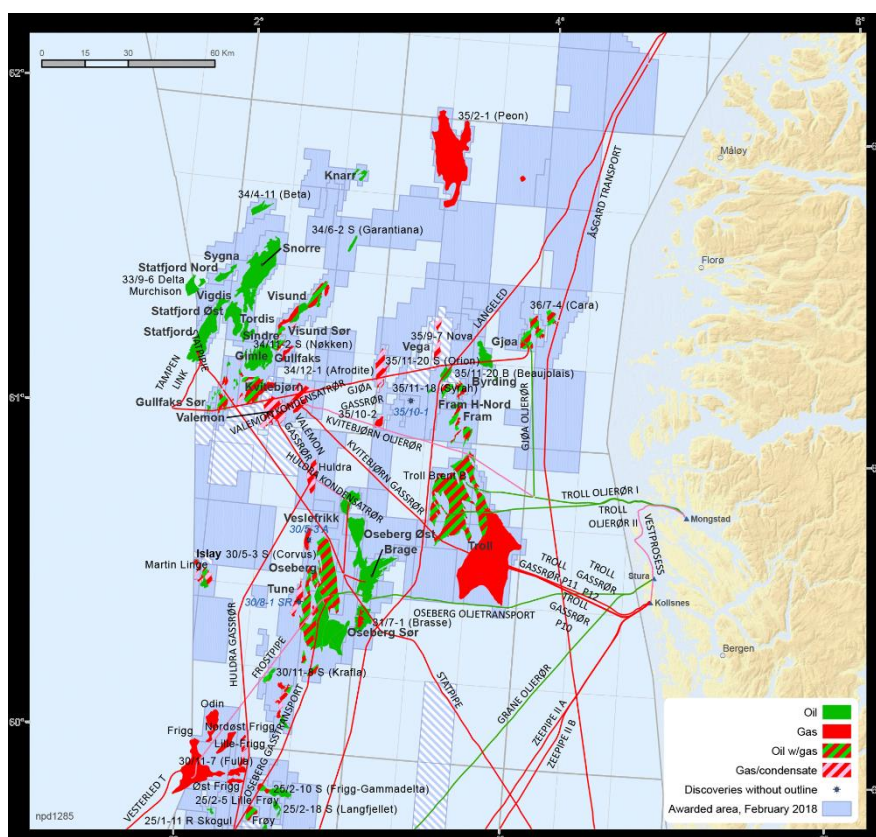
Figure 1 Map of the Gjøa area. Source: Norskpoleum.no

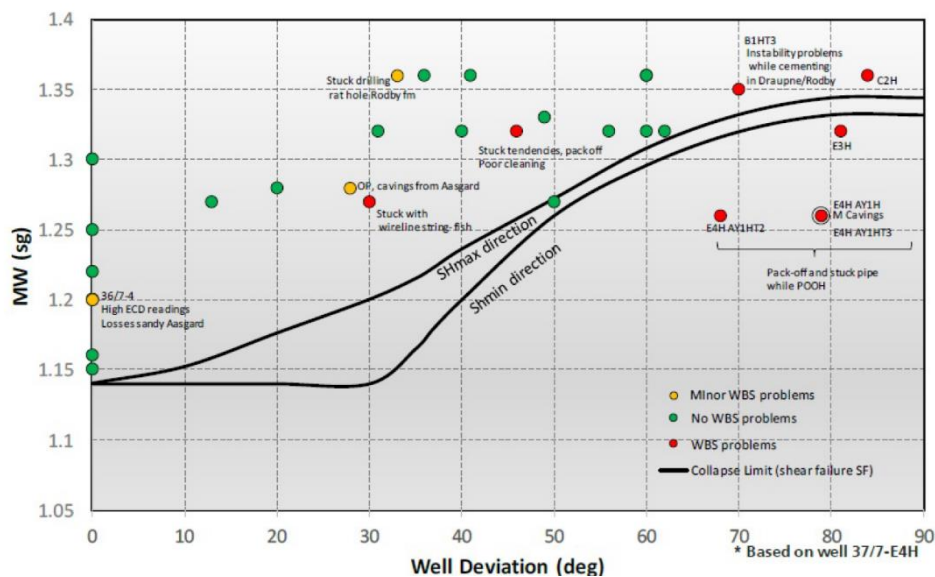
Figure 9 Åsgard inclination versus MW offset experience plot. Source: Neptune Energy – activity programme Gjøa P1 35/9-G-4 H.

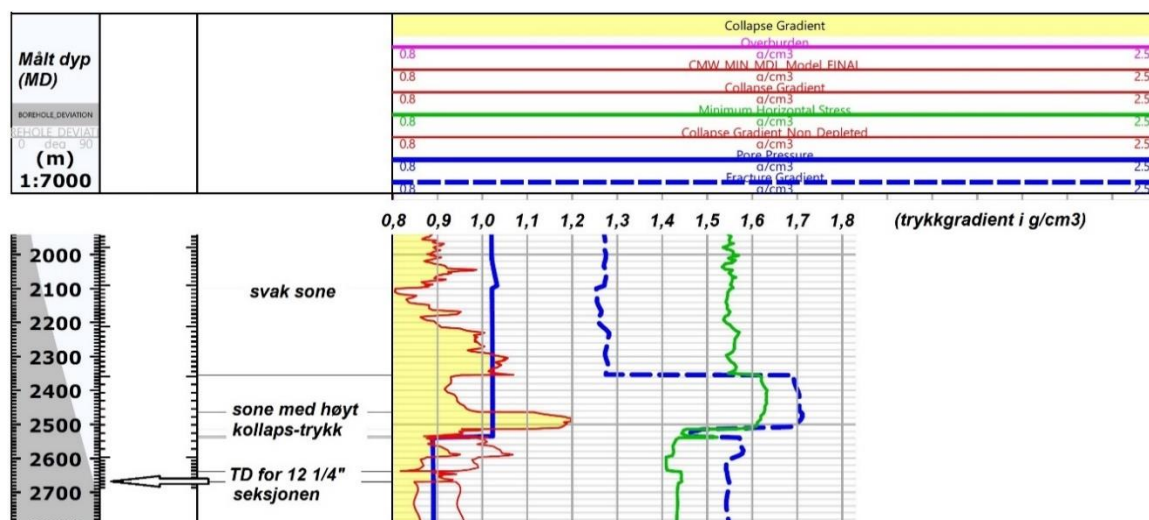
Figure 12 Edited figure showing in part the pore and collapse pressures in the relevant part of the well. Source: Neptune Energy – activity programme Gjøa P1 35/9-G-4 H.

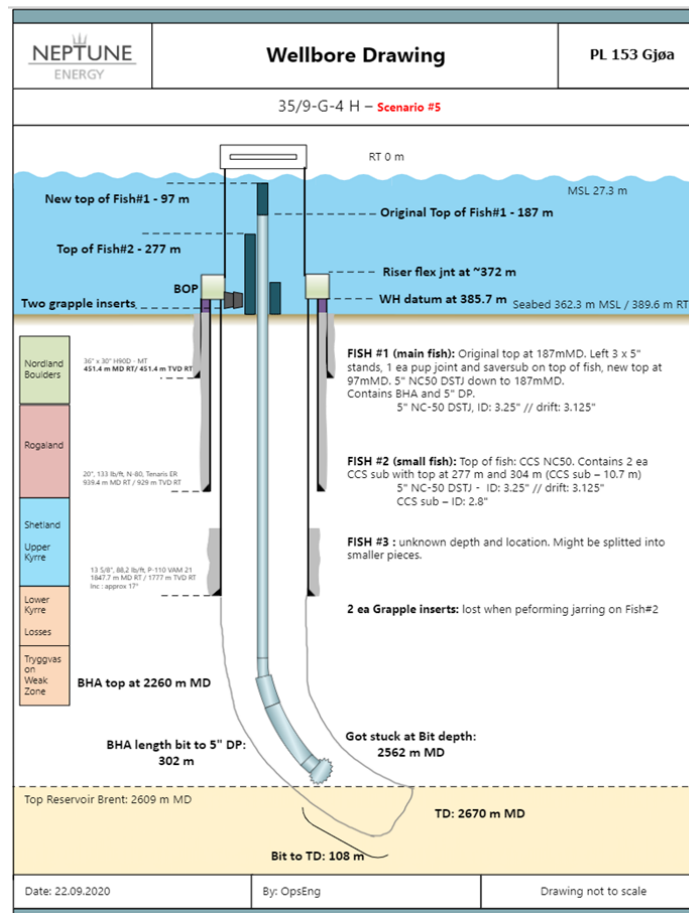
Figure 13: Well status 22 September 2020, where the perception was that the second dish stopped on top of the wellhead. This meant that three fish were assumed to exist. Source: Neptune Energy.

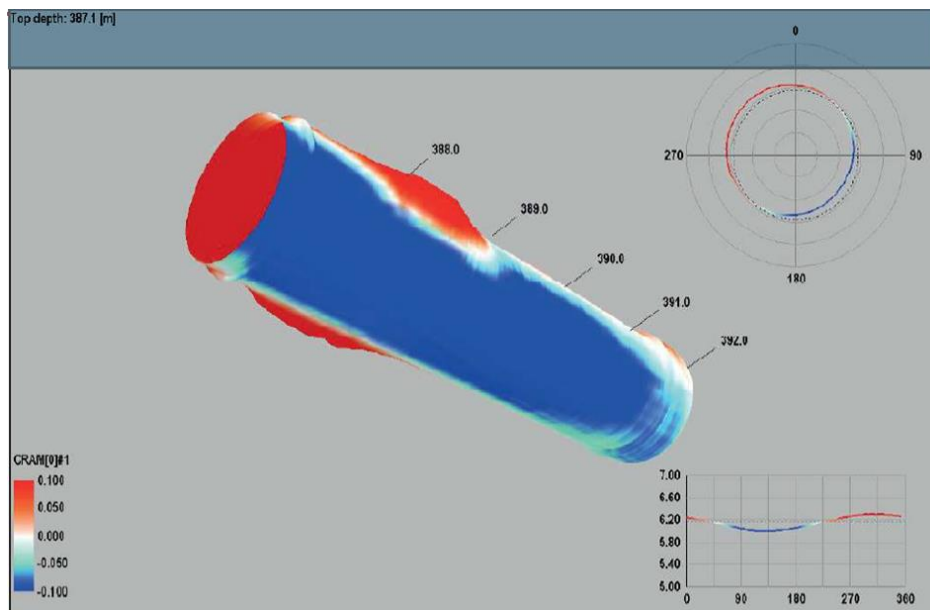
Figure 14 3-D wellcad over the 387-392 metre interval showing casing deformation. Source: Neptune Energy.
