## Investigation report

Classification	
<input checked="" type="checkbox"/> Unclassified	<input type="checkbox"/> Exempt from publication

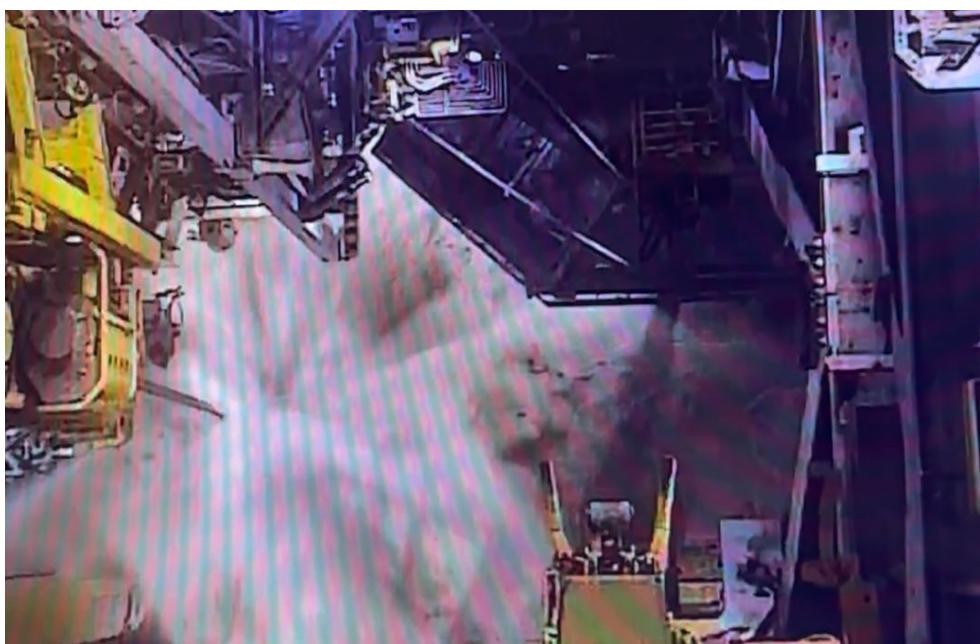
*Photo 2 Still image from a video showing outflow onto the drill floor, viewed from above (source: Odfjell Drilling)*

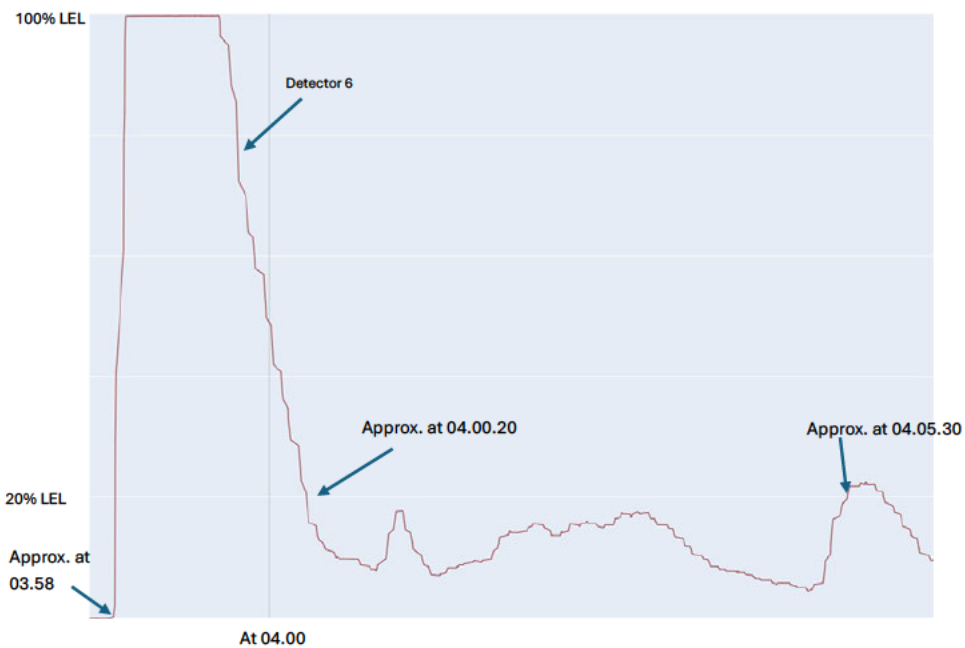
Figure 7 Readings from gas detector underneath the drill floor during the incident. (source: Odfjell Drilling)

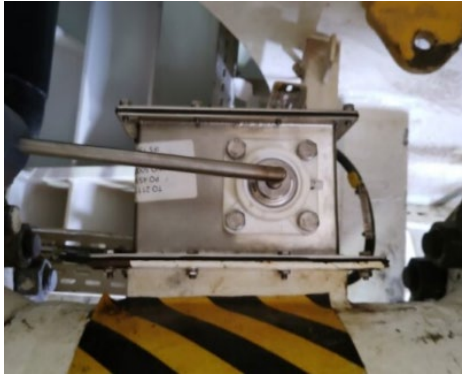
Photo 9 Flapper valve on the return flow line to the shakers (source: Havtil)

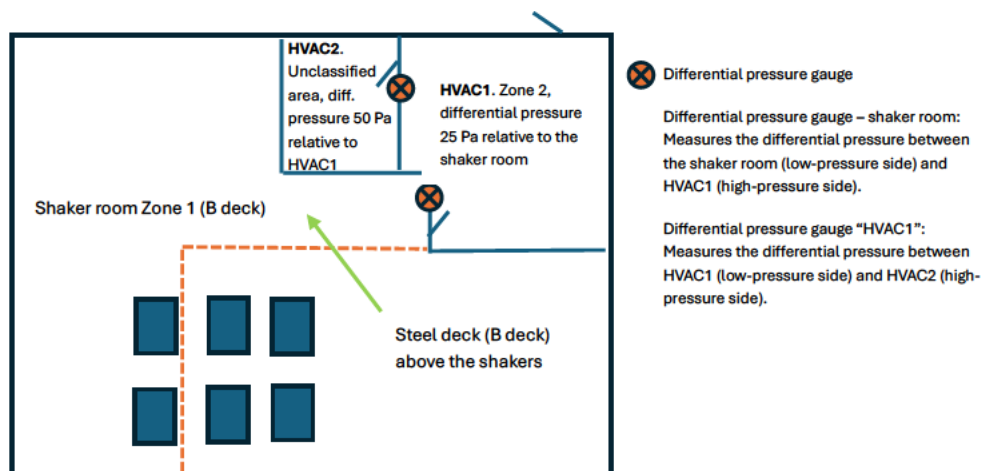
Figure 14 Overview of area classification and defined differential pressures for the shaker room and adjacent rooms on A Deck. (source: Odfjell Drilling)

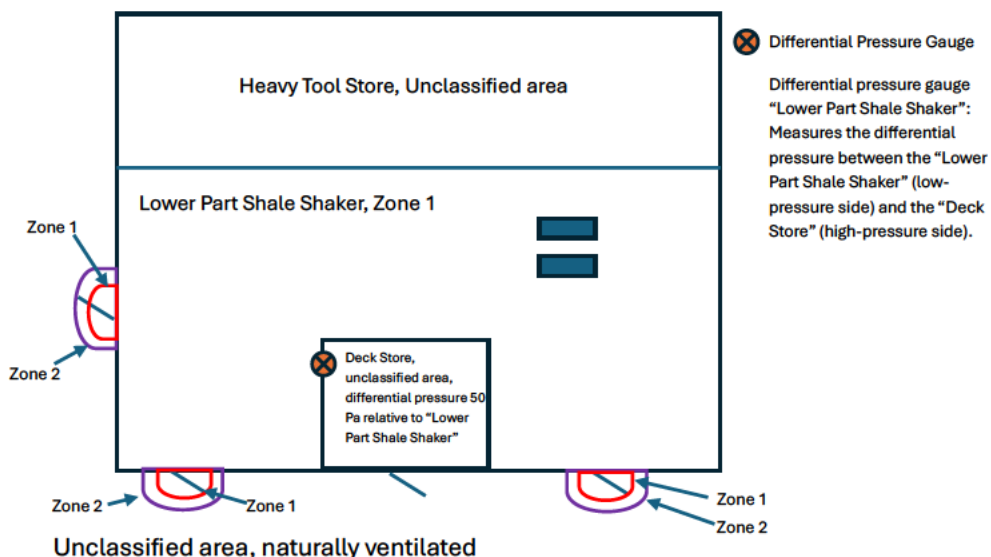
Figure 15 Overview of area classification and defined differential pressures for the Lower Part Shale Shaker and adjacent rooms on the Upper Deck. (source: Odfjell Drilling).

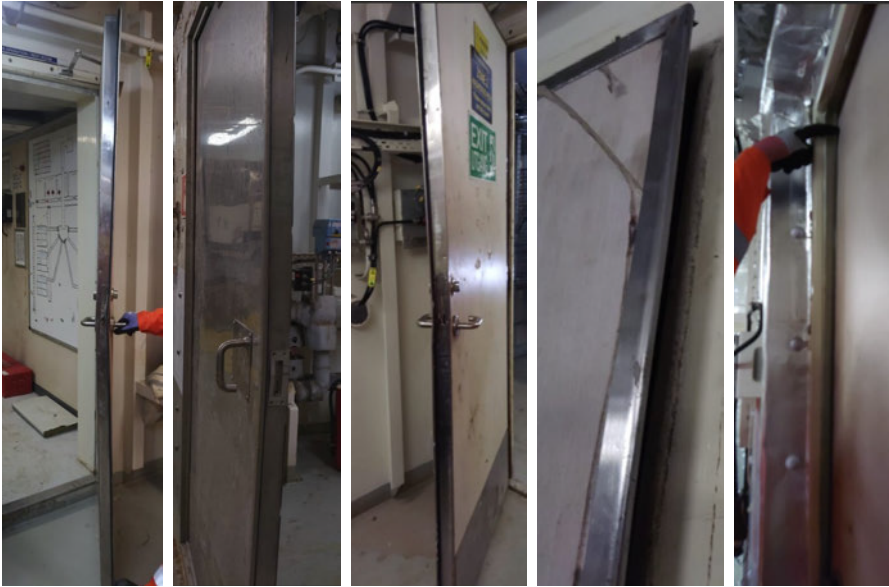
*Photo 10 Examples of damage to doors in the shaker room and adjacent areas where door panels are warped or dented (source: Havtil)*

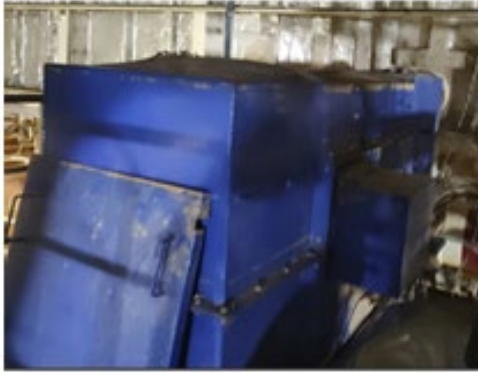
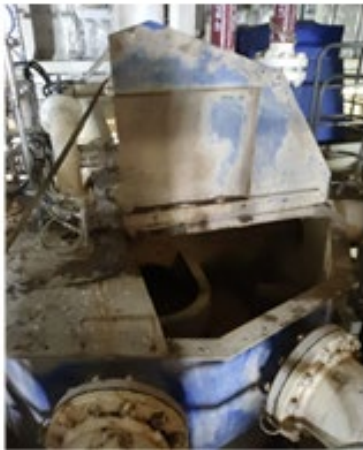
*Photo 11 The gumbo box is shown at the top and the header box below (source: Havtil)*

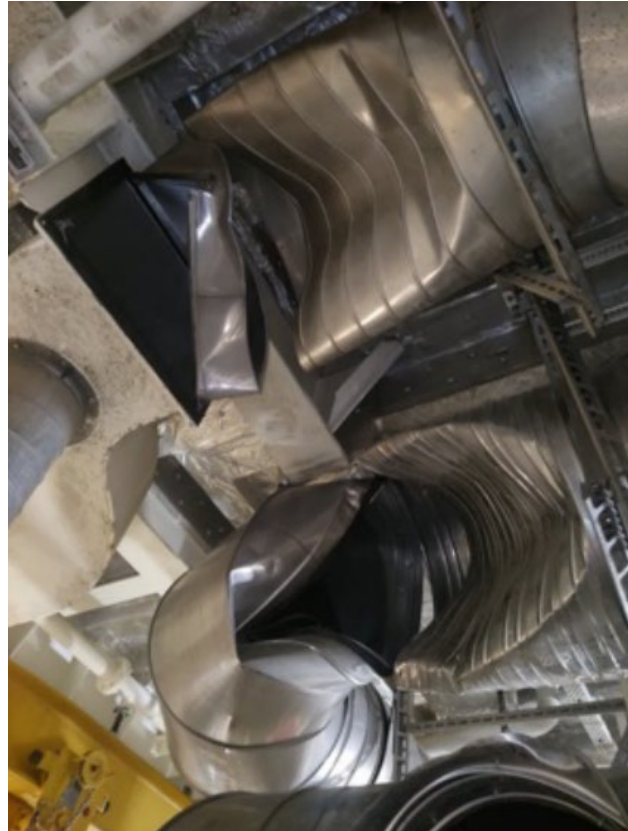
*Photo 12 Exhaust ducts in the shaker room that were damaged during the incident (source: Havtil)*

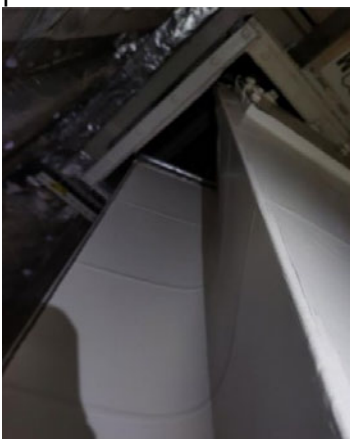
*Photo 13 Imploded exhaust duct from the Shale Shaker House & Lower Part Shale Shaker located in HVAC 1 (source: Havtil)*

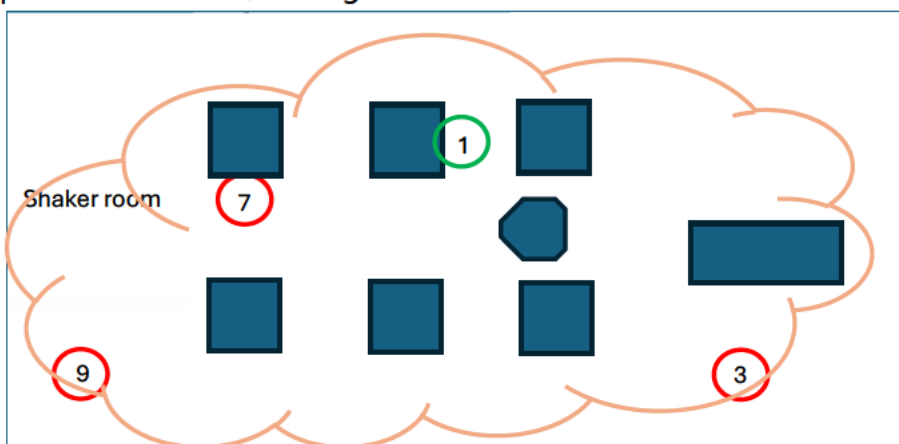
*Figure 18 Sketch of the possible size of the gas cloud (over 100% LEL) in the shaker area during the incident (source: Havtil)*

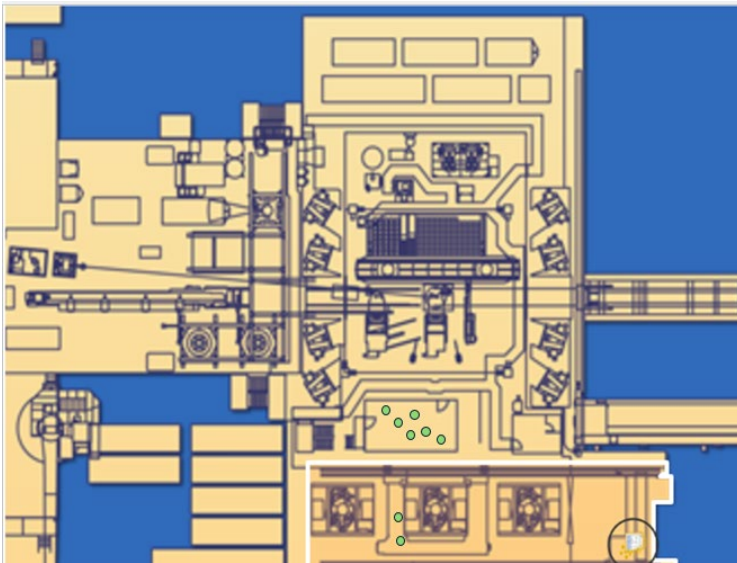
*Figure 19 Floor plan of the drill deck showing the location of personnel during the incident.*

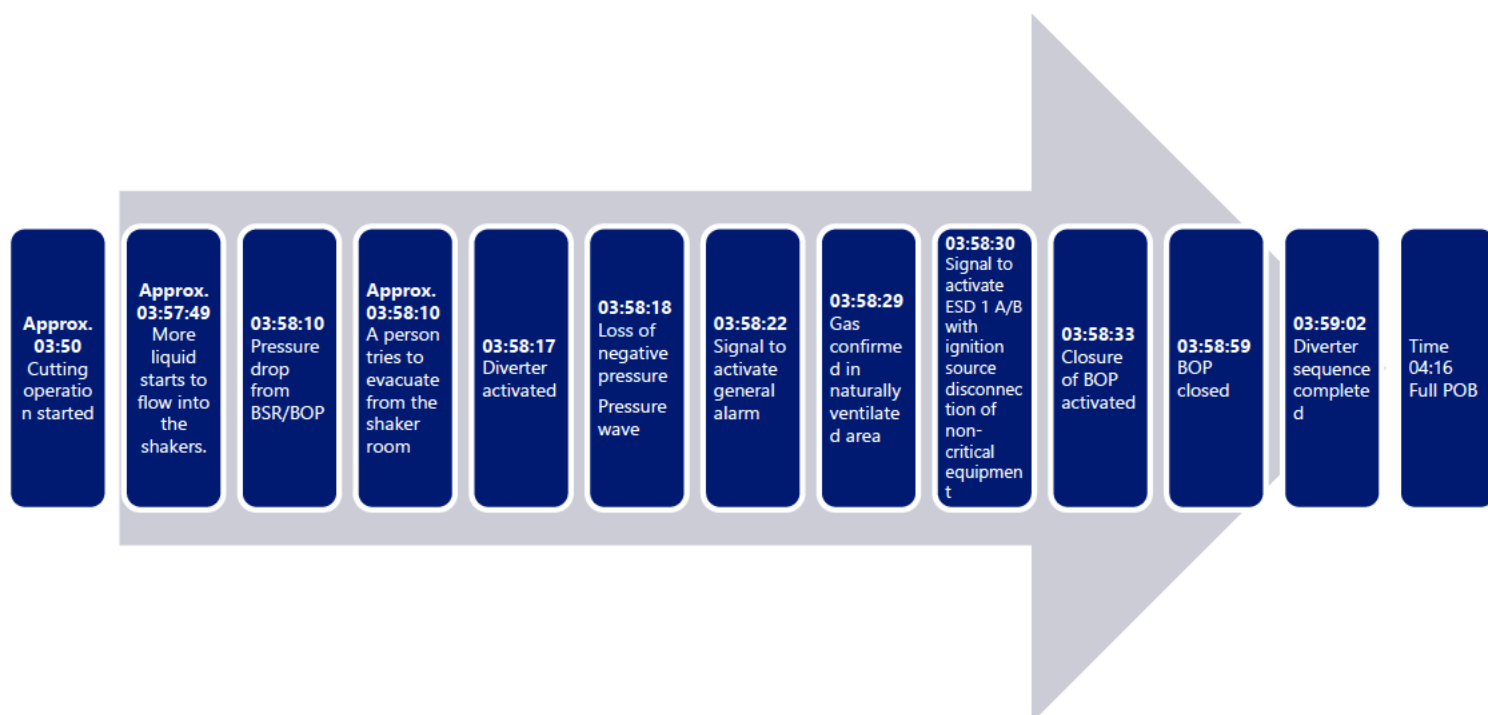
Figure 20 Overview of situations/actions during the course of events, including times (source: Odfjell Drilling)
