Investigation report

Report			
Report title		Activity number	
Investigation of lifting incident	Investigation of lifting incident with dropped object on Jotun B 044027505		
Security grading			
☑ Public	Restricted	Strictly confidential	
Not publicly available	Confidential		
Involved			
Team		Approved by/date	
T-3		Erik Hörnlund/10 September 2018	
Members of the investigation tceam		Investigation leader	
Sigmund Andreassen, Kenneth Skogen, Lars		Ola Heia	
Melkild (only on land)

1 Summary

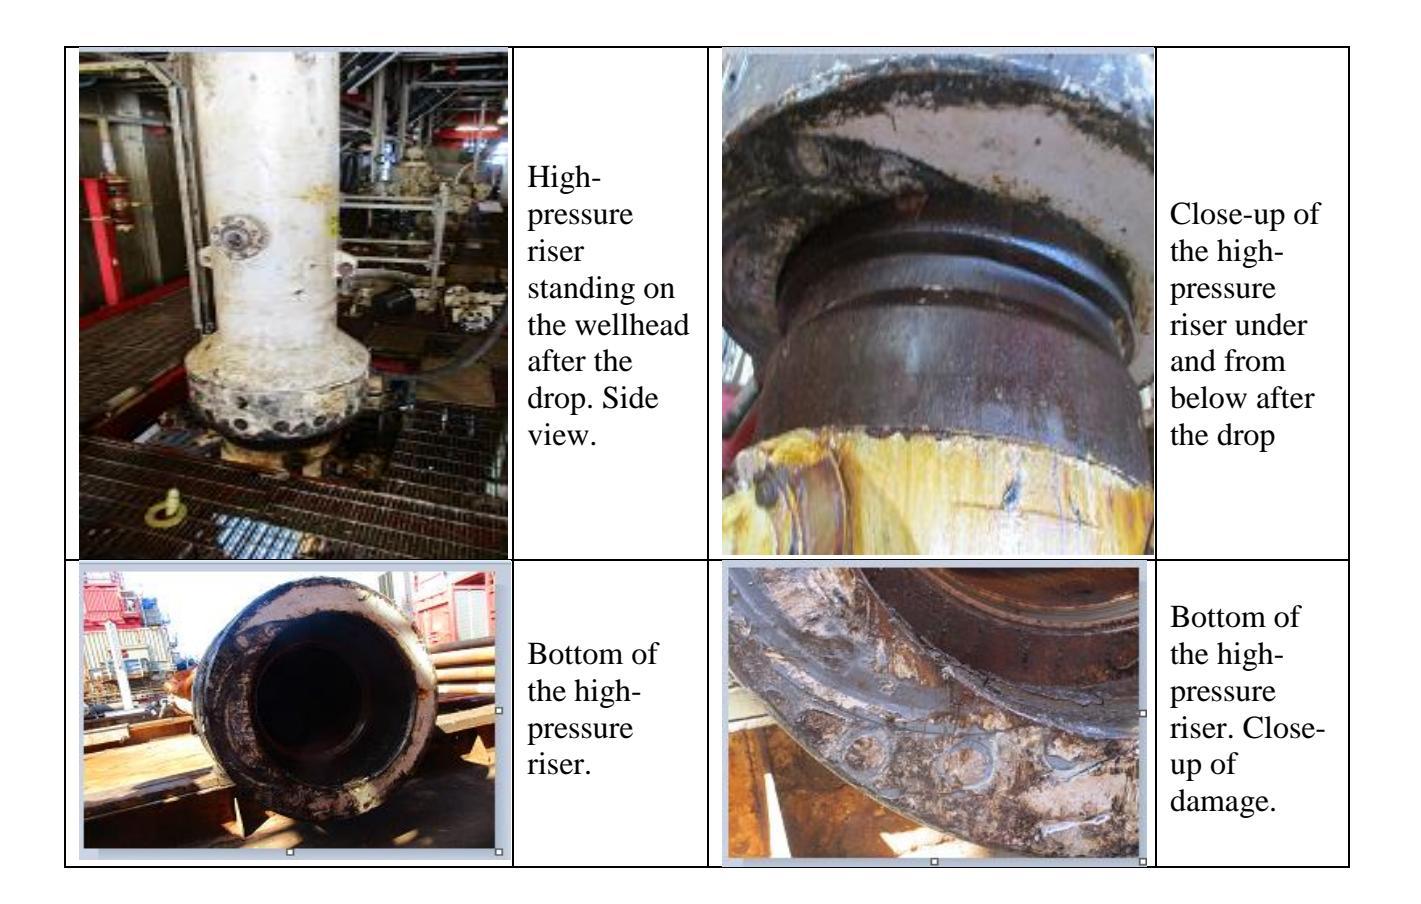
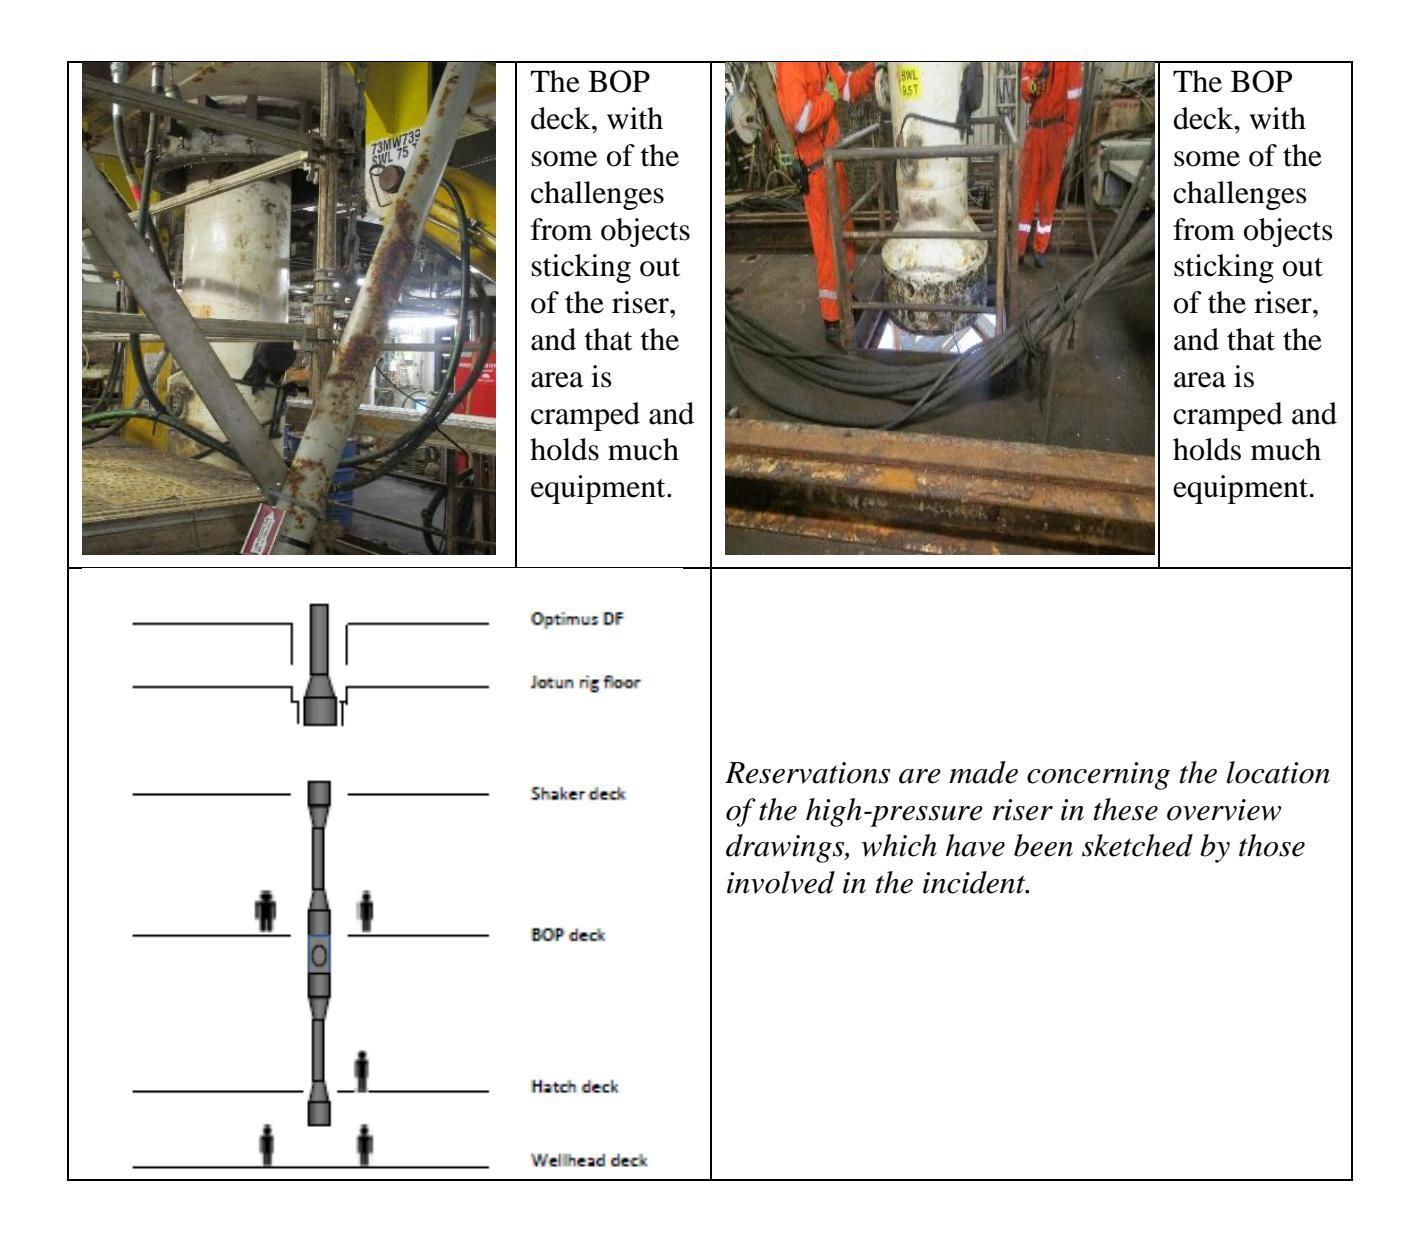
Material damage appeared to be confined to the lower part of the high-pressure riser which landed on the wellhead, and to the top of the latter. Visually, the wellhead suffered the greatest damage. It was unclear how quickly plugging work on B-18 could resume, given the damage caused to the wellhead and riser.

Top of wellhead with damage.	Top of wellhead with damage.
Top of wellhead with damage.	Top of wellhead with the area around it.
Close-up of the top of the wellhead flange showing dented metal.	Close-up of wellhead top.
Photo showing that the lifting accessory is not centred in the drill floor on the Optimus rig.	Lifting accessory passing through the old drill floor on Jotun B. It is visibly displaced towards the liner wall.

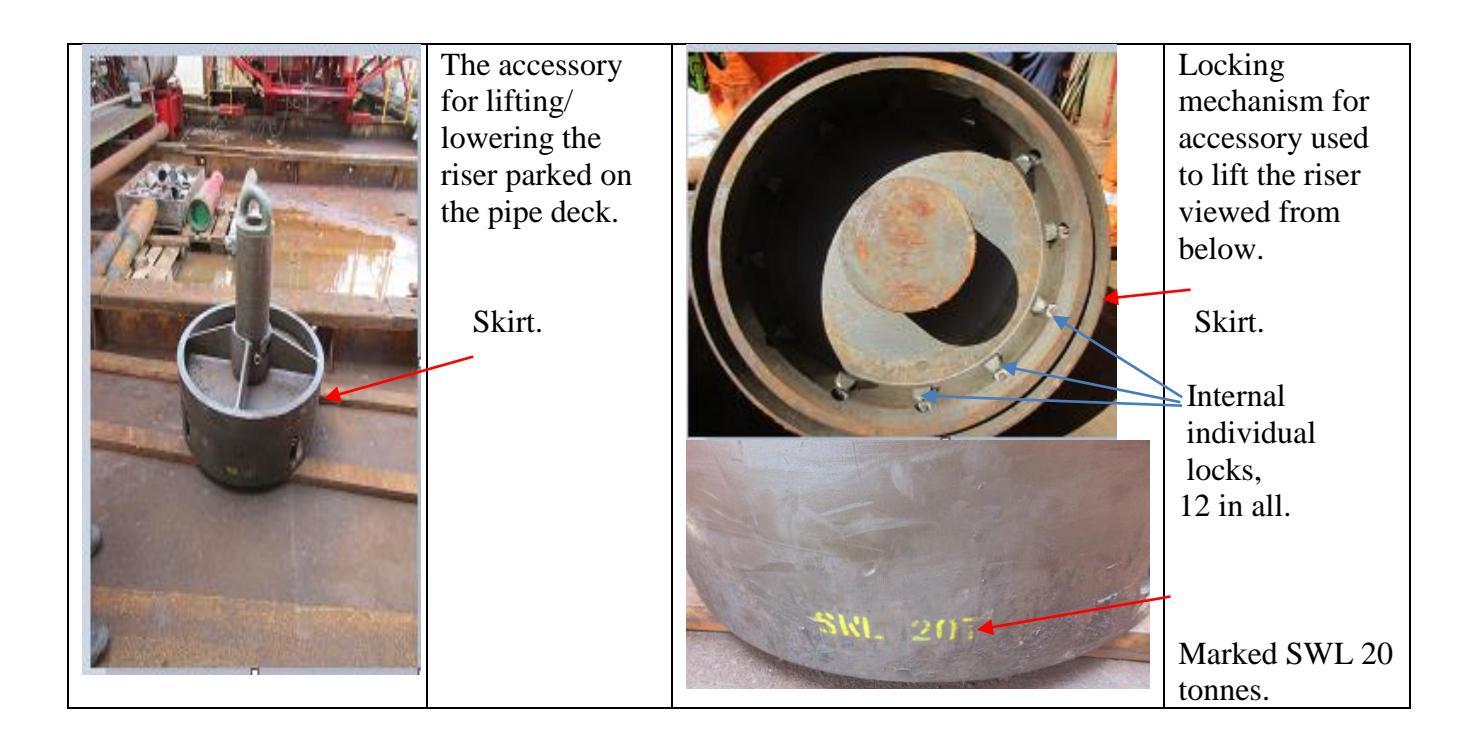
The locking mechanism in the lifting accessory failed. This accessory lacked a secondary locking mechanism for suspended loads in case the primary device failed. The load would accordingly come loose if the only barrier is a non-functioning locking mechanism.

- the skirt of the lifting accessory was pressed against the side wall in a narrow area, so that the mechanism ceased to function
 dropped high-pressure riser
- the skirt or part of it caught on an edge in a narrow area, pushing up the skirt and putting the mechanism out of action → dropped high-pressure riser.

Locking mechanism for accessory to lift the riser viewed from below in the locked position.		The accessory for lifting/ lowering the riser on its way down through the hatch and next to the diverter.
	The accessory for lifting/ lowering the riser parked on a beam in the locked position.		The accessory for lifting/ lowering the riser parked on a beam in the open position. The beam has caught the skirt and deactivated its locking mechanism.
Position of the locking		Position of the locking mechanism.	
mechanism. Right up		Right down means no locking/	
means maximum		attachment function.	
locking/attachment			
function.
