STUDY ON PLANNING, FABRICATION AND MAINTENANCE OF TERTIARY
CONSTRUCTION ELEMENTS AND PIPE SUPPORT

Tertiary structures and their connections

Petroleumstilsynet

Report no.: 2023-1207, Rev. 1

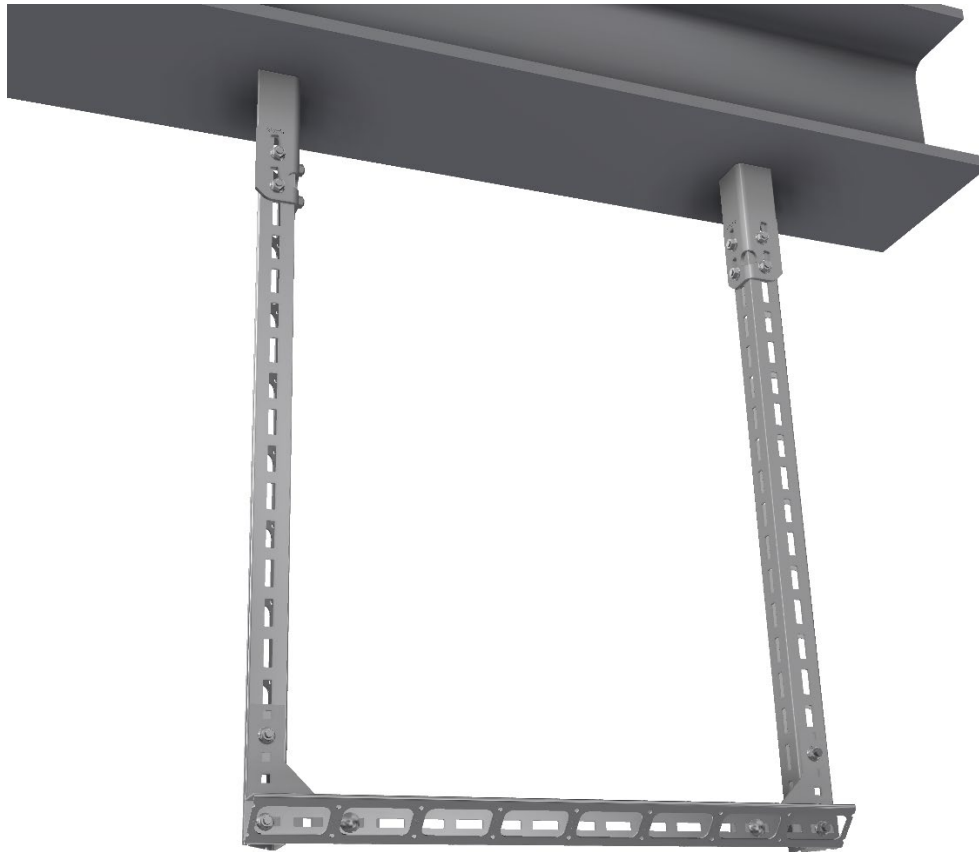
Figure 3-2 Example of starter brackets for assembly of trays and ladders. Photos: Permission to use from Øglænd systems

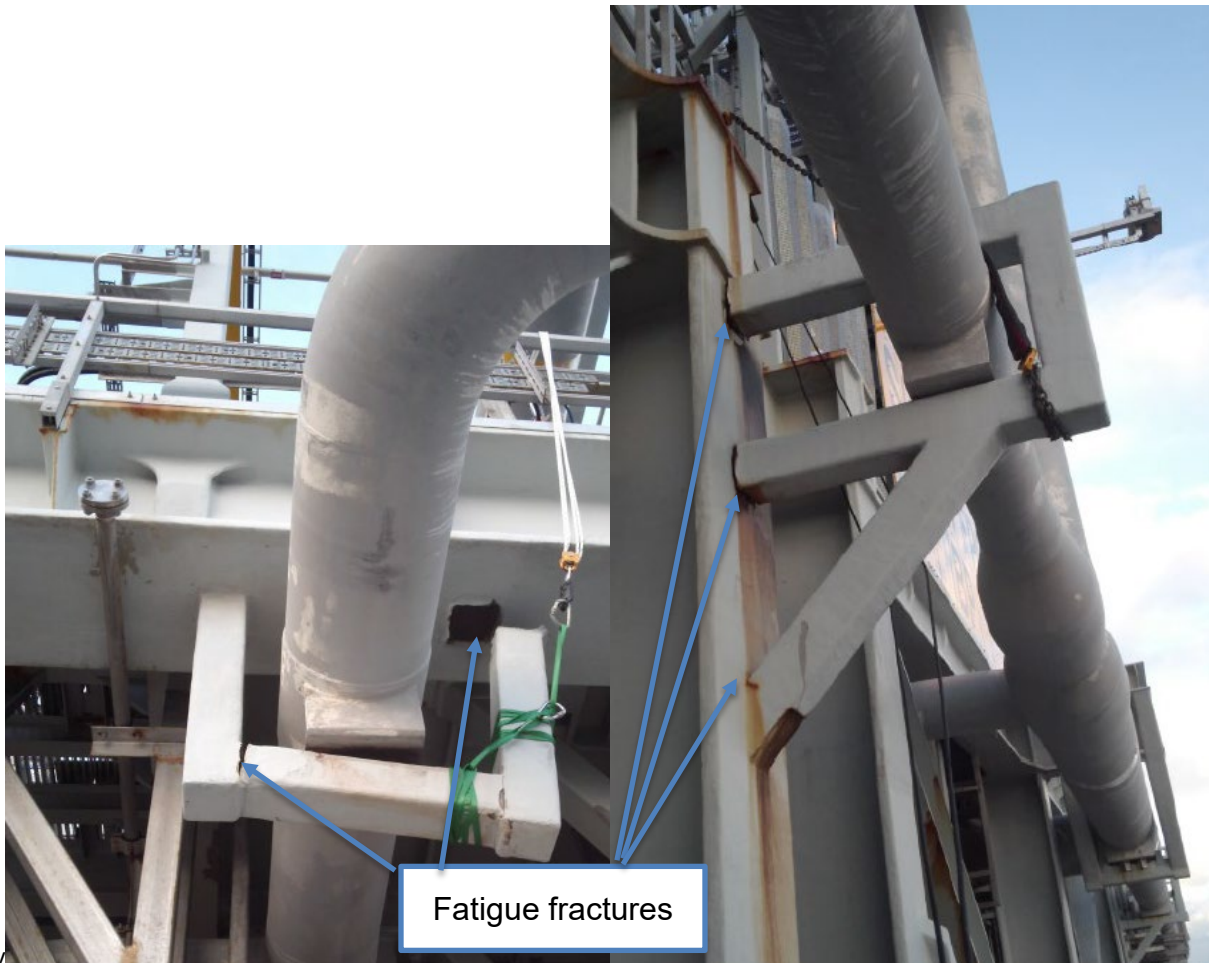
Below photo (Figure 3-9) shows one example known to DNV with an incident with fractured welded pipe supports of a pipe running through several modules on an FPSO. The likely cause was high frictional loads transferred from pipe to supports, due to global deformations from wave loads.

Figure 3-9 Example of two adjacent, welded pipe supports (RHS 150 and RHS200) failed by fatigue. Photos used with permission from operator.
