TECHNICAL REPORT

PETROLEUM SAFETY AUTHORITY NORWAY (PSA)

MATERIAL RISK - AGEING OFFSHORE INSTALLATIONS

REPORT No. 2006-3496

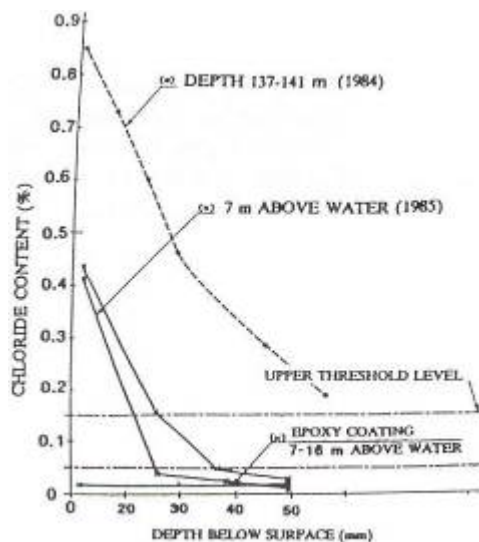
Figure 3-1-1 Chloride penetration into concrete of Statfjord A Platform (1977) after 8 years of exposure /18/.

For Statfjord A Platform the design specification required that the shafts of the structure should be protected in the splash zone by an epoxy coating. From Figure 3-1-1 it can be seen that such a coating had very efficiently prevented the chlorides from penetrating the concrete, and even after 15 years, this protection still appeared to be very effective /22/. However, for Heidrun Platform, Figure 3-1-5 shows that a much poorer surface coating partly applied to the legs of this platform was not so efficient in keeping the chlorides out, even after an exposure period of only two years.

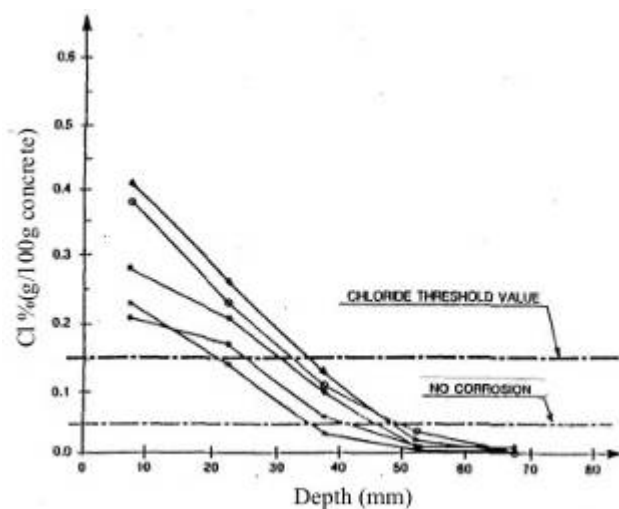
Figure 3-1-2 Chloride penetration into concrete of Ekofisk Tank (1973) after 17 years of exposure /19/.

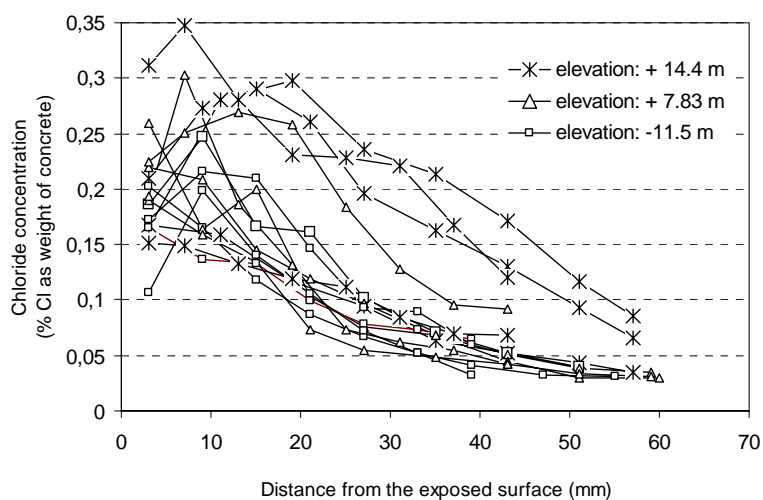
Figure 3-1-3 Chloride penetration into concrete of Brent B Platform (1975) after 20 years of exposure /20/.

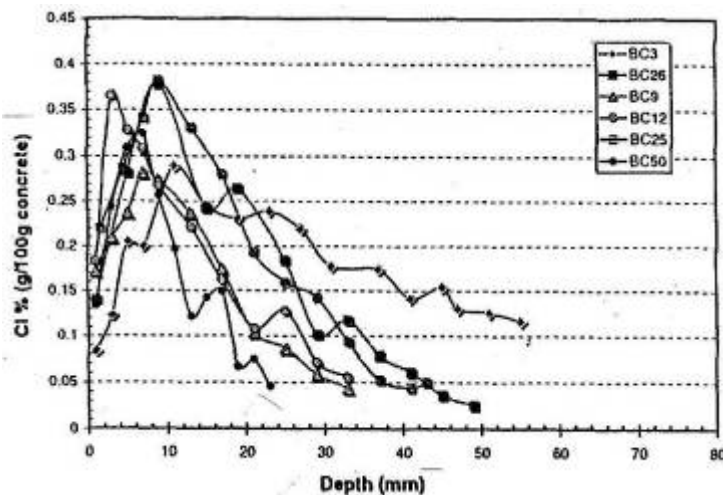
Figure 3-1-4 Chloride penetration into concrete of Brent C Platform (1976) after 18 years of exposure /17/.

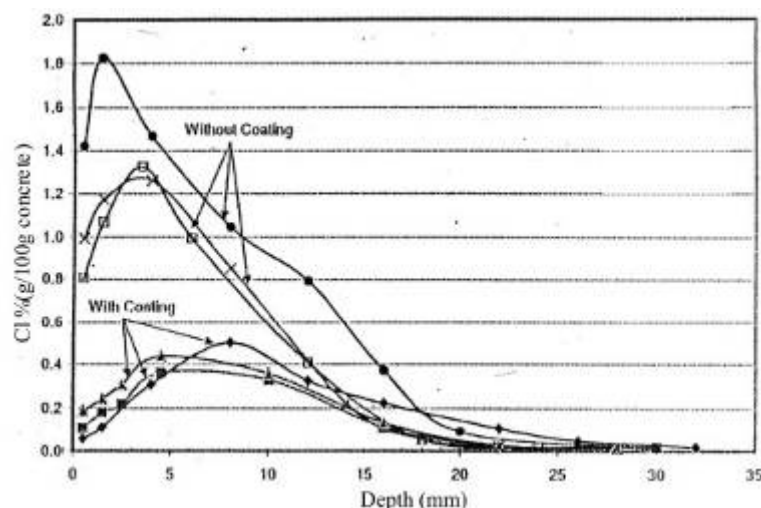
Figure 3-1-5 Effect of concrete coating on chloride penetration into concrete of Heidrun Platform (1995) after 2 years of exposure /17/.

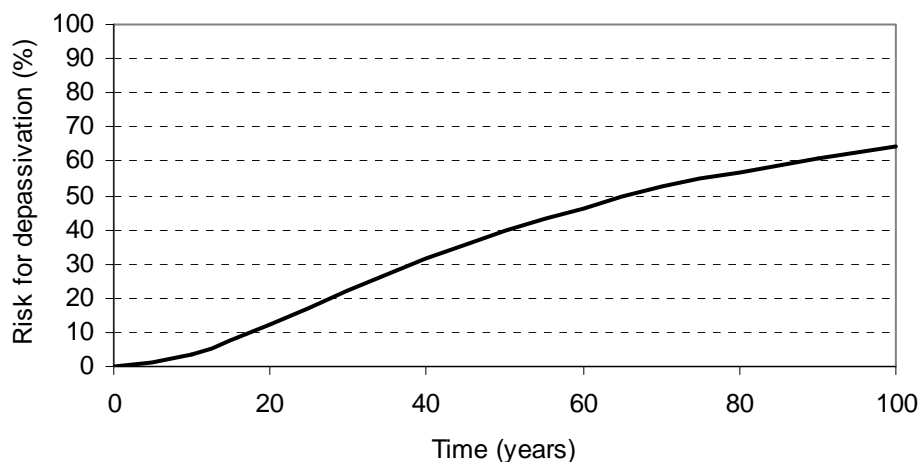
Figure 3-1-6 Development of risk for steel corrosion in the Brent B Platform (1975) /20/.

However, for several of the structures, a certain amount of steel corrosion has already been observed and minor repairs carried out. The above results indicate that the chlorides may penetrate the specified concrete cover in the splash zone within a service period of 25-30 years. For the Brent C Platform (1975), where enough data was available to carry out a probability-based durability analysis, Figure 3.1.6 shows that a risk level of 10 % for steel corrosion is rapidly exceeded after a service period of approximately 20 years.

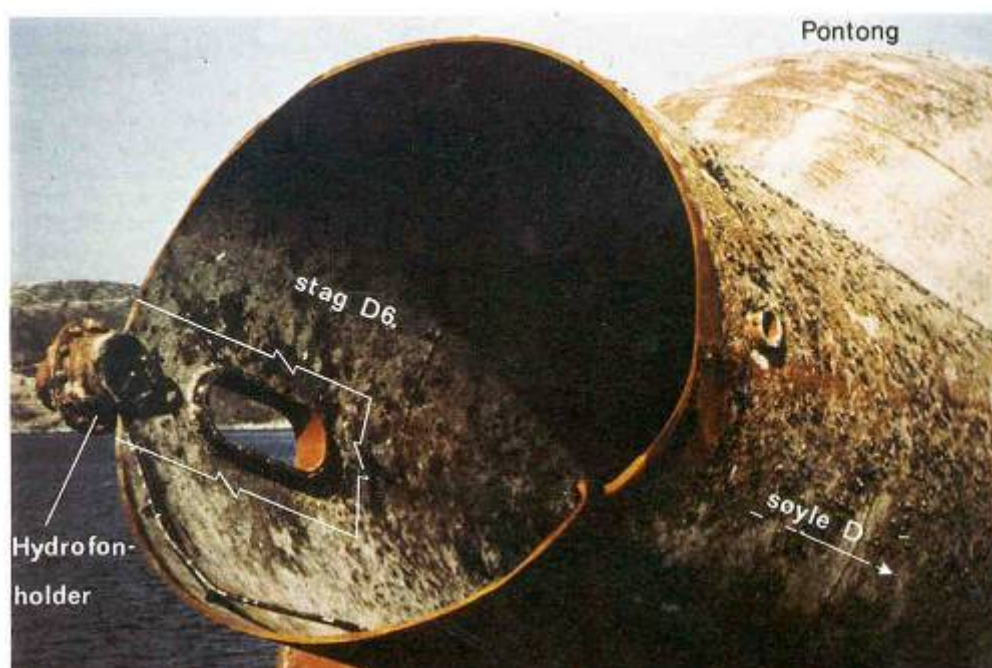
Figure 3-2-1 Alexander L. Kielland – loss of column (Source: The Alexander Kielland Accident. NOU 1981:11) /2/.

There have been relatively few major accidents due to degradation of floating units. The most severe accident is Alexander Kielland (1980), which lost one column due to fatigue cracking. The crack started from welded detail in way of a hydrophone (Figure 3-2-1 and Figure 3-2-2). At that time the braces were normally filled with water, which made it impossible to detect any leakage due to the fatigue cracking, and the crack could grow to a critical size, with the following rupture of the brace element.

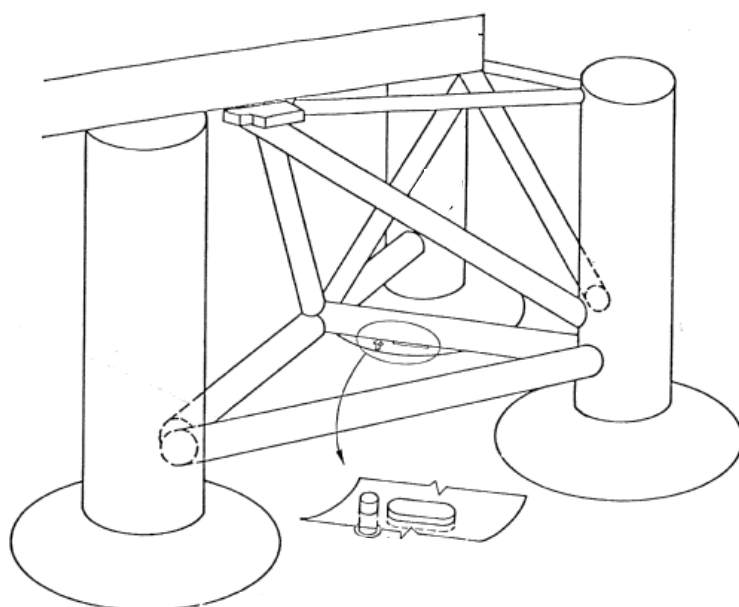
Figure 3-2-2 Alexander L. Kielland – position of crack (Source: The Alexander Kielland Accident. NOU 1981:11) /2/.

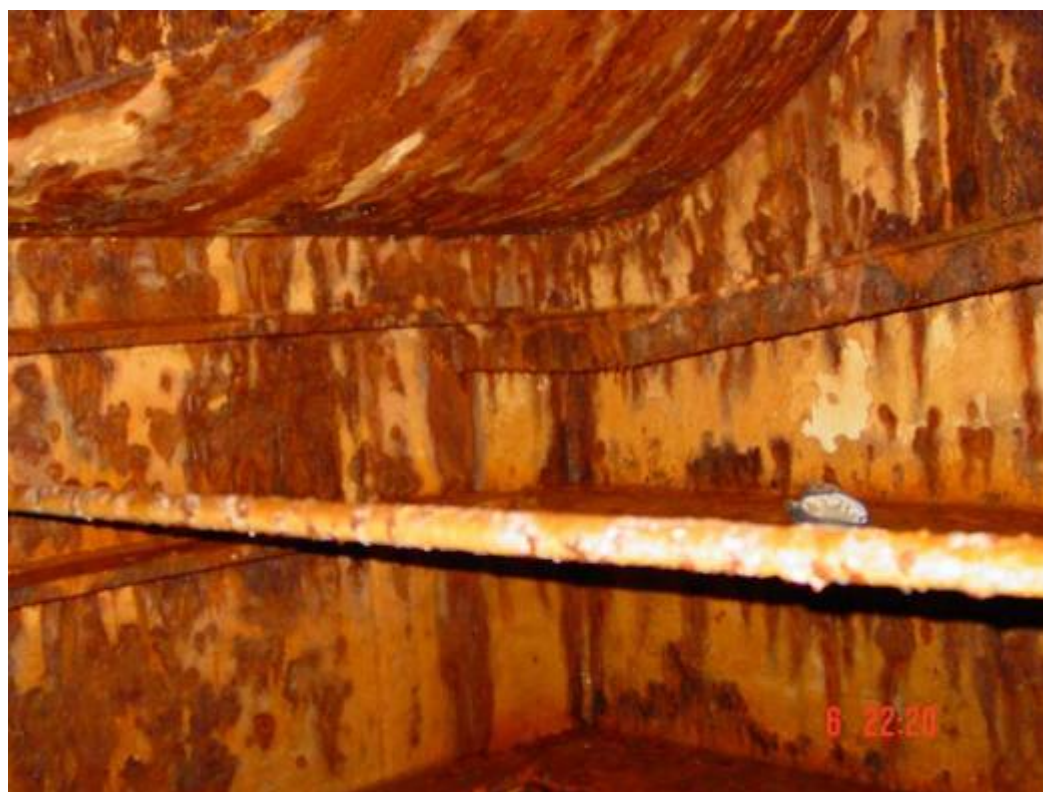
Figure 3-2-3 General Corrosion inside ballast tank (DNV photo).

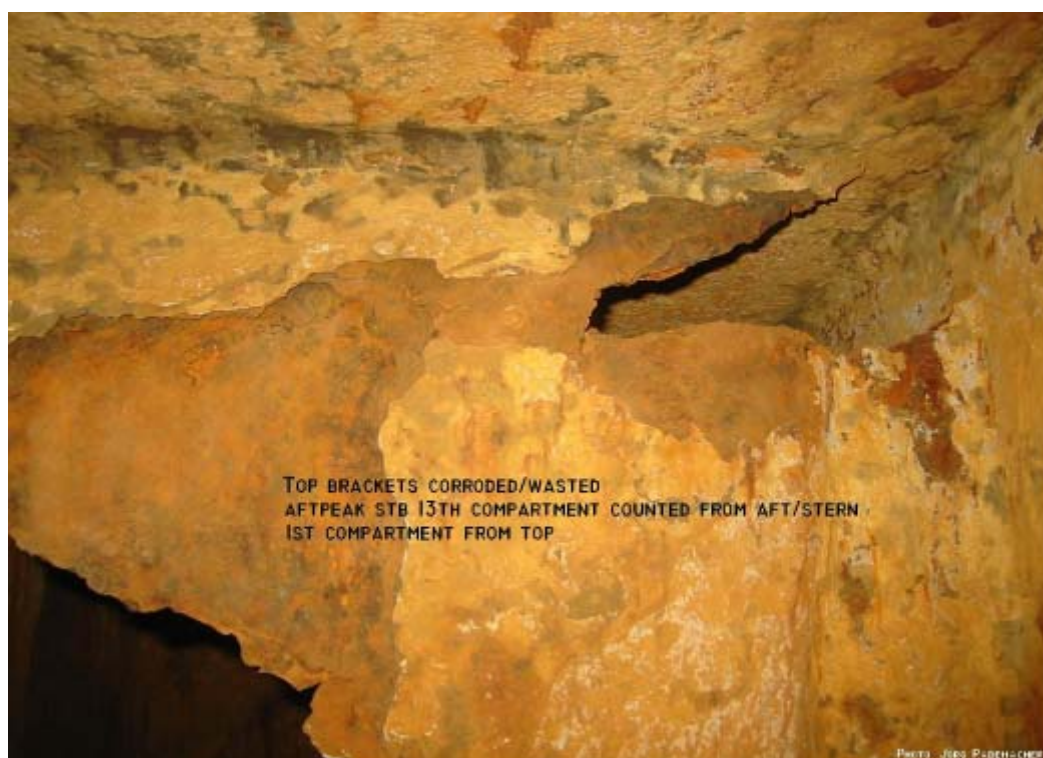
Figure 3-2-4 Heavy Corrosion inside aft peak ballast tank.

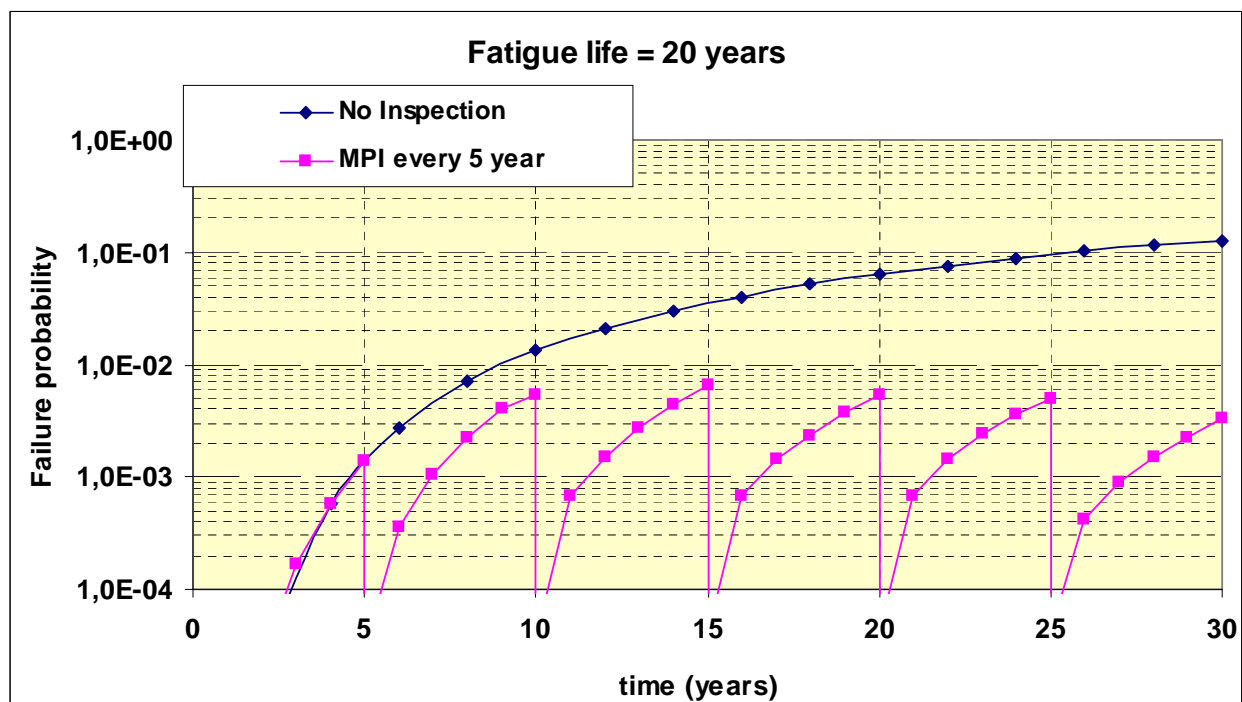
Figure 3-2-5 Failure probability.

1. Units with no fatigue cracks during the first 20-30 years of operation can continue to follow the existing inspection schedule. Risk-based inspection methods show that unit with no cracks maintain the safety level also after exceeding the document fatigue life as long as no cracks are detected, see Figure 3-2-5. The methodology is described in OTC 11950 (2000): "Fatigue Reliability of Old Semi-submersibles", /3/.

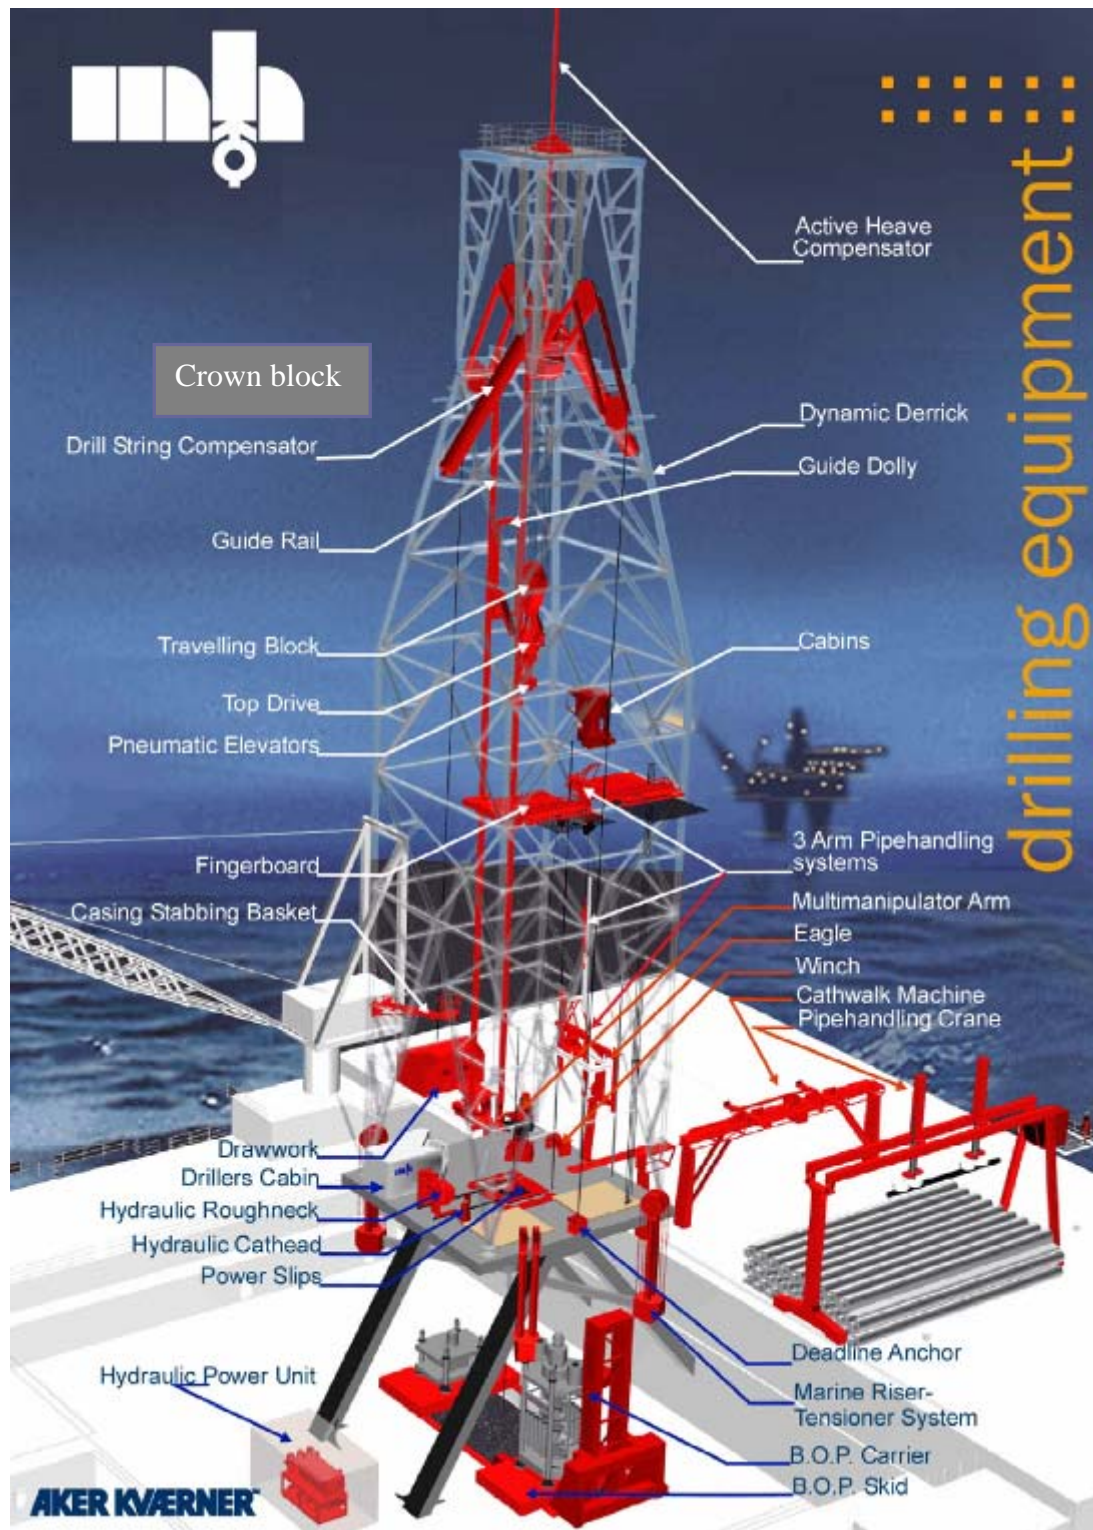
Figure 6-1 Typical schematic layout, drilling equipment (Aker Kværner).

A typical schematic layout of the drilling equipment is shown in Figure 6-1.

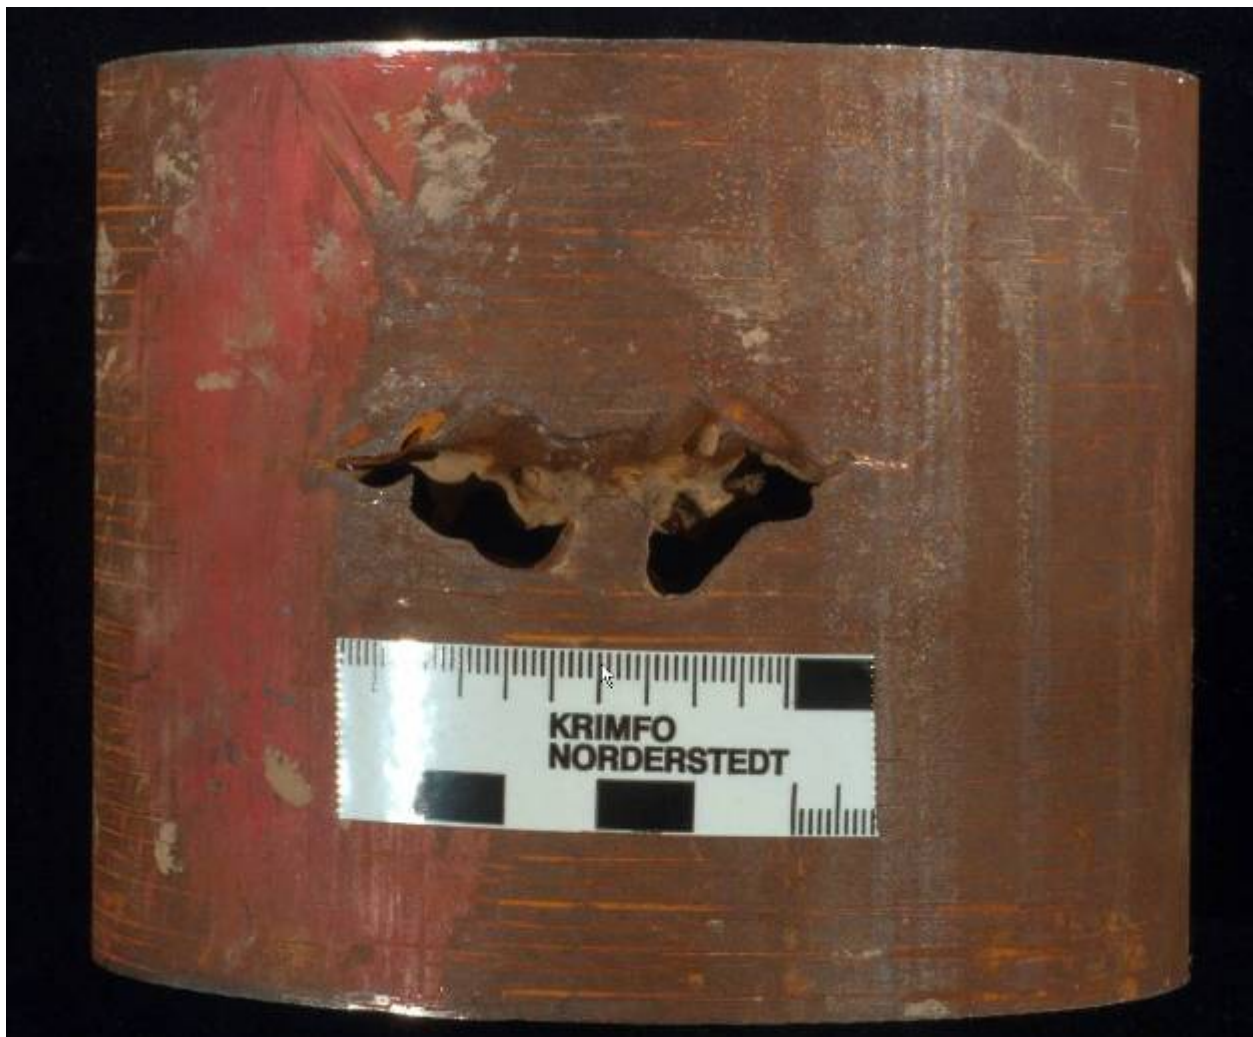
Figure 6-2 Typical example wash-out of drill string (DNV photo).

The drill string often experience fatigue cracking due to ageing and poor control with the number of load cycles. The handling and use of the drill string give small damages which lead to corrosion, which accelerates fatigue (i.e. corrosion fatigue as described in Section 2.1.4) and thereby give a fatigue weakness and damage. High differential pressures combined with eroding environment might lead to wash-out of the drill string as shown in Figure 6-2.

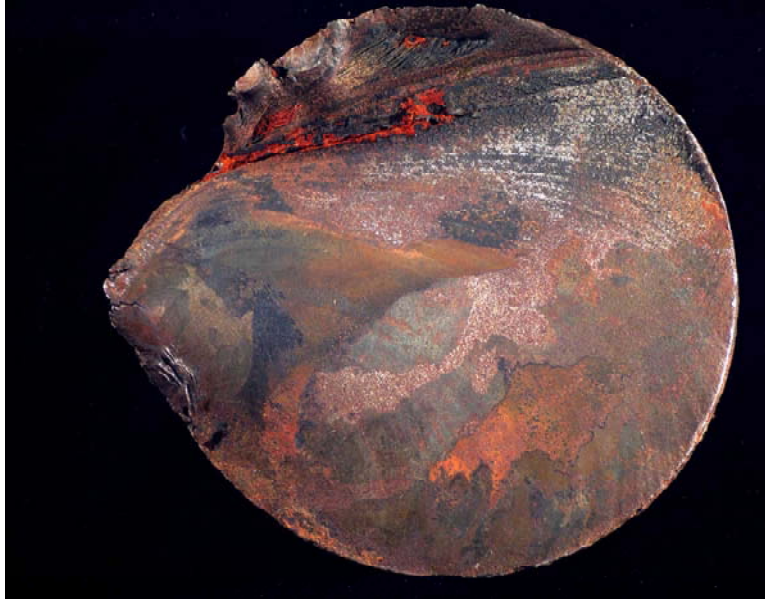
Figure 7-1 Fatigue (DNV Photo).

In Figure 7-1 the line failure was caused by fatigue. The fatigue initiation has caused the chain link fracture and growth has been probably due to overloading of the chain link. Most likely the overloading has been probably due to twisting of the chain link, in addition to high cyclic axial tension loading of the mooring chain.

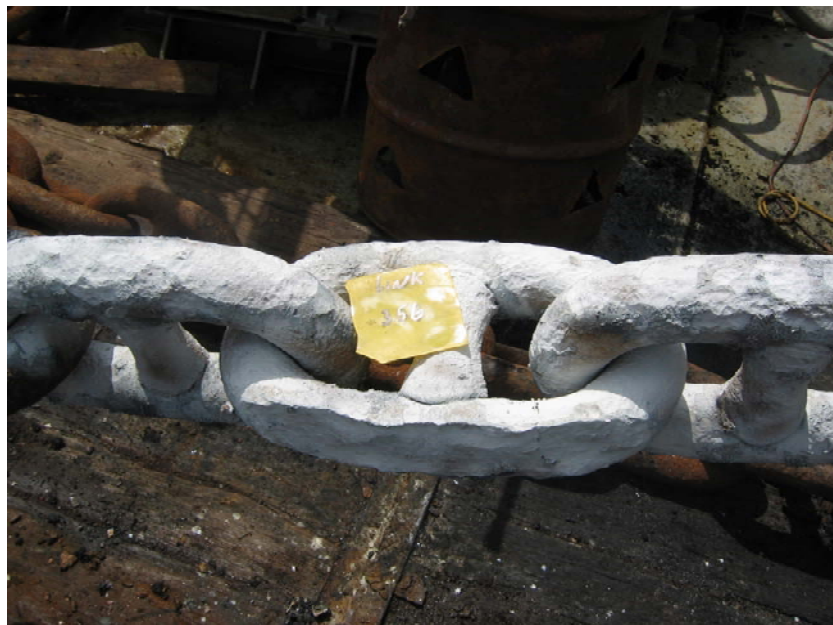
Figure 7-2 Bacterial corrosion (DNV classed FPSO offshore West Africa).

The chain links shown in Figure 7-2 have suffered bacterial corrosion along one of the straight sides. The corrosion rate was estimated to be of 2.5 mm/year at the contact area between chain and seabed based on this examination. Even though the damage was confined to the straight sides of the chain links (areas away from those with the highest potential stresses), a corrosion rate of this order can obviously affect life of a mooring system that is designed to be in operation during a 20 year period. In Figure 7-3 a crack was detected, which was initiated in the foot print area.

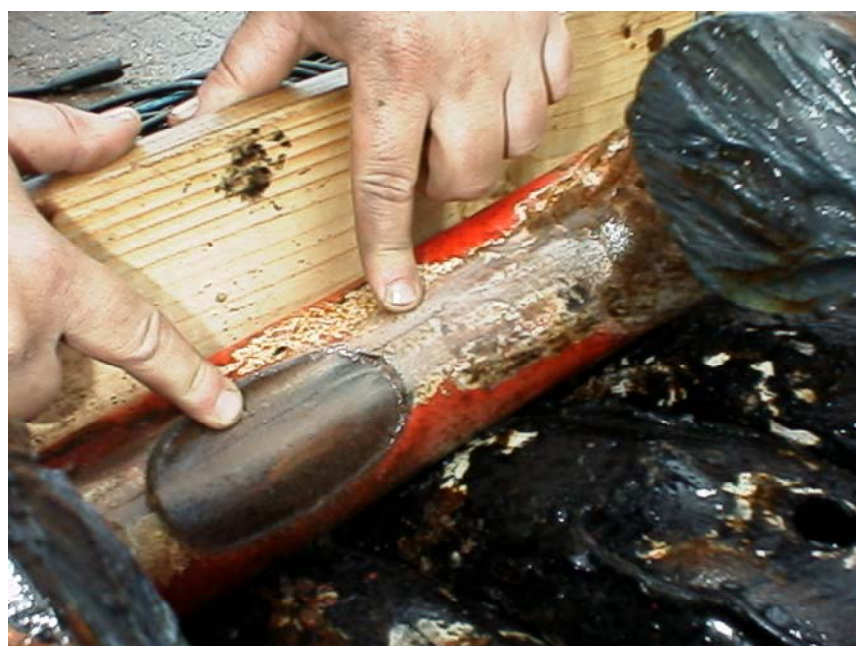
Figure 7-3 Crack initiated in the stud foot print (DNV photo).

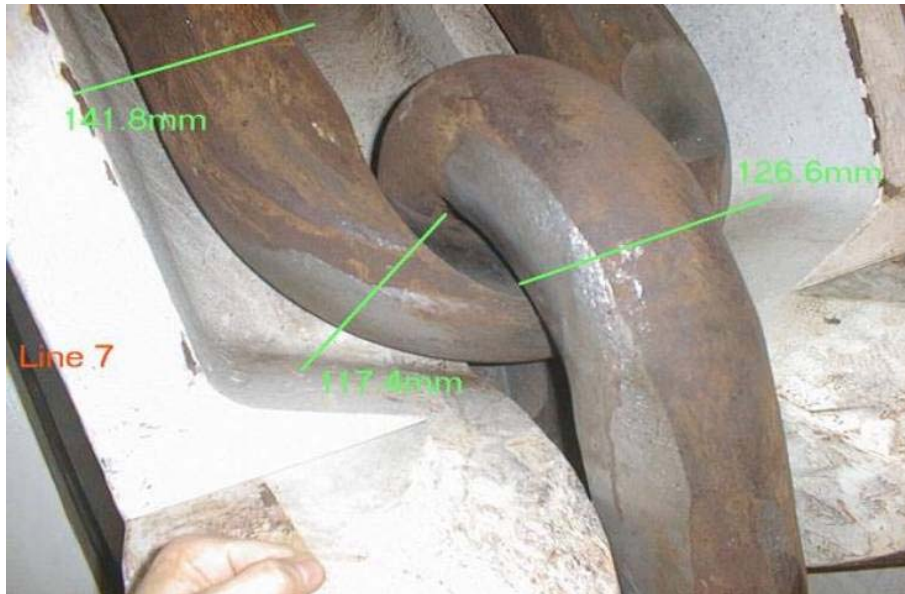
Figure 7-4 Wear and tear in chain links (Photo Norsk Hydro).

Figure 7-4 shows severe wear and tear in a long term mooring system.
