# Hydrogen assisted cracking of jack-up installations

<b>Document name:</b>	<b>Document number:</b>
Hydrogen assisted cracking of jack-up installations	323-20070-002
<b>Project name:</b>	<b>Project number:</b>
Ptil studie Hydrogeninduserte sprekker på jack-up innretninger	323-20070
<b>Project manager:</b>	<b>Department:</b>
Cicilie Mathisen	311

This study is based on available literature and practical service experiences with cracking in the lower leg and spudcan areas in jack-up offshore structures as response to increasing interest in causes, effects and prevention of hydrogen related cracking in high strength steel weldments. The aim is to map the causes, mechanisms and extent of hydrogen-induced cracks in high strength steels used in jack-up installations.

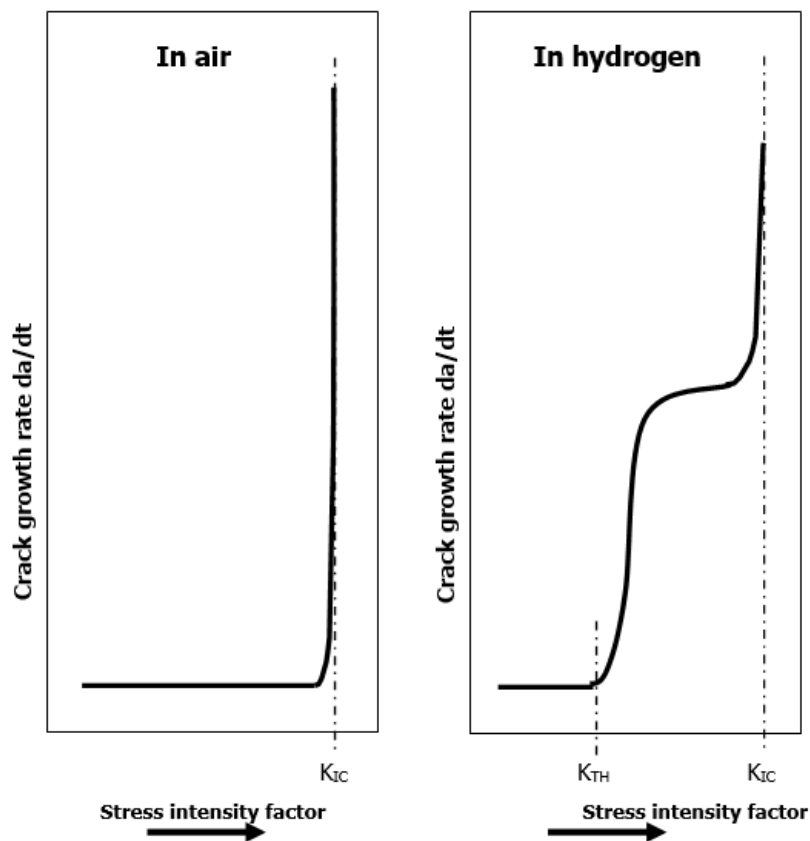
Figure 3-5 Schematic crack growth rate  $da/dt$  versus stress intensity factor. ( $a$  - crack length,  $t$  - time).

The behaviour can be described and predicted by linear elastic fracture mechanics (LEFM) as illustrated in Figure 3-5. If the stress intensity factor,  $K$ , reaches or exceeds a critical, material intrinsic, value at the crack tip known as the critical stress intensity factor, also termed fracture toughness,  $K_{IC}$ , the crack becomes unstable, and the structure may fail catastrophically. If the steel contains or is charged with hydrogen the onset of crack growth takes place at a lower (subcritical) stress intensity known as  $K_{TH}$ . The crack propagation rate may initially rise but will stabilise at a more or less stable rate independent of the  $K$ -value. Cracking will continue only if the  $K$  value remains above the  $K_{TH}$  and if the level of absorbed hydrogen is maintained ahead of the crack tip. As a result, the critical stress intensity level,  $K_{IC}$ , may never be reached in real structures:

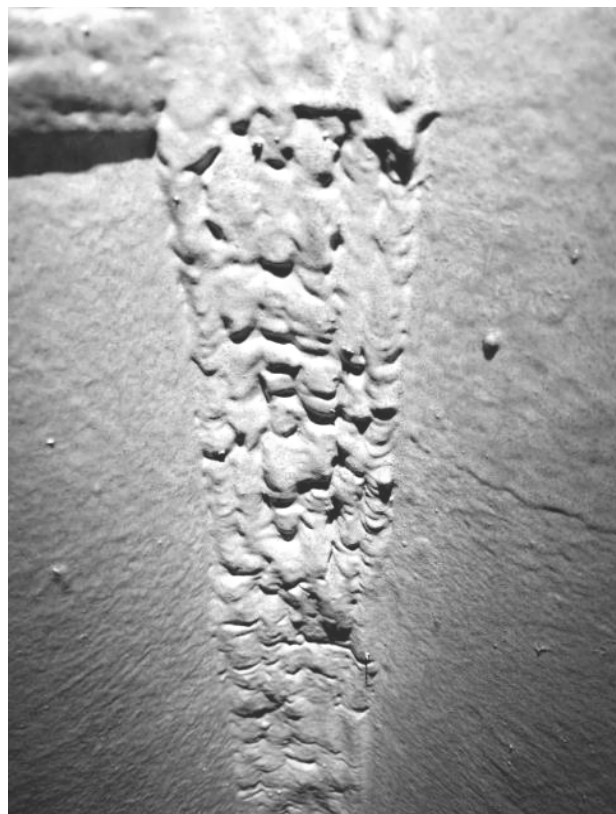
Figure 3-8 Example of poor weld quality.

The weld surface appearance as shown in Figure 3-8 is unsuitable for any kind of NDT. Further details on this matter are found in Section 10. The presence of such welds can be due to a lack of quality control, the omission of 3<sup>rd</sup> part surveillance, difficult welding conditions or lack of workmanship.

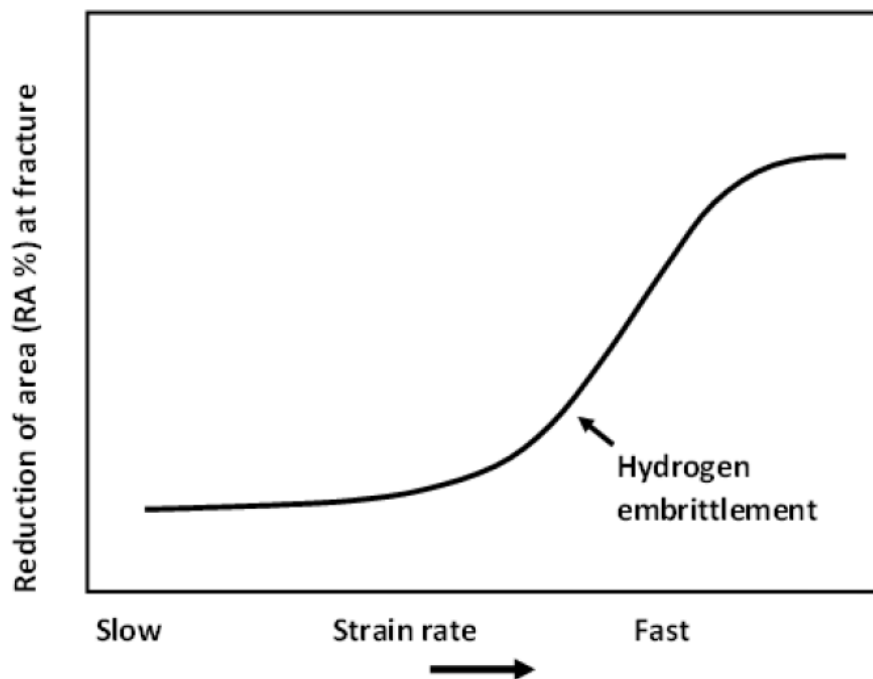
Figure 4-4 Schematic illustration of the effect of strain rate on fracture ductility in presence of hydrogen.

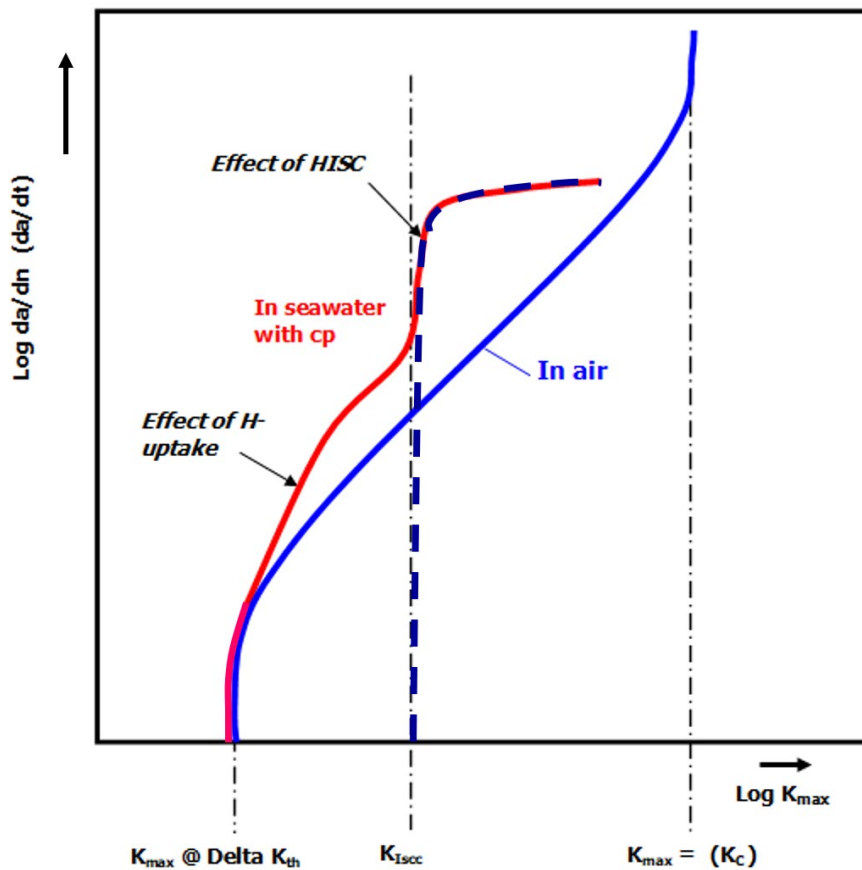
Figure 4-8 Schematic illustration of combined hydrogen assisted fatigue crack growth and hydrogen induced stress cracking behaviour versus  $K_{max}$  for a given stress ratio.

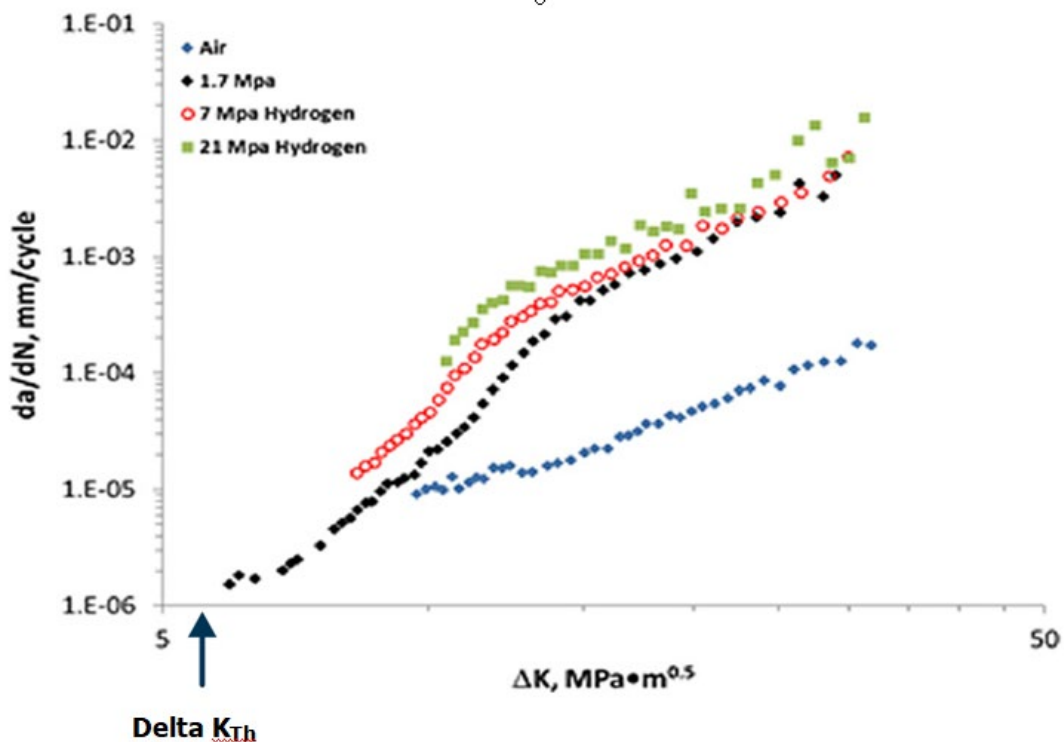
Figure 4-9 Fatigue crack growth of X100 steel in air and in hydrogen [32].

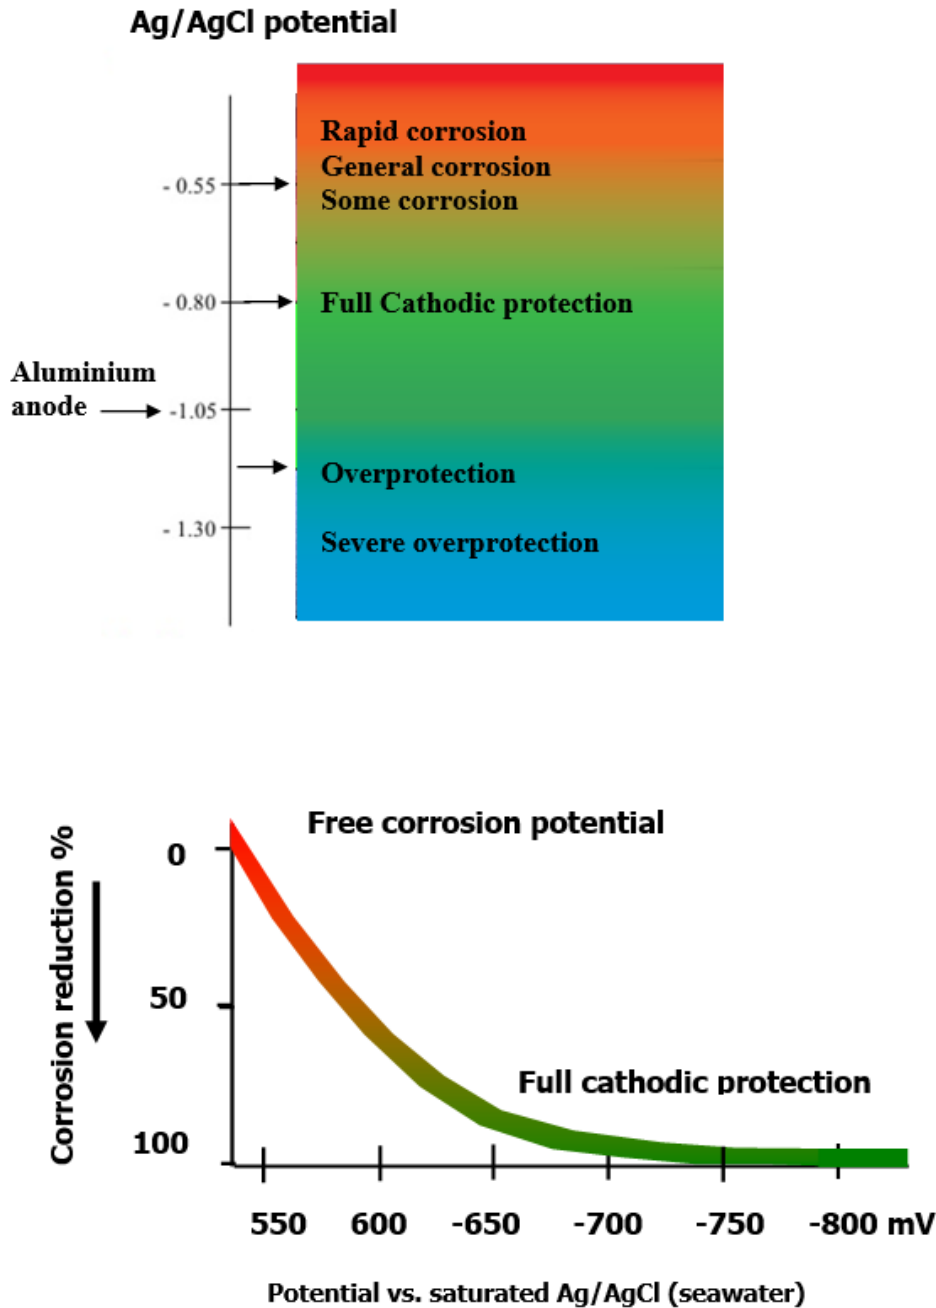
Figure 5-2 Illustration of by cathodic protection in seawater.

As previously mentioned, cathodic protection (CP) consists of lowering the electrode potential of the steel to sufficiently low potential to stop corrosion. Figure 5-2 illustrates the influence of potential on the corrosion rate of steel in seawater. In neutral seawater, a potential around -0.8 V (Ag/AgCl) is sufficient to prevent corrosion.

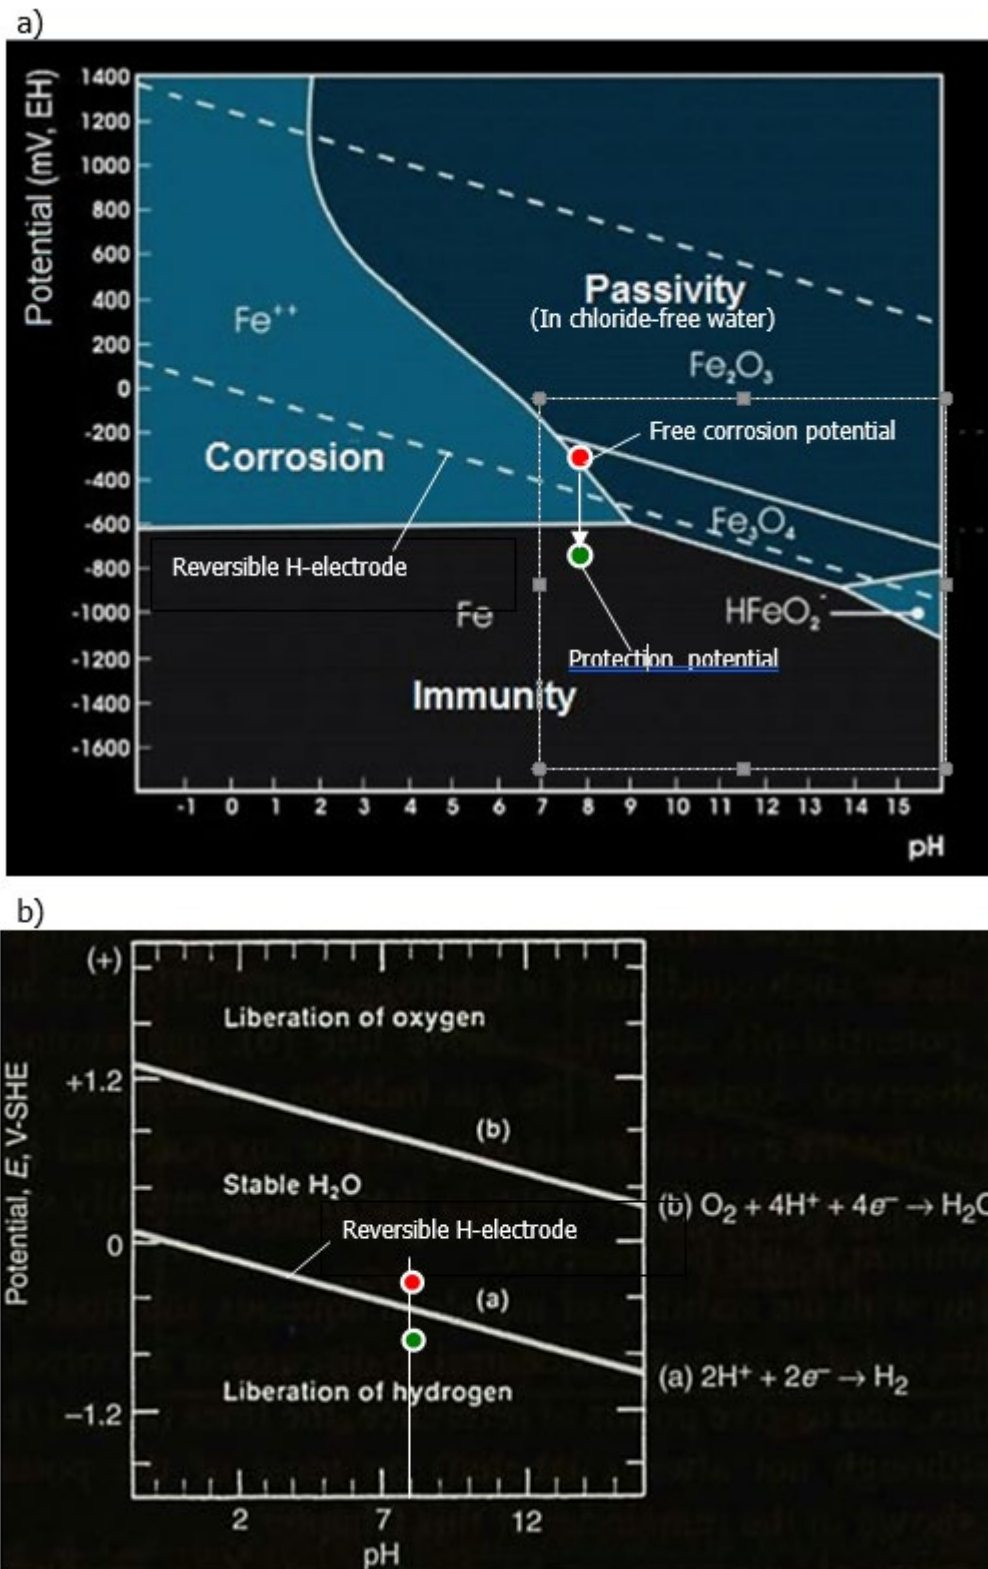
Figure 5-3 Pourbaix diagram, steel in water (a) and hydrogen equilibrium diagram (b).

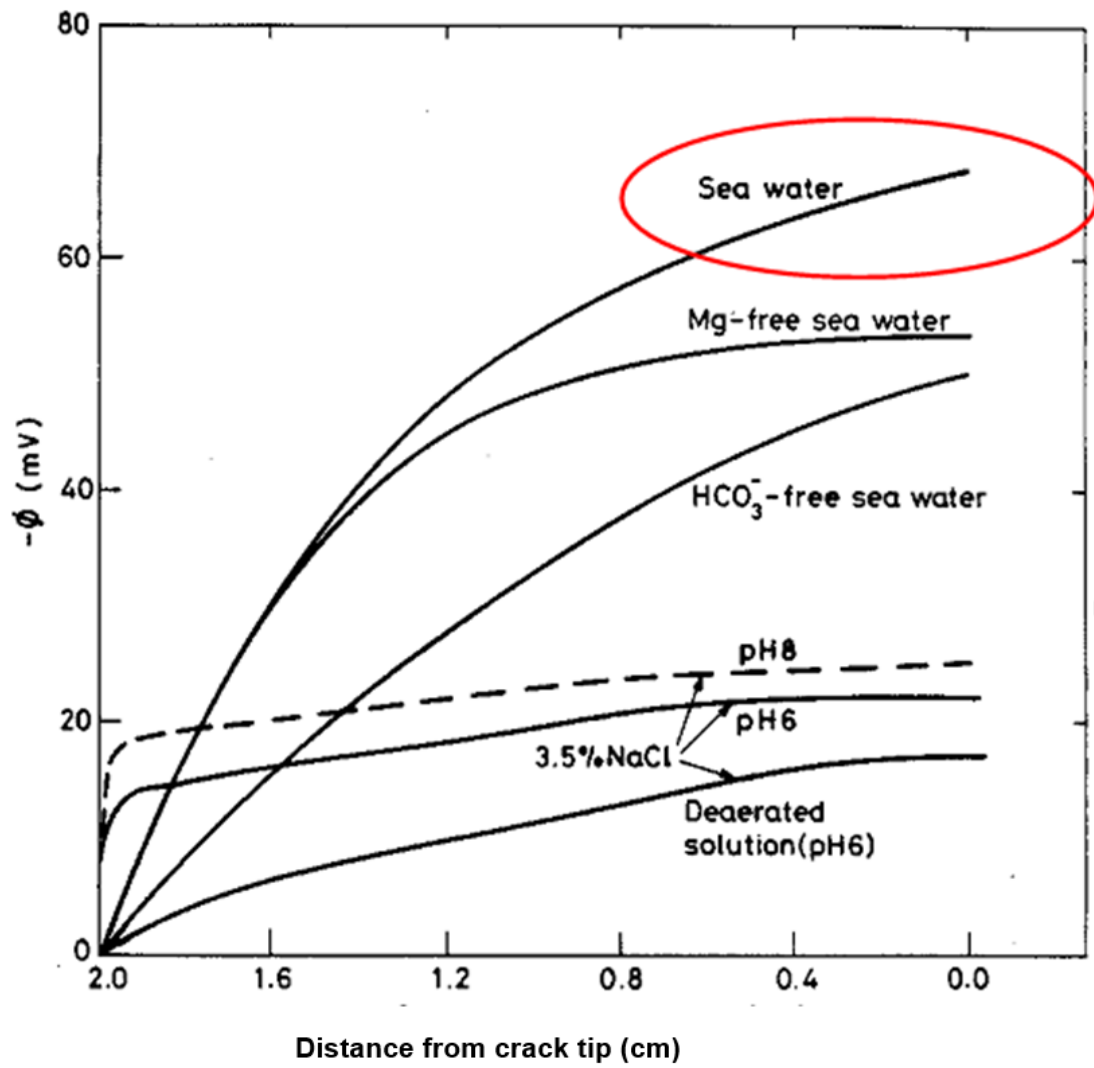
Figure 5-6 Variations of the potential drop with distance from the crack for different bulk solution chemistries [39].

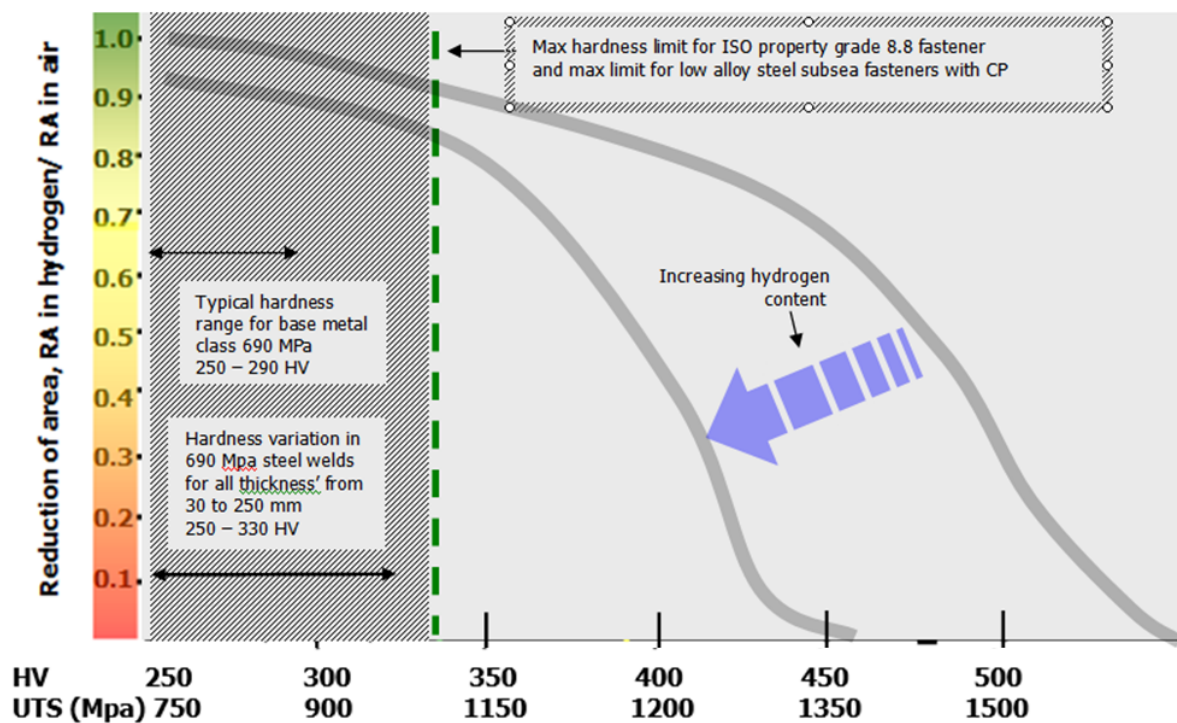
Figure 6-2 Susceptibility to hydrogen embrittlement expressed as ratio of reduction of area at fracture in slow strain rate testing in hydrogen and air, versus hardness.

Maintaining  $RA_H/RA_{Air}$  above 0.90 gives credit to the intrinsic material properties. Resistance to weld cold cracks and hydrogen embrittlement can be obtained by careful selection and testing of steels, weld consumables and welding parameters. Furthermore, a qualified welding procedure specification (WPS) is required for each steel to control the thermal cycle during welding and eliminate excessive hydrogen absorption.

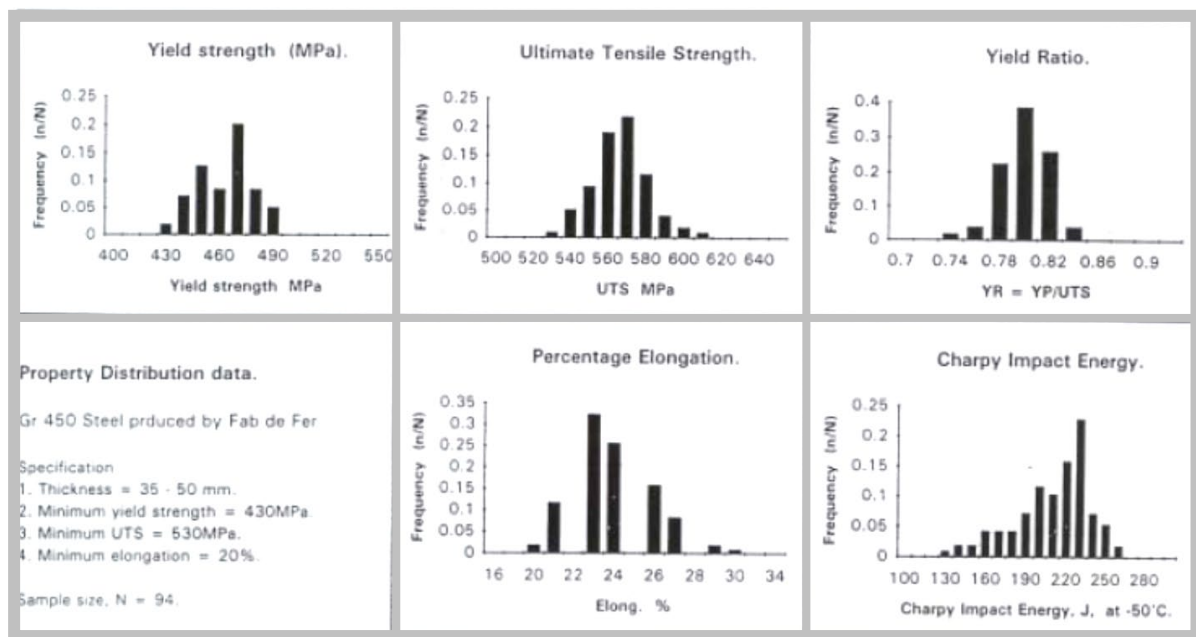
Figure 6-3 Example of variations in mechanical properties for 450 MPa steel.

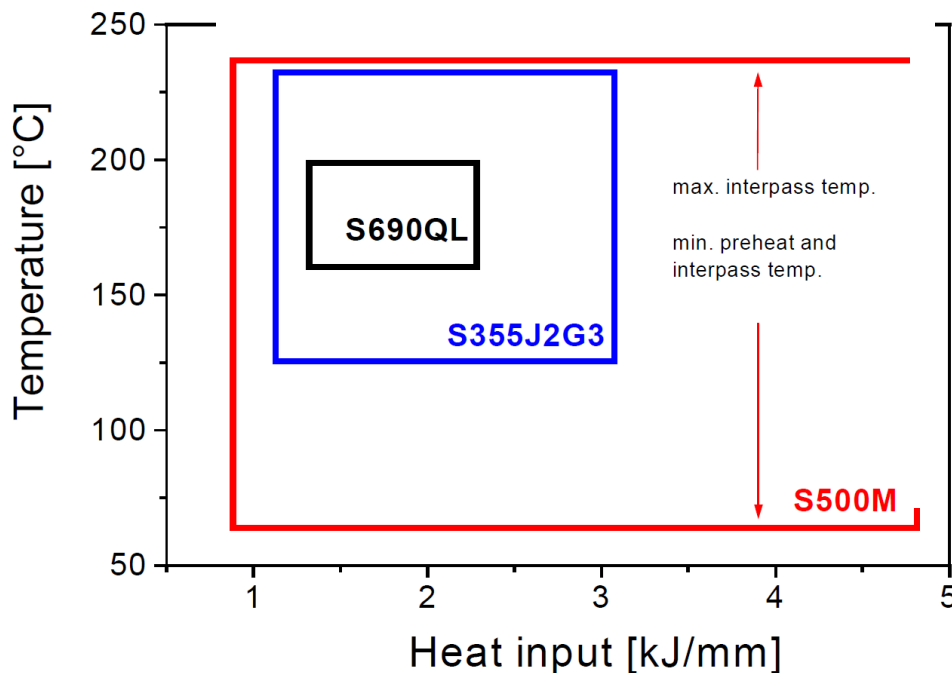
Figure 6-8 Examples of working ranges ("safe windows") for welding of different structural steels with plate thickness providing equal load carrying capacity [45].

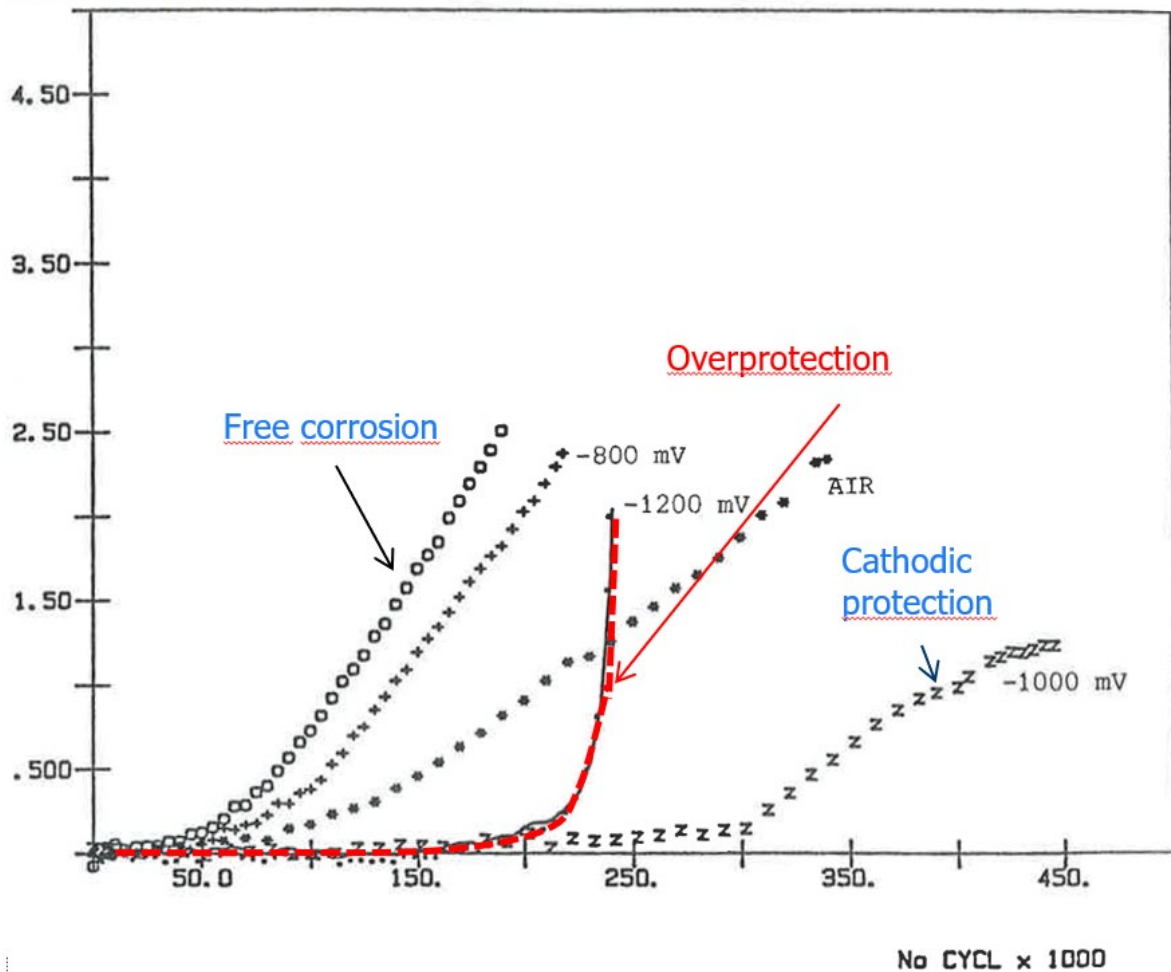
Figure 7-1 Crack length versus number of load cycles in fatigue tests of 50D steel in seawater at 5 °C at various potentials (SCE) [37].

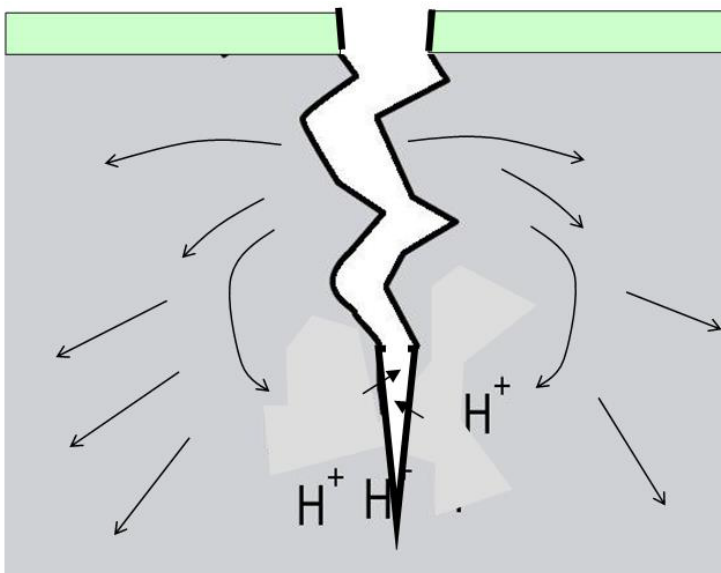
Hydrogen escapes through new crack surface, but starts to rebuild high concentration again to repeat the cracking process

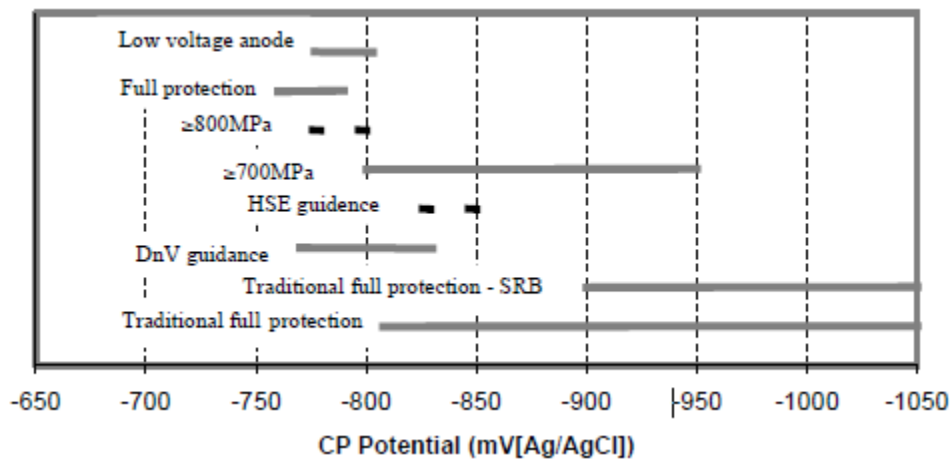
Figure 9-1 Overview of CP potential ranges [2].
