CoilHose

CoilHose | Introduction

CoilHose | Mk.6

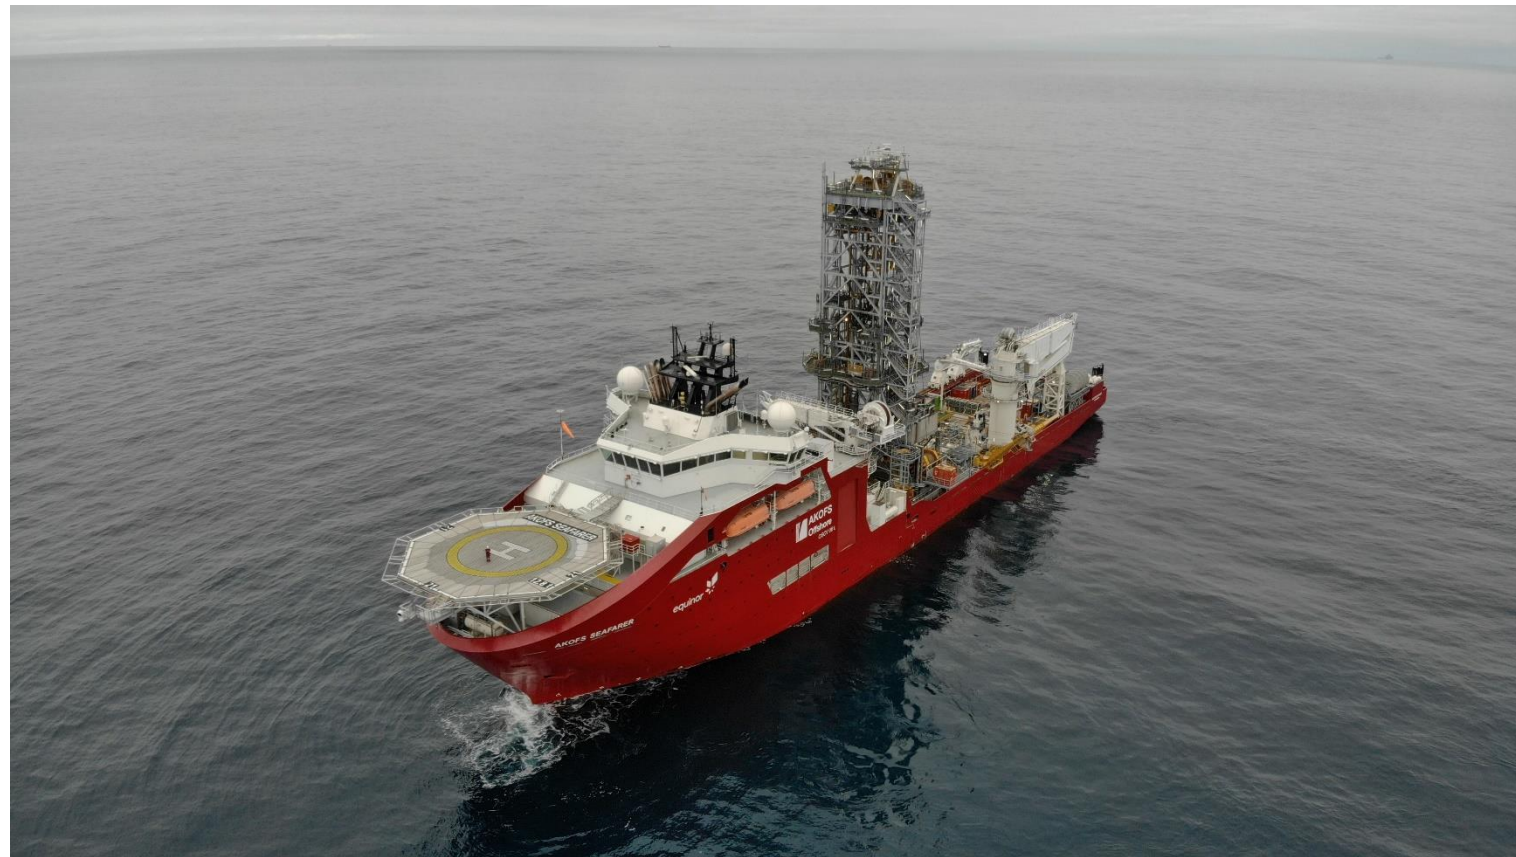
Equinor had a newly completed well that had been left with a full column of brine during the completion phase. Simulations showed that N2 gas lift was necessary to start production

The alternative to CoilHose™ would have been Coil Tubing which is logistically challenging, High POB and very much weather dependent

Equinor had previously worked with Expro and have a good understanding of our CoilHose™ technology and our ability to perform open water intervention from RLWI with a limited footprint and less POB

CoilHose™ was positioned at a depth of 2,150 m MD while the well was unloaded over a period of 7hrs

Expro deployed a 'hybrid' CoilHose™ package to work in conjunction with the customers preferred wireline vendor resulting in a fully integrated service delivery platform

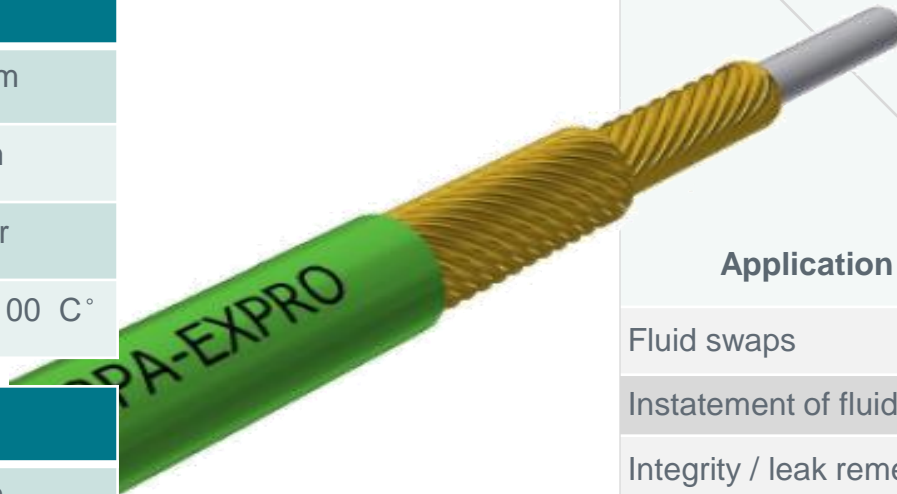
AI Hose and Fluid pumping table

Large AI Hose	
OD	11.5 mm
ID	6.3 mm
Working pressure	600 Bar
Temperature rating	-30 to 100 C°

Small AI Hose	
OD	6.9 mm
ID	3.4 mm
Working pressure	690 Bar
Temperature rating	-30 to 100 C°

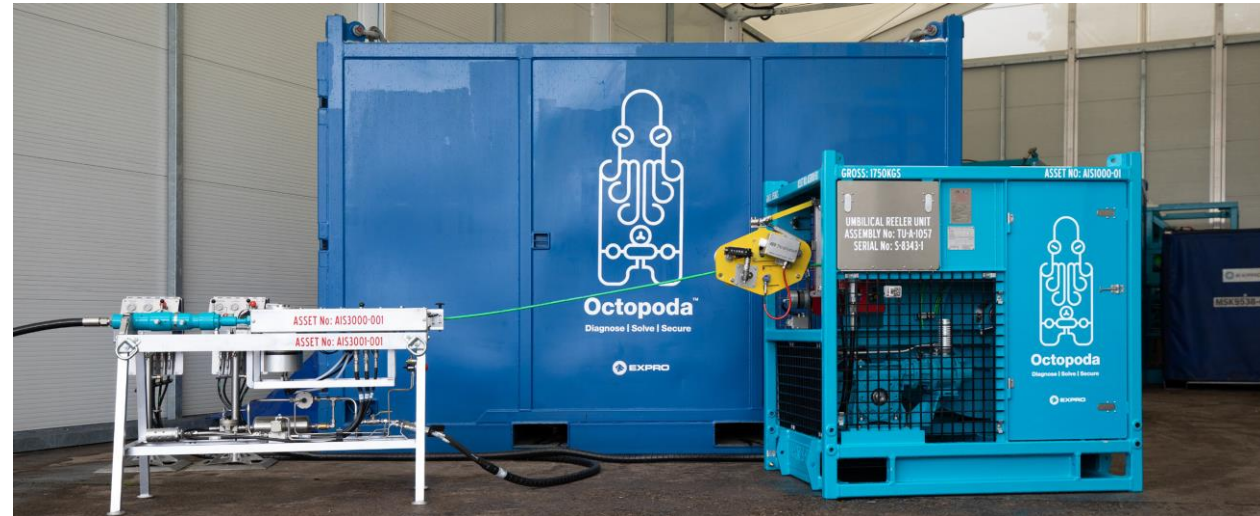
This was a cost-effective alternative to a full well workover and competitor solutions

The customer was able to regain annulus integrity within acceptable limits by swapping out the annulus contents with a heavy (14.8 PPG / 1.8 SG) brine

The Expro Octopoda™ solution utilized minimal personnel and equipment footprint and was powered by the Platform air supply
