Investigation report

| Report title Investigation of an incident with personal injury and gas leak when splitting a blind hub on Statfjord B on 22 April 2023 | Activity number 001037074 |

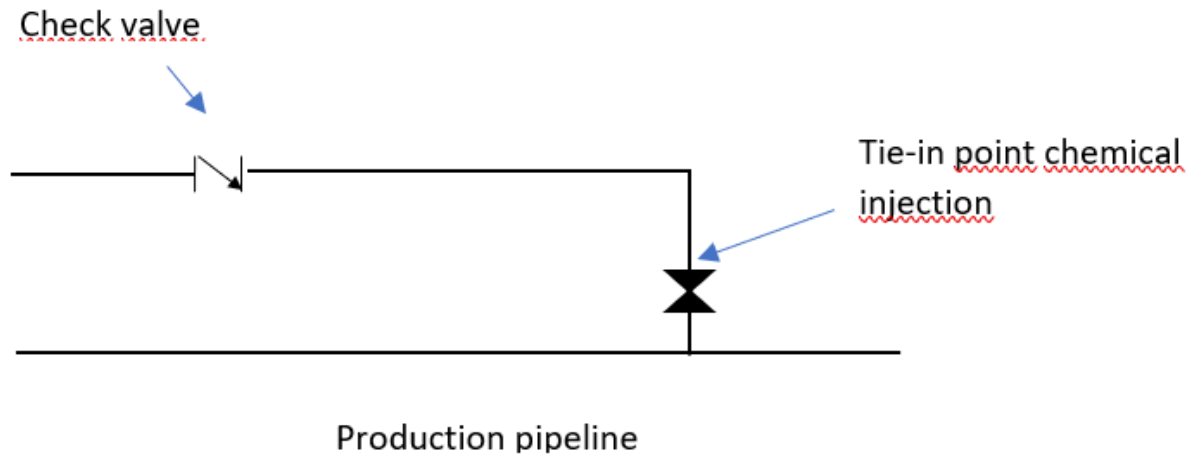
SFB has different design solutions for chemical injection lines. Old (unmodified) wells have a solution without a check valve between the tie-in point and the production pipeline (see the example in the illustration of the technical solution presented in figure 6).

Figure 6 "Old" type of chemical injection valve, where the check valve is installed upstream of the chemical injection point.

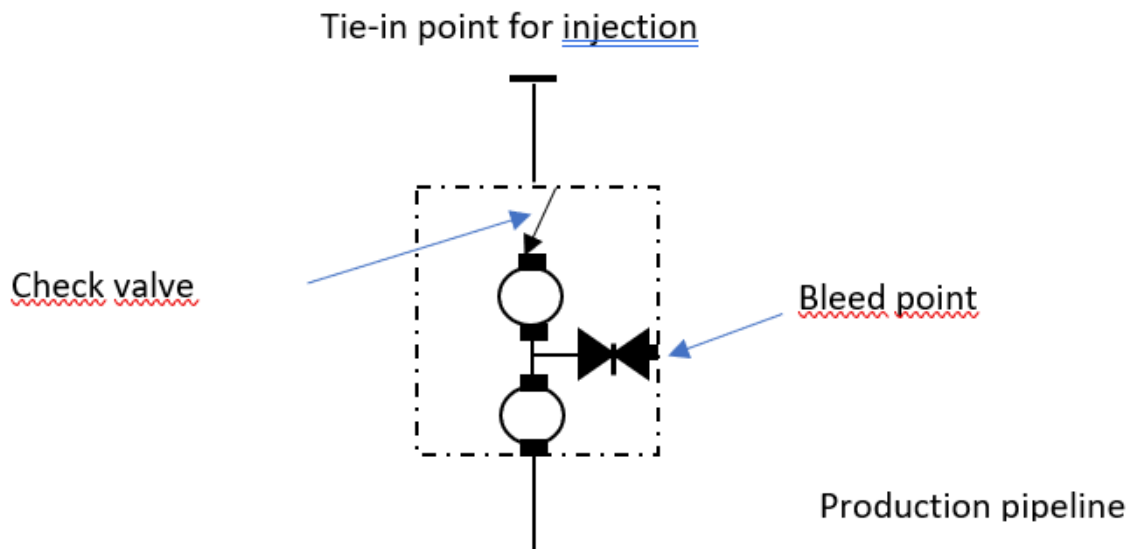
New wells (where older production pipelines in carbon steel are replaced by corrosion-resistant piping) are fitted with "new" double block and bleed (DB&B) valves featuring a built-in check valve. See figure 7.

Figure 7 Diagram of the "new" DB&B valve, where the check valve is installed in the valve cavity. Injection takes place through a pipe nozzle. The check valve prevents backflow of gas or liquid from the production pipeline.

The "new" DB&B valve type with built-in check valve was installed in this modification project.

This “new” type DB&B valve is labelled with a red arrow. The Havtil team has been informed that the latter shows the direction of flow through the valve/check valve. The “old” type of valve is not marked in this way.

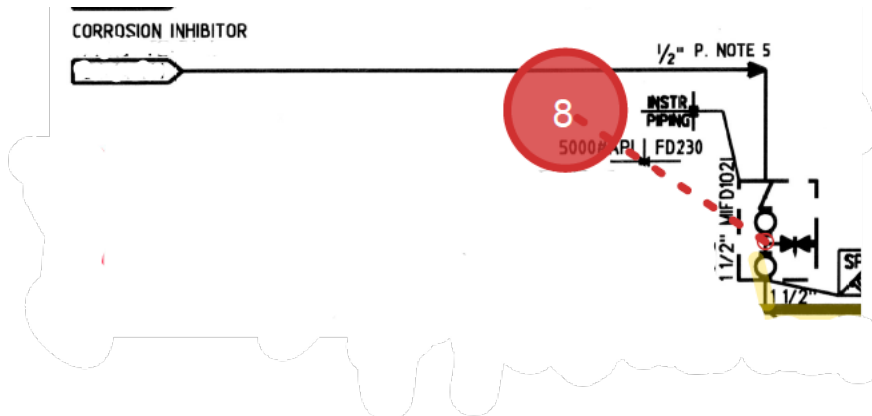
The “new DB&B valve type with check valve is marked in several places on the P&ID for well B-18 (after modification). See the extract from the P&ID in figure 8.

Figure 8 Extract from the P&ID for well B-18 after installation of the “new DB&B valve type. (Source: Equinor)
