Investigation report

Report title Report from the investigation of the listing of <i>Floatel Superior</i> , 7 November 2012 on the Njord field	Activity number 420001003
---	------------------------------

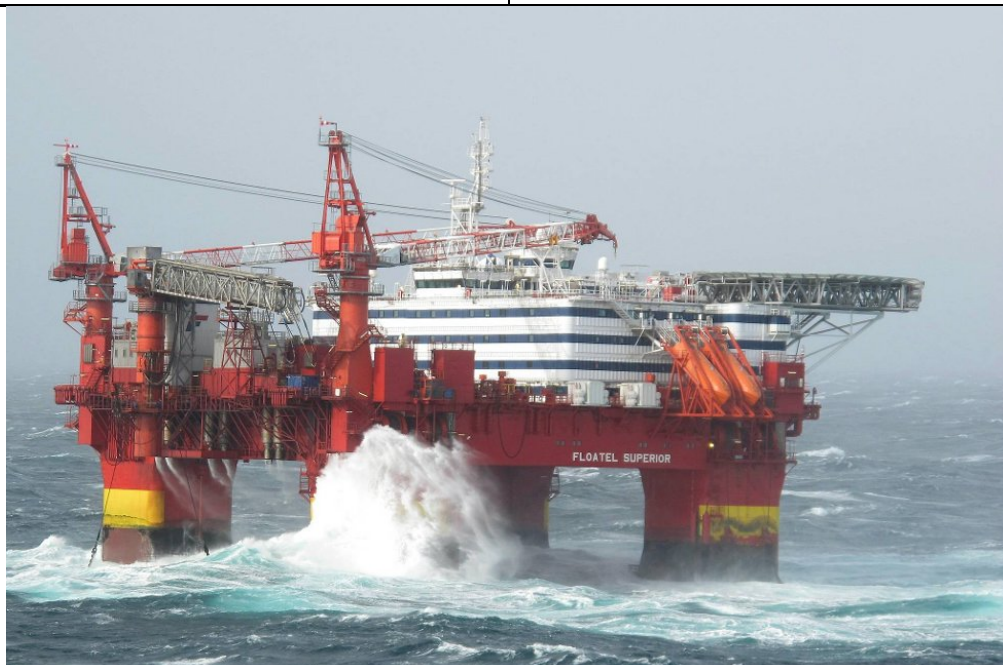
Figure 1: *Floatel Superior* at survival draft (13 metres). The air gap is 14.5 metres from sea level to the underside of the topside (beneath the text “FLOATEL SUPERIOR” in the photograph). Spray from the wave in the foreground reaches the drum of winch 4 (with anchor line 8) on the forward port column. The photograph was taken during an earlier episode of bad weather. Copyright Erik Sevaldsen¹.

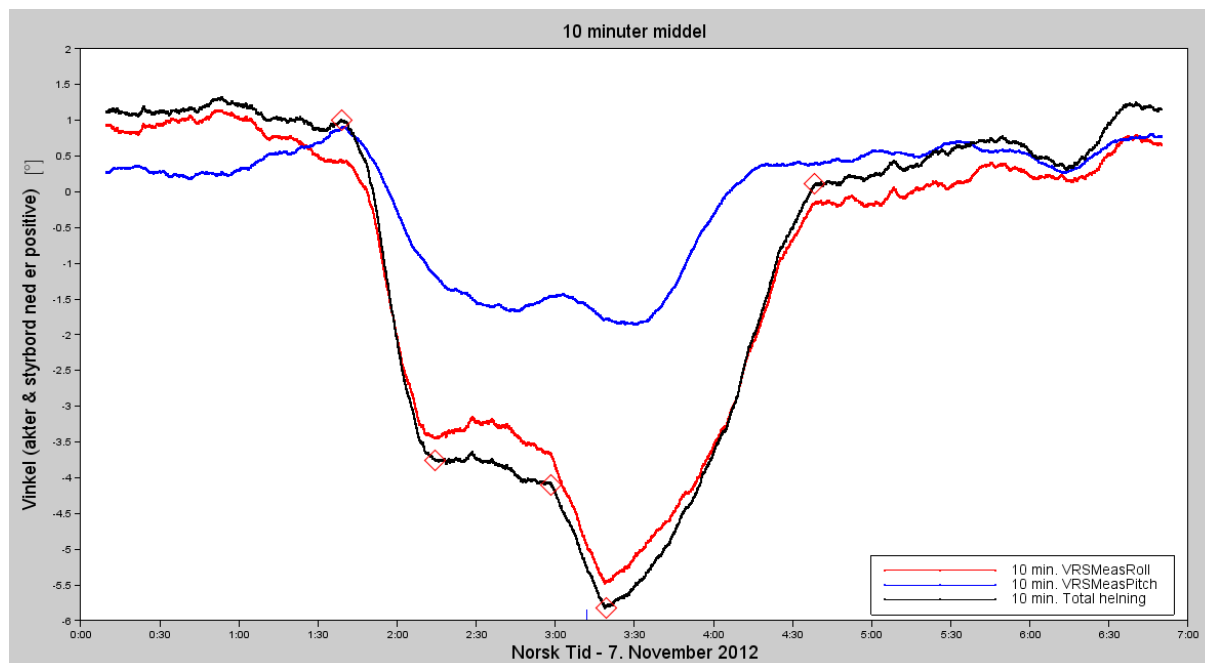
Figure 9: Calculated mean listing history from measured roll and pitch motions on the incident night. The diamond symbols mark the times when clear changes occur in the graphs – about 01.40, 02.15, 03.00, 03.20 and 04.40. These incidents and times are discussed in the text. The figure has been produced by the PSA on the basis of data files from Floatel International [56 and 57].

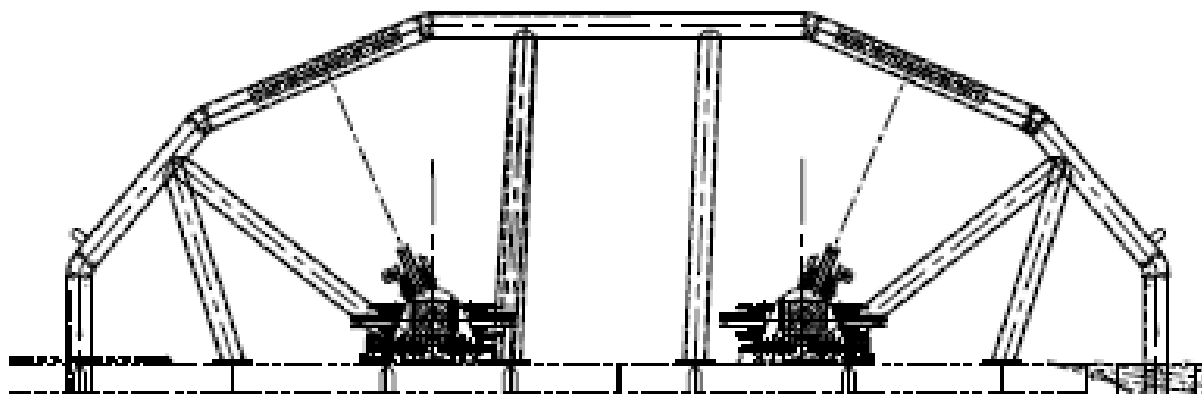
Figure 11: A drawing of the bolster on *Floatel Superior* produced by Keppel FELS [58]. It consists of 14- and 16-inch steel tubes welded together. The anchors are attached to the wear surfaces identified by black infill. The dotted lines show the wire ropes from the winches to the anchors. The latter are not shown, but their intended positions are indicated by the wire ropes. Anchor position 8 is on the right-hand side of the figure and 7 to the left. See also Figure 12, which shows the same bolster after the damage.

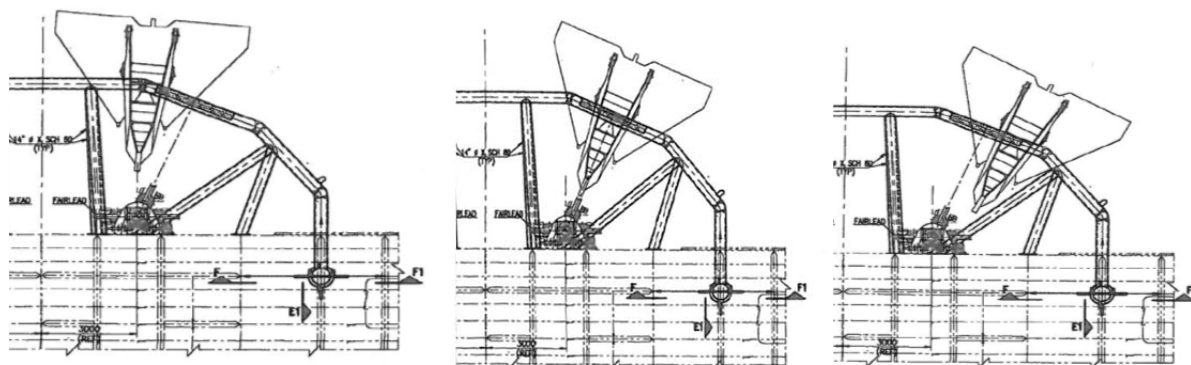
Figure 14: Drawing of the anchor positions: Centre: correctly stowed in contact with the wear surface on the bolster and with a short line (about 22 metres⁴⁷). Left: against the bolster's aft brace. Right: against the forward brace. The bolster section intended to hold the anchor is roughly right-angled at the shortest distance from fairlead to hull side under the fairlead (centred). If displaced in the order of one metre to either side, the contact points on the anchor reach the bend on the bolster and the line is lengthened by about 50 millimetres⁴⁸. That causes the active part of the wire to be elongated by $50/22000 = 0.3$ per cent. Our estimate for the increase in line tension to reach this geometry is 44-63 tonnes⁴⁹.

Keppel FELS has subsequently calculated⁵⁰ that, when the anchor moved from its intended position and towards the brace, the line must have elongated by the equivalent of 44 tonnes of tension. That is substantially larger than the load applied by Keppel FELS in its wave analyses.

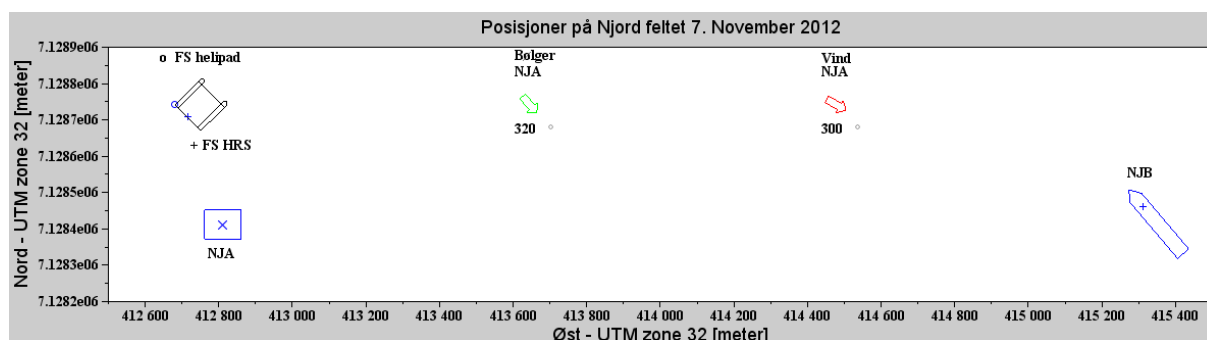
Figure 16: Position of the facilities on the incident day, 7 November, with wind and wave directions. The arrows point in the direction of the weather. The coordinates for Njord A (NJA) and B (NJB) are from the Sisu database. Those for *Floatel Superior* labelled as *FS helipad* (indicated by 0) are from the video during the evacuation,⁶⁹ and the point marked *FS HRS* (indicated by +) are the coordinates specified by the JRCC at 03.59 on 7 November 2012. We have positioned *Floatel Superior* in relation to these two positions. The coordinates have been transformed to UTM zone 32 by the NPD.

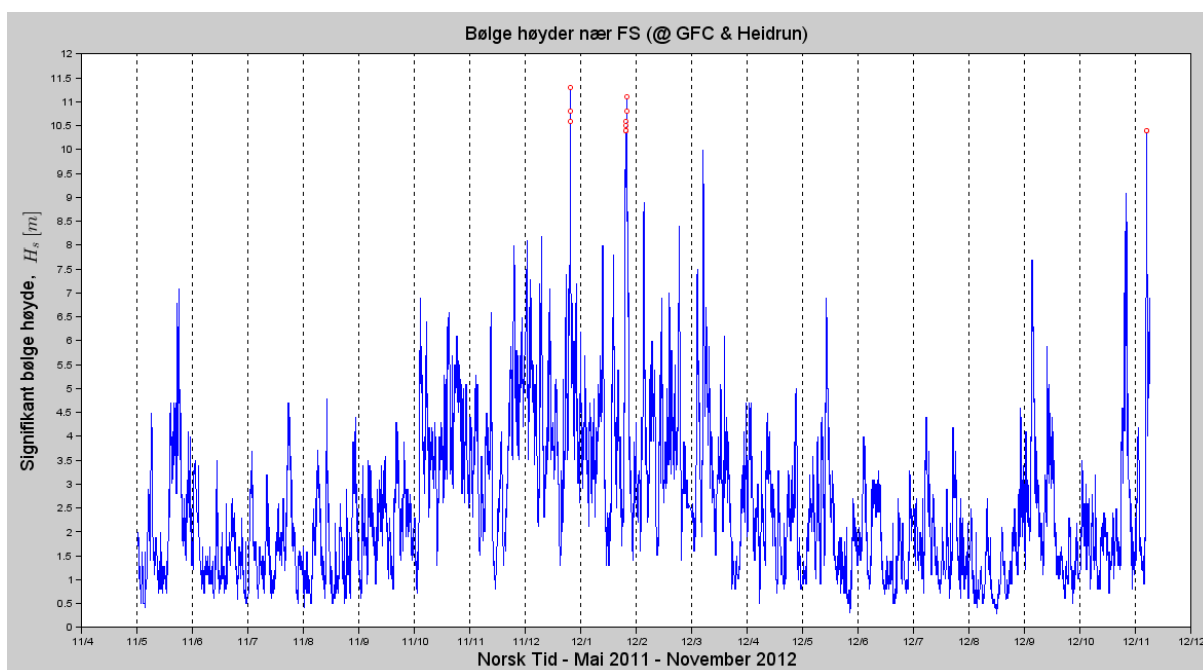
Figure 18: Wave conditions in locations close to *Floater Superior* when operating on the NCS (measurements from Gullfaks C from 1 May-31 July 2011 and Heidrun from 1 August 2011-8 November 2012). The weather on 7 November was registered as Hs 10.4 metres at 00.00 and 01.00 (on Heidrun). *Floater Superior* has only experienced worse seas in two previous storms: 25 December 2011 with maximum Hs = 11.3 metres and 26 January 2012 with maximum Hs = 11.1 metres. Observations of Hs = 10.4 metres and above are marked with red circles. Information from Statoil [124].

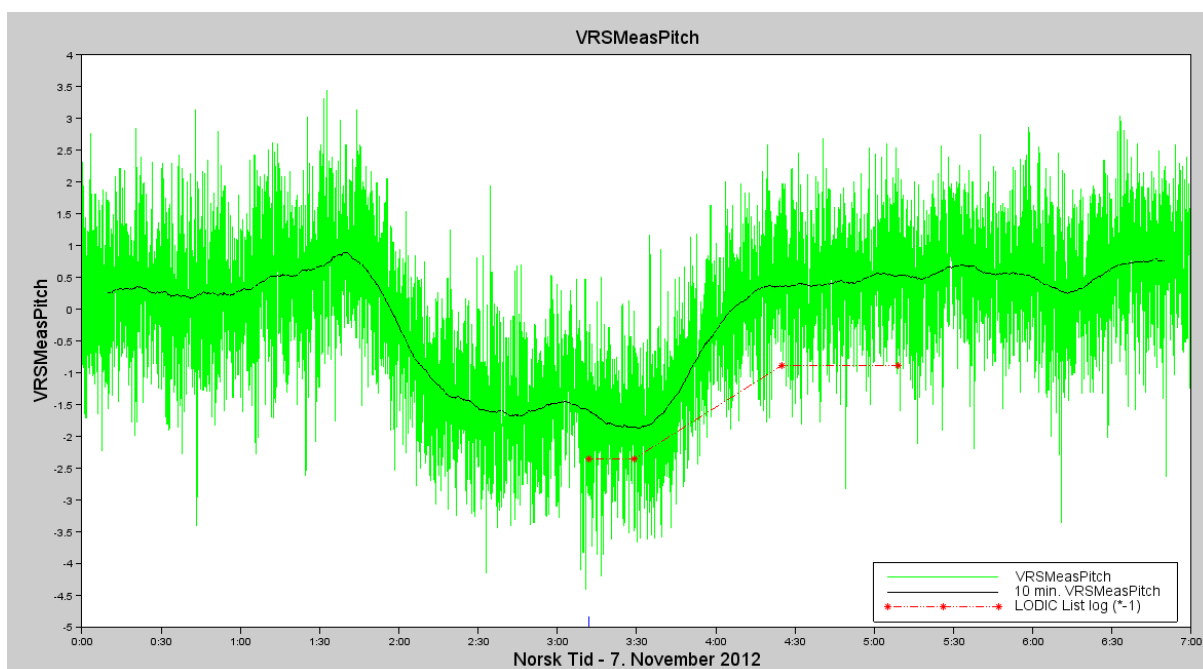
Figure 21: Registered pitch for *Floatel Superior* on the incident night. The horizontal axis shows Norwegian clock time on 7 November. The vertical axis shows pitch in degrees. Red stars show list from the stability programme (with opposite sign) [12 and 13] at times specified in the DP event log [19]. The graph has been produced by the PSA on the basis of data files from Floatel International [56 and 57].

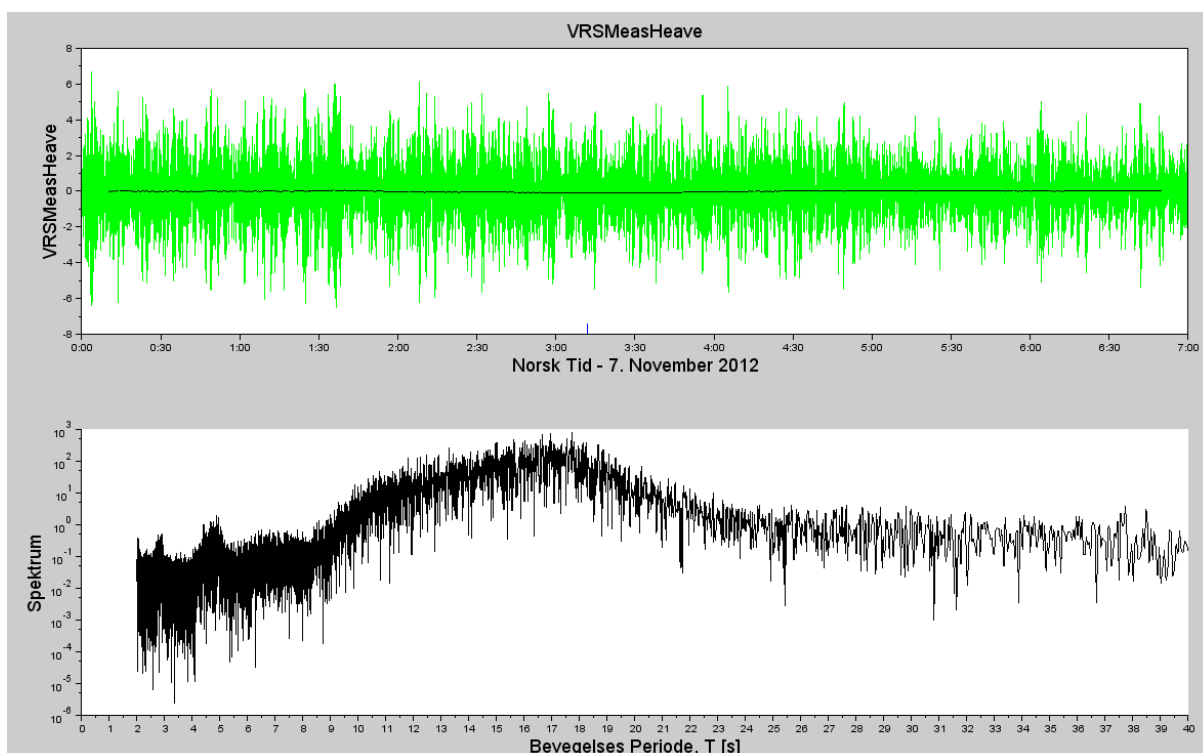
Figure 22: Registered heave for *Floatel Superior* on the incident night. The topmost graph shows the timeline. The horizontal axis shows Norwegian clock time on 7 November. The vertical axis shows heave and the 10-minute mean line. The graph above shows wave energy spectral density on a logarithmic scale as a function of the motion period. Note that motion in the 10-18 second interval is dominant, and at peak is at about the 17 second period in accordance with the weather information about T_p . The figure has been produced by the PSA on the basis of data files from Floatel International [56 and 57]. According to the marine operations manual [95], the natural period for roll and pitch for *Floatel Superior* lies between

48 and 77 seconds at drafts from 16.0-20.5 metres, and is thereby far outside first-order wave influences. The natural period for heave is given as 18.7-19.0 seconds, and is thereby very close to the dominant T_p on the incident night. Nevertheless, no clear spike can be seen in the spectrum which shows any marked dynamic amplification.

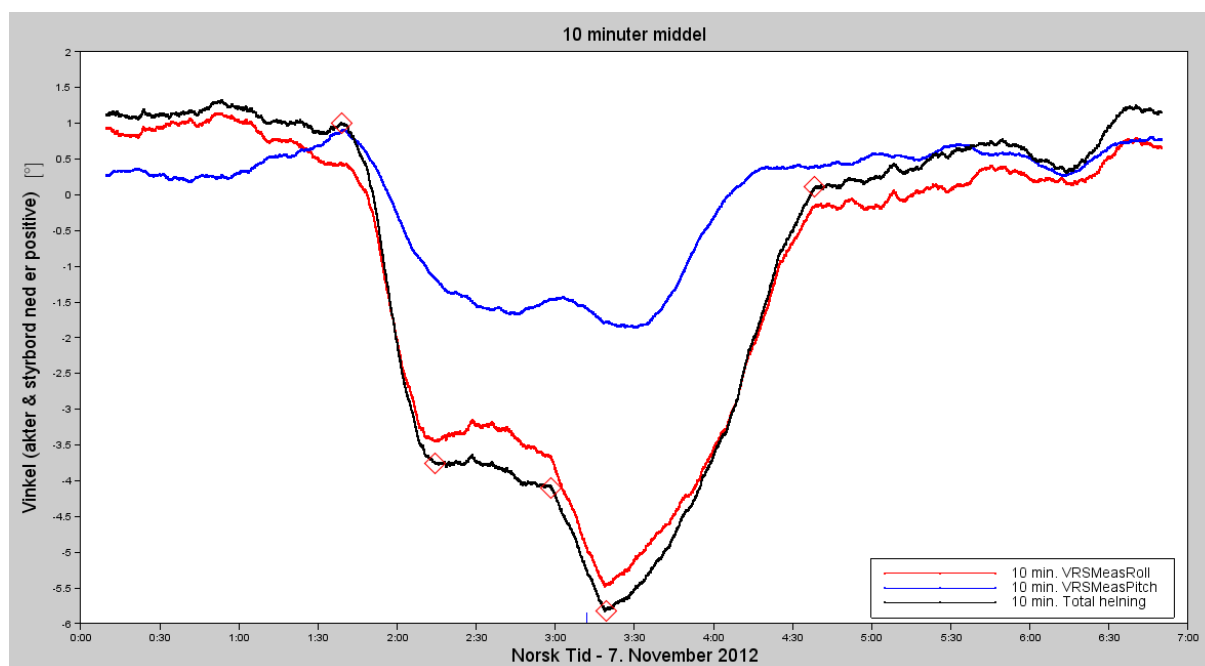
The deballasting which began after the crew discovered the problem is clearly visible on the list graph in Figure 23. Between 03.20-04.40, the facility was righted by 5.9° to roughly even keel – 0.1° (4.4° per hour)⁸¹. Stability reports before and after deballasting show that the facility was lightened by a total of 464 tonnes, including 451 tonnes of ballast water.⁸² The latter comprised 226 tonnes from tank number 1 outer port, 115 tonnes from 5B outer port, 47 tonnes from 10 outer port (punctured, but partly above water), 33 tonnes from 2 outer starboard and 23 tonnes from 3A outer starboard. In addition come several minor tank adjustments.

Figure 23: Calculated averaged list history from measured roll and pitch on the incident night⁸⁵. The diamond symbols mark times when clear changes occur in the graphs – about 01.40, 02.15, 03.00, 03.20 and 04.40. Incidents and times are discussed in the text. The figure has been produced by the PSA on the basis of data files from Floatel International [56 and 57].

It is emphasised that the crew, from the sounding of the bilge alarm at 03.12 until after deballasting (right up to 08.45), were convinced that only one tank had been damaged. Given the information presented above, it can be stated that tank 3A outer port was punctured at 02.15. It was then virtually empty but according to the crew should have been full⁸⁶. The tank took in some 360 tonnes of water^{87 and 88} over 45 minutes (eight tonnes per minute). See also chapter 5.3.4 on measurements and alarms in the event of unintended tank filling.

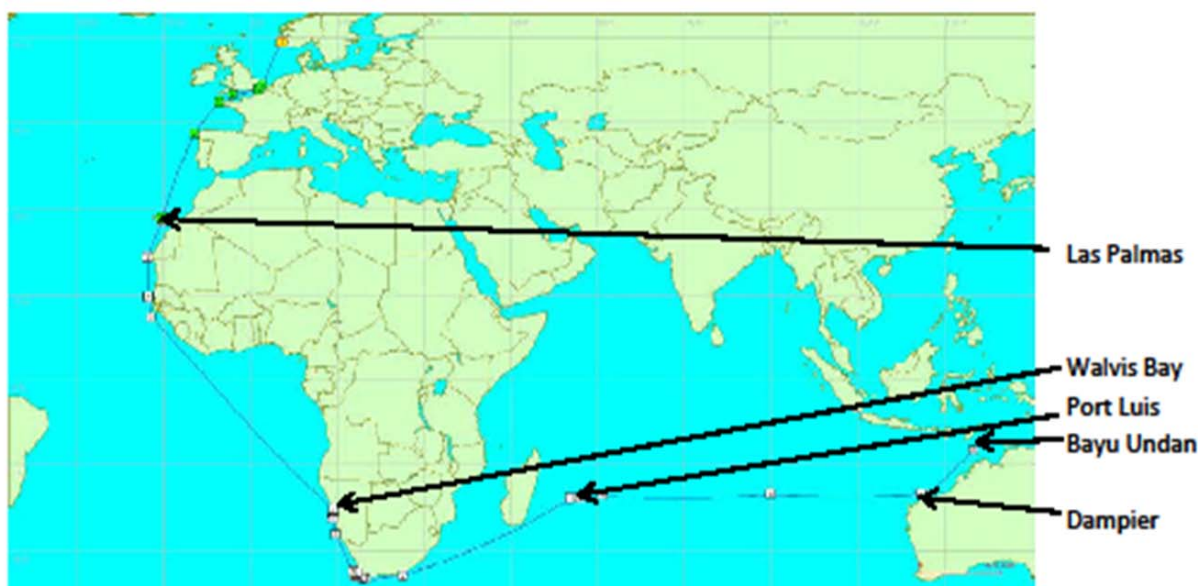
Figure 25: *Floatel Superior*'s route from Dampier to Ølen [73] from July to October 2010.

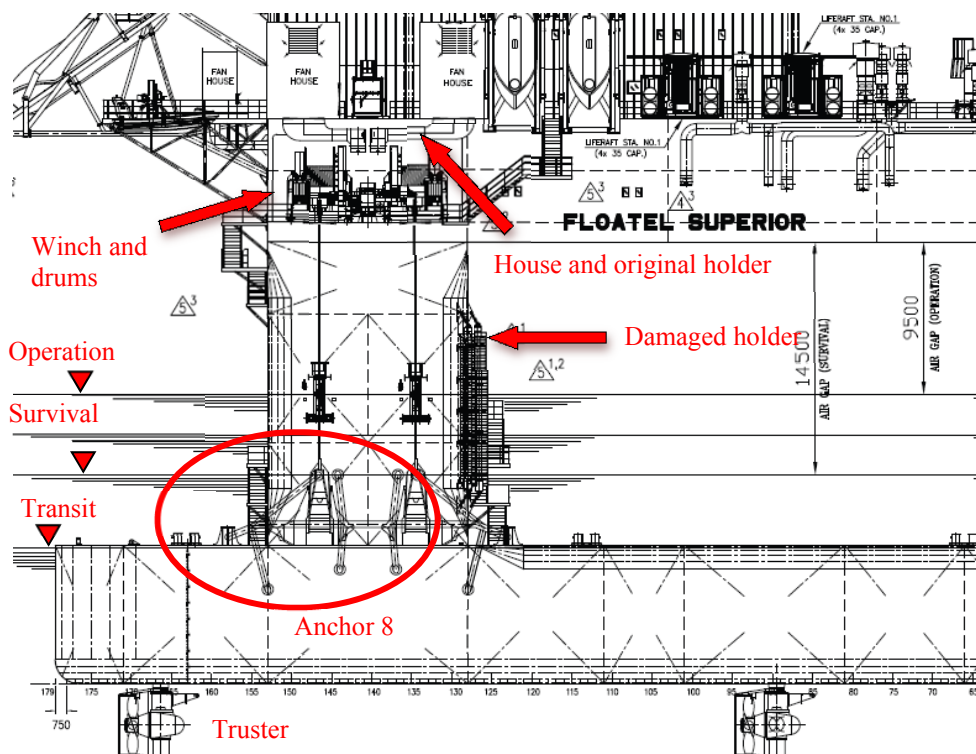
Figure 41: The pennant wire holder for anchor 8 after it had been torn free and damaged the railings and operating house. The overview photo on the left shows that the pennant wire must have become caught up in the railings or something else on a level with the anchor winch and drums (see Figure 42, where the positions are marked). The pennant wire hangs from a position above the top of the photo and down to the anchor, and also down to the damaged holder. The wire has apparently become wedged in the bumper¹¹⁴, and the terminal cable eye has come out of the holder. It appears to hang usually with a security lashing, which the crew reported was normal in order to secure the end of the pennant wire. The photograph was taken by Floatel International personnel on board during the incident day on 7 November.

Figure 42: Detail from the side of *Floatel Superior* which shows the forward port column with anchor position 8 circled. The topmost arrow shows the operating house with railing where the pennant wire was positioned before the incident. The bottom arrow shows the final position where the ripped-off wire holder was found after the damage. At far left, the markings for operating (top – 18 metres), survival (centre – 13 metres) and transit (bottom – about 8.5 metres) draft are shown by red triangles. Two of the six thrusters are seen under the pontoon. If the pennant wire had not been caught up in the facility after being ripped from its holder, it could have hung 15-20 metres beneath the keel. That would have given it the potential to be drawn into the forward thruster on the port pontoon. The drawing shows anchors of another type and a different position in the bolsters than those which were actually installed. From Keppel FELS' drawing [58].
