Investigation report

Report	
Report title Investigation of hydrocarbon leak on Gudrun of 18 February 2015	Activity number 001025017

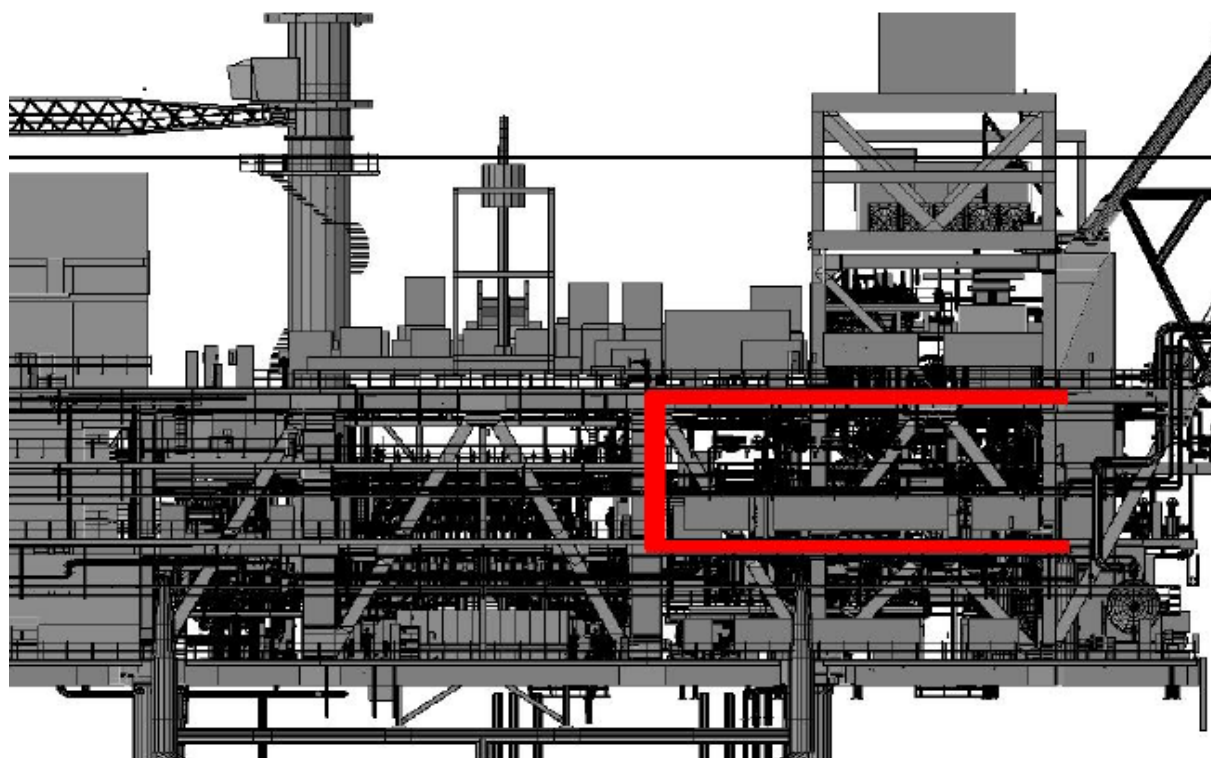
Figure 5: Layout viewed looking north. (Illustration: Aibel)

Large quantities of gas were released as a result of the pressure drop, and gas was detected in much of module M30 within a minute.

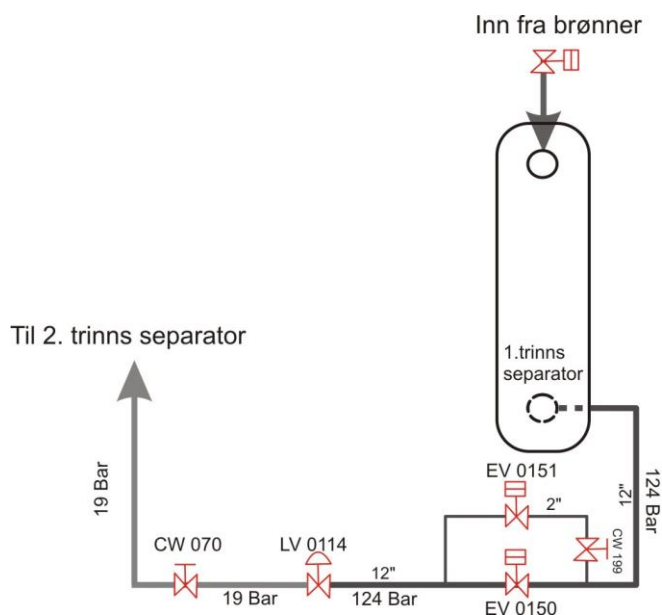
Figure 7: Diagram of liquid outflow from separator. (Illustration: police)

Leakage of condensate was observed at 06.23.39 on 18 February 2015. Hot condensate, 90-100°C, under high pressure, 124 bar, flowed from a rupture in a two-inch pipe in the bypass line downstream of the first-stage separator. The failure surface embraced 90 per cent of the pipe diameter, and the leak was accordingly limited by comparison with a full rupture.

Key: To second-stage separator In from wells First-stage separator
