Investigation report

Report	
Report title Investigation of loss of gangway between Oseberg H and service operation vessel	Activity number 001053076 412000007
Classification	
<input checked="" type="checkbox"/> Unclassified	<input type="checkbox"/> Exempt from publication
Parties involved	
Team A-1 / A-3	Approved by / date Elin S. Witsø / 29.04.2026 Ingvil Håland
Investigation group participants [REDACTED]	Investigation leader [REDACTED]

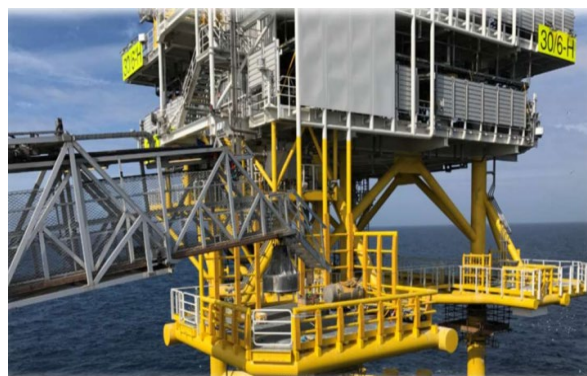
Photo 3: Eastern landing area with W2W system in cone mode. (Source: Equinor)

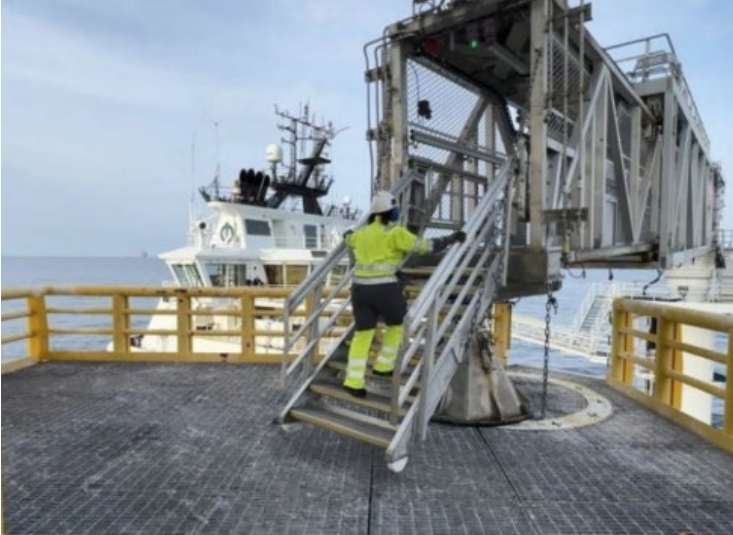
The gangway is designed to be used in both bumper mode and cone mode. At Oseberg H, cone mode is used. This means that the gangway is equipped with a cone mounted at one end of the gangway. The weight of the gangway and friction between the landing area and the cone create a stable connection between the gangway and the facility. The gangway remains continuously connected as long as there are people on Oseberg H.

The cone is designed with extra height, specifically for OSH, due to the height of the railings around the landing area. The cone is suspended from a transverse beam at the end of the gangway.

Photo 4: Gangway with landing area (Source: Equinor)

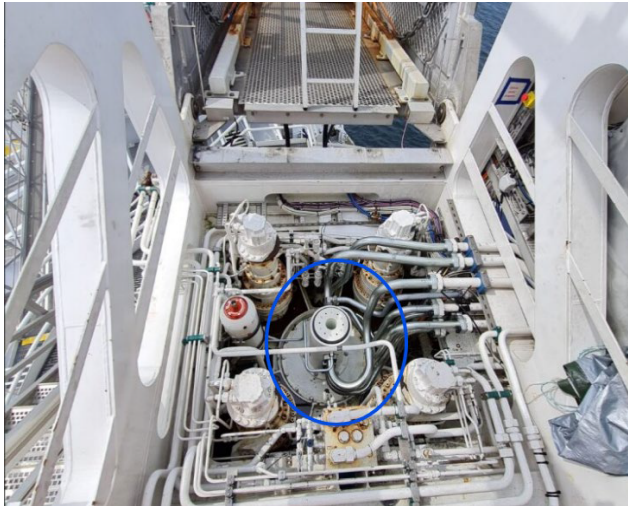
A hydraulic swivel is mounted at the top of the pedestal to transmit hydraulic power from the fixed pedestal to the rotating section of the gangway for the boom lift, swing and telescoping functions.

Photo 5 below shows the swivel with hydraulic pipe spools. While replacing the swivel, hydraulic hoses were temporarily installed, as shown in Photo 6, pending the prefabrication of new fixed pipes.

Photo 5: Swivel and hydraulic pipe spools (Source: Equinor/Island Offshore)
