Investigation report

Report title Gas leak at Statoil Mongstad on 25 October 2016	Activity number 001902037
---	------------------------------

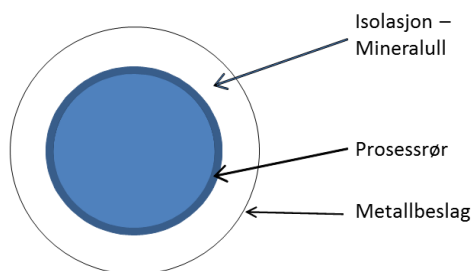
CUI is one of the biggest challenges faced by the petroleum industry in older facilities (Næss, 2016). Insulation is very extensive because of the need to preserve thermal energy and control heat flows. The main reason for insulation at Mongstad is to retain energy in piping and equipment in order to achieve efficient refinery processes. Other reasons for insulating also exist, as outlined in Norsok R-004, for example (Norsok, 2006). Generally speaking, an insulation system comprises the actual insulating material and external weather protection. The latter can be a metal mantling (sheath) or tar paper. The actual pipe or equipment is inside the insulation, with or without a protective coating. See Figure 4 for an illustration.

Figure 4: Cross-section of insulated pipe.

Key: insulation – mineral wool, process pipe, metal mantling.

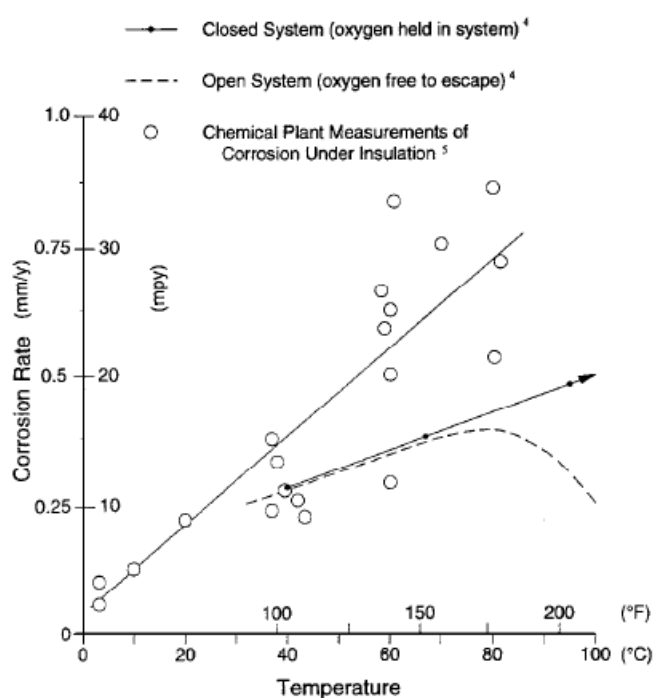
For normal steel under high temperatures (80-90°C), a general corrosion rate could be 0.5mm/y, more than 10 times faster than the assumptions usually applied in calculations. At chemical facilities, annual corrosion could be twice as fast. Other challenges related to insulation and CUI repairs could include chlorides in the environment and corrosive water condensation on steel surfaces, sub-optimum inspection methods, inadequate surface treatment of pipes and equipment, process design, poor mantling of the insulation, access, costs and investment considerations (Næss, 2016).

Figure 5: CUI for carbon steel, corrosion rate as function of temperature and system, (Nace , 2010).

Where temperatures exceed 100°C, the increase in corrosion speed could reverse outside the curve in Figure 5 with a further temperature rise. This is plant-specific knowledge.
