Investigation report

Re	port						
Rep	ort title				Activity number		
Investigation of an incident with fatal consequences on					418005005		
CC	COSLInnovator, 30 December 2015						
Sec	curity grading						
\checkmark	Public		Restricted		Strictly confidential		
	Not publicly available		Confidential				
e	mmary

Mobile drilling unit *COSLInnovator* was struck by a wave at 16.38 on 30 December 2015. The impact occurred forward on the port side, and the unit suffered extensive damage. One person died and four were injured. The damage was confined to part of the living quarters.

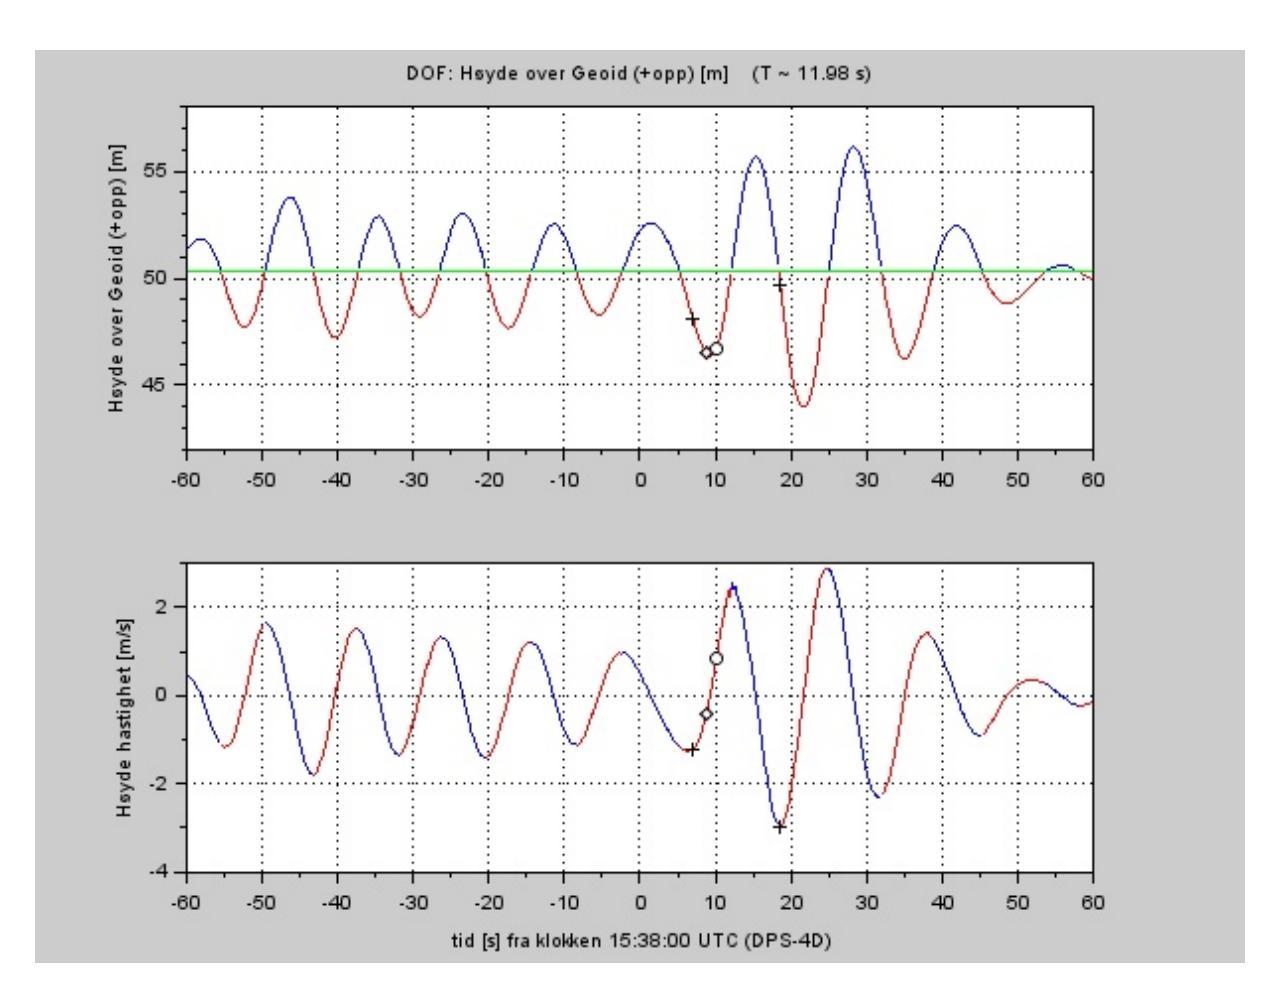
Figure 5 Vertical position of CI's CoG during the period from one minute before 15.38.00 UTC to one minute after on 30 December 2015. The green line marks the short-time average (still-water position of the unit). The blue line shows that the unit has a CoG above the short-time average (lifted by a wave). The red line shows that the unit has a CoG below the short-time average (in a trough). The top graph presents the motion's position, the lower one presents its speed.

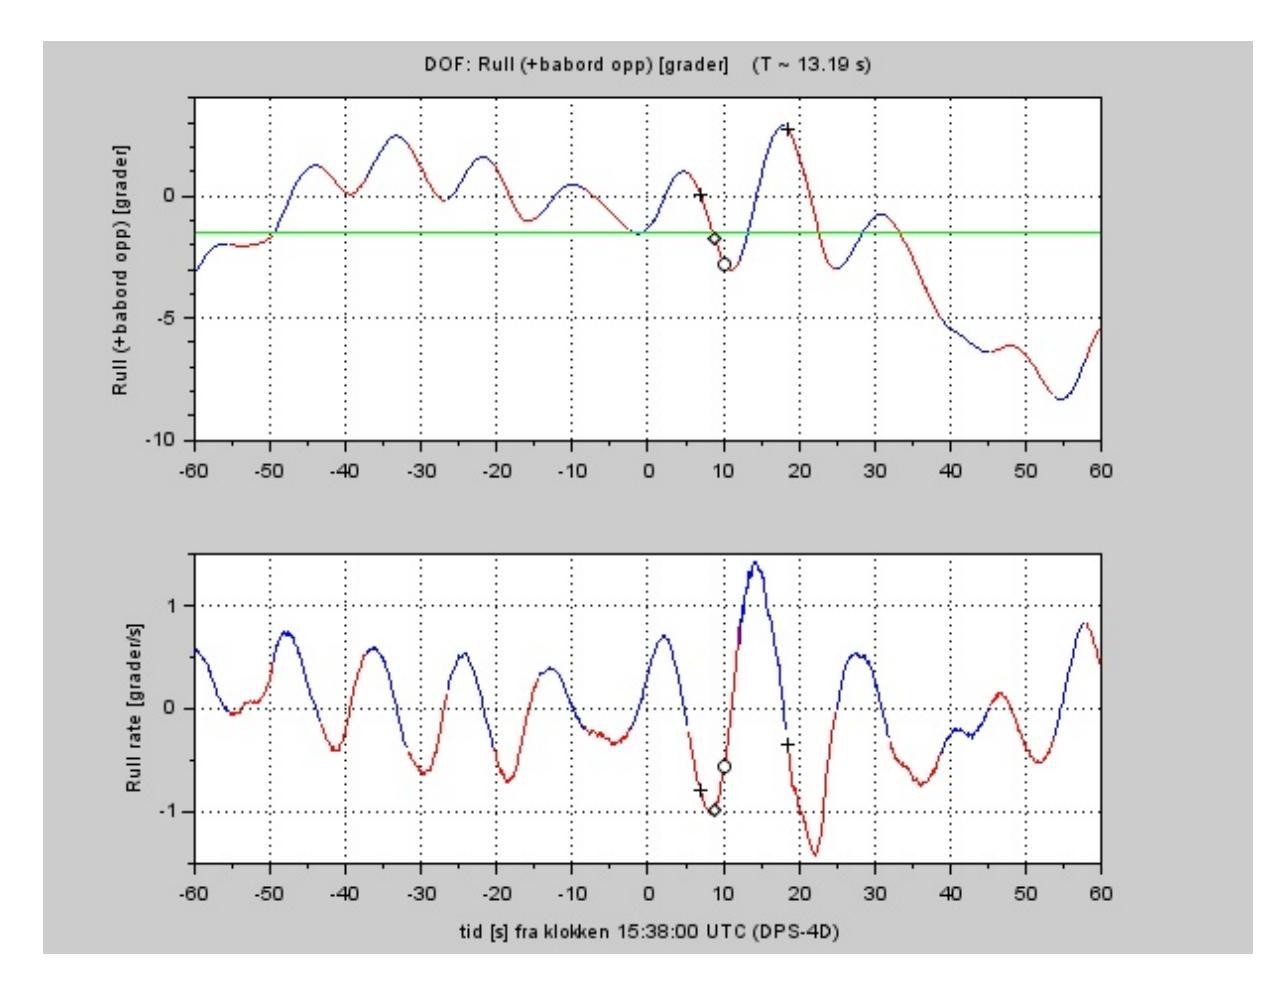
Figure 6 Roll in the period before and after the incident. The top graph presents the motion's position, the lower one its speed.

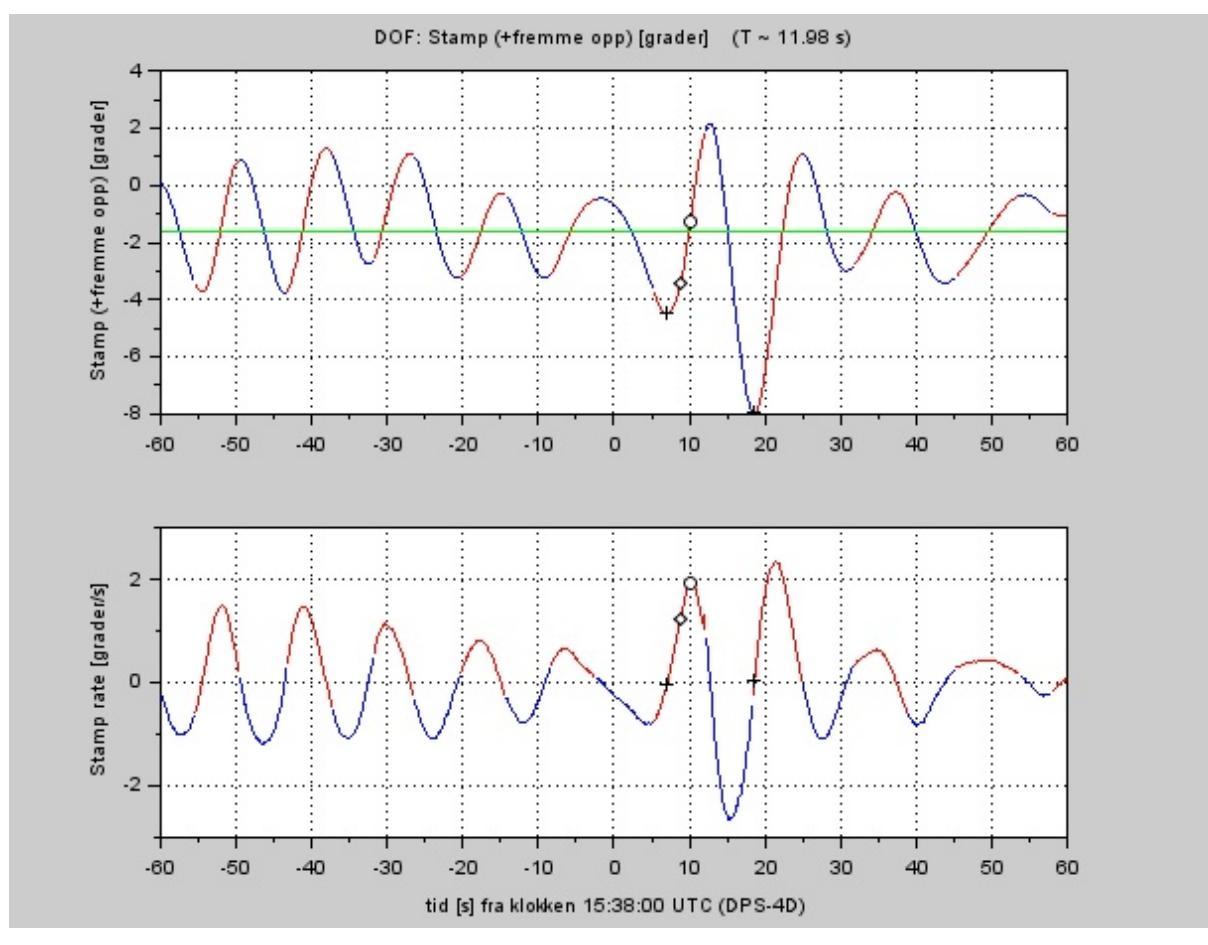
Figure 7 Pitch in the period before and after the incident. The top graph presents the motion's position, the lower one its speed.

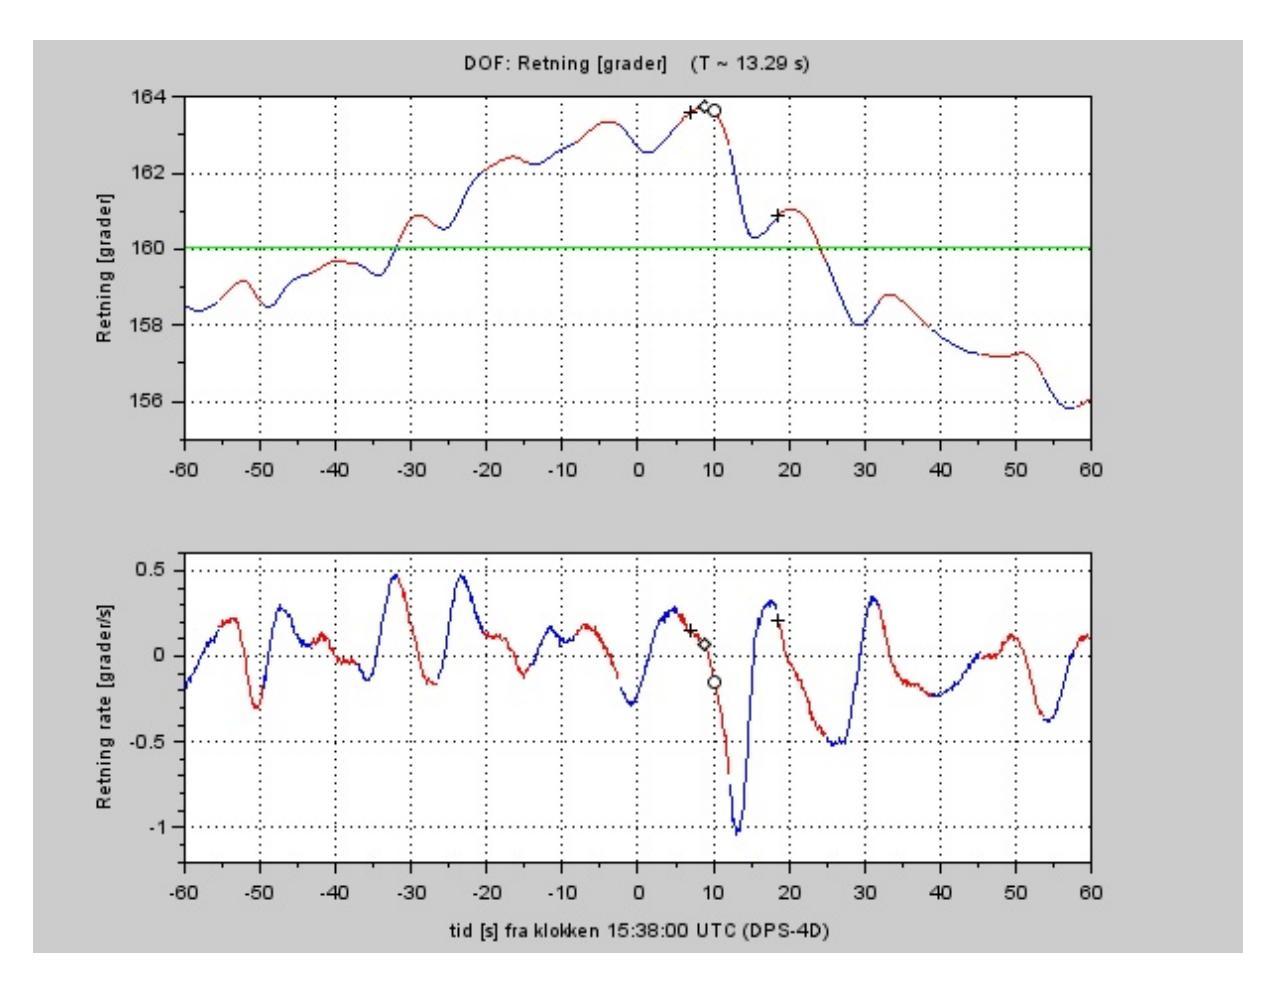
Figure 8 Vessel heading in the period before and after the incident. The top graph presents the motion's position, the lower one its speed.

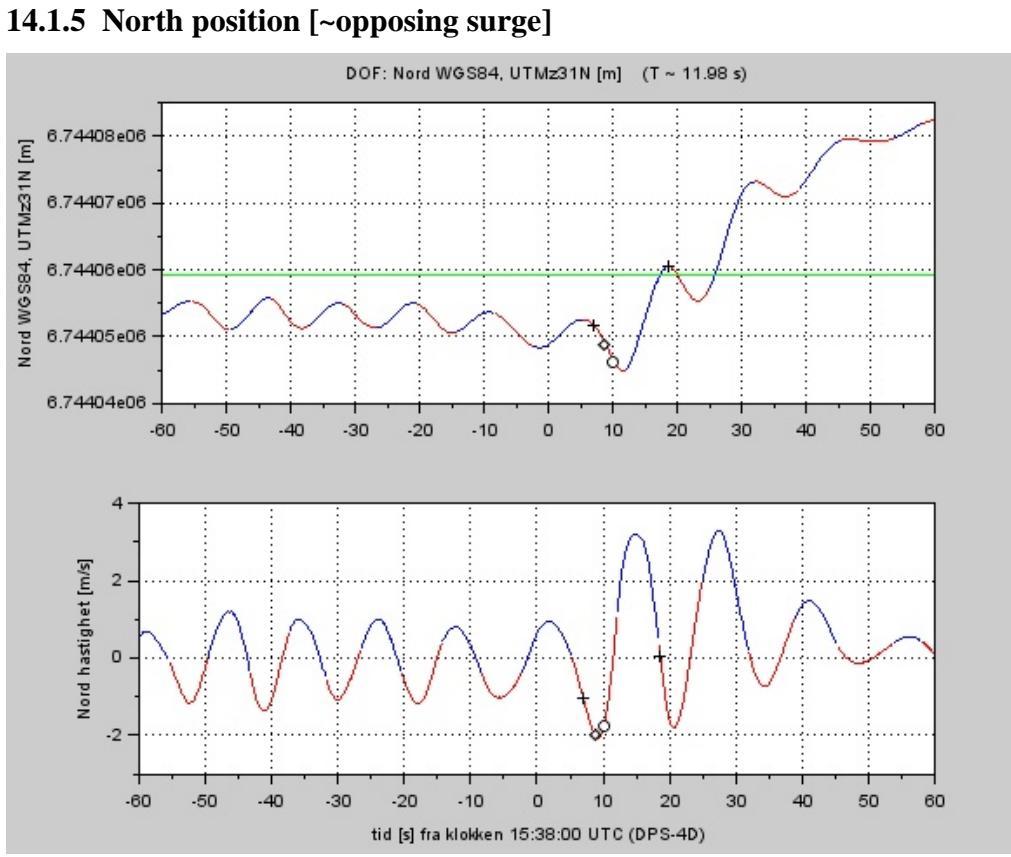
Figure 9 North position and speed in the period before and after the incident. The top graph presents the motion's position, the lower one its speed.

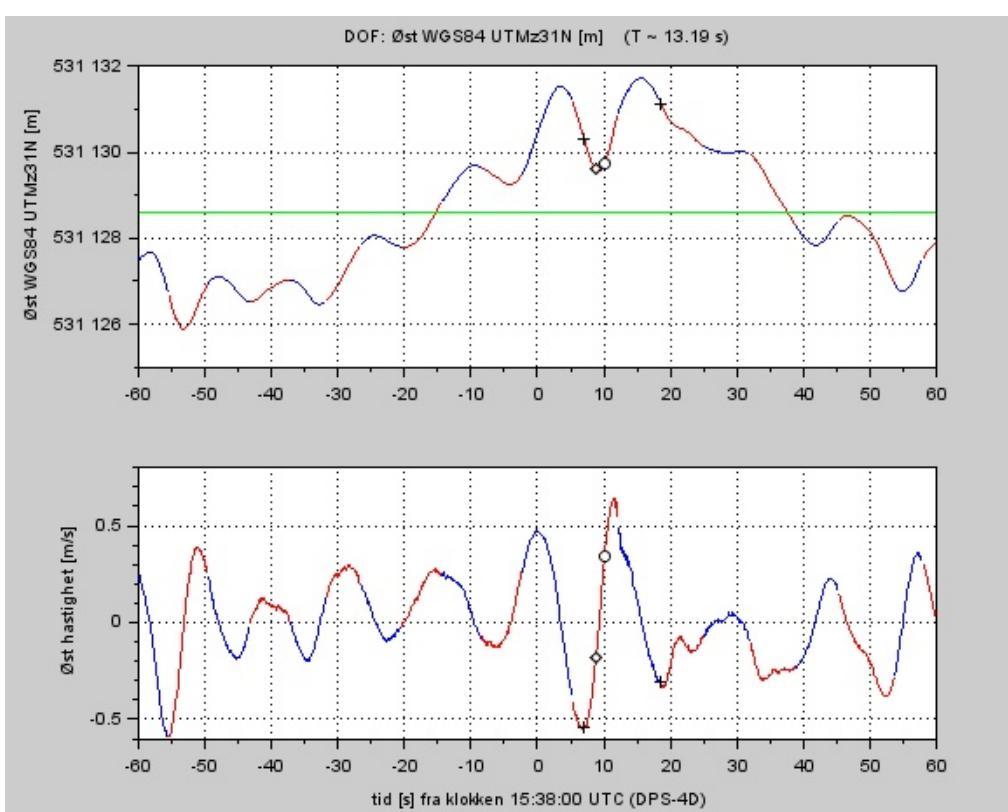
Figure 10 East position and speed in the period before and after the incident. The top graph presents the motion's position, the lower one its speed.

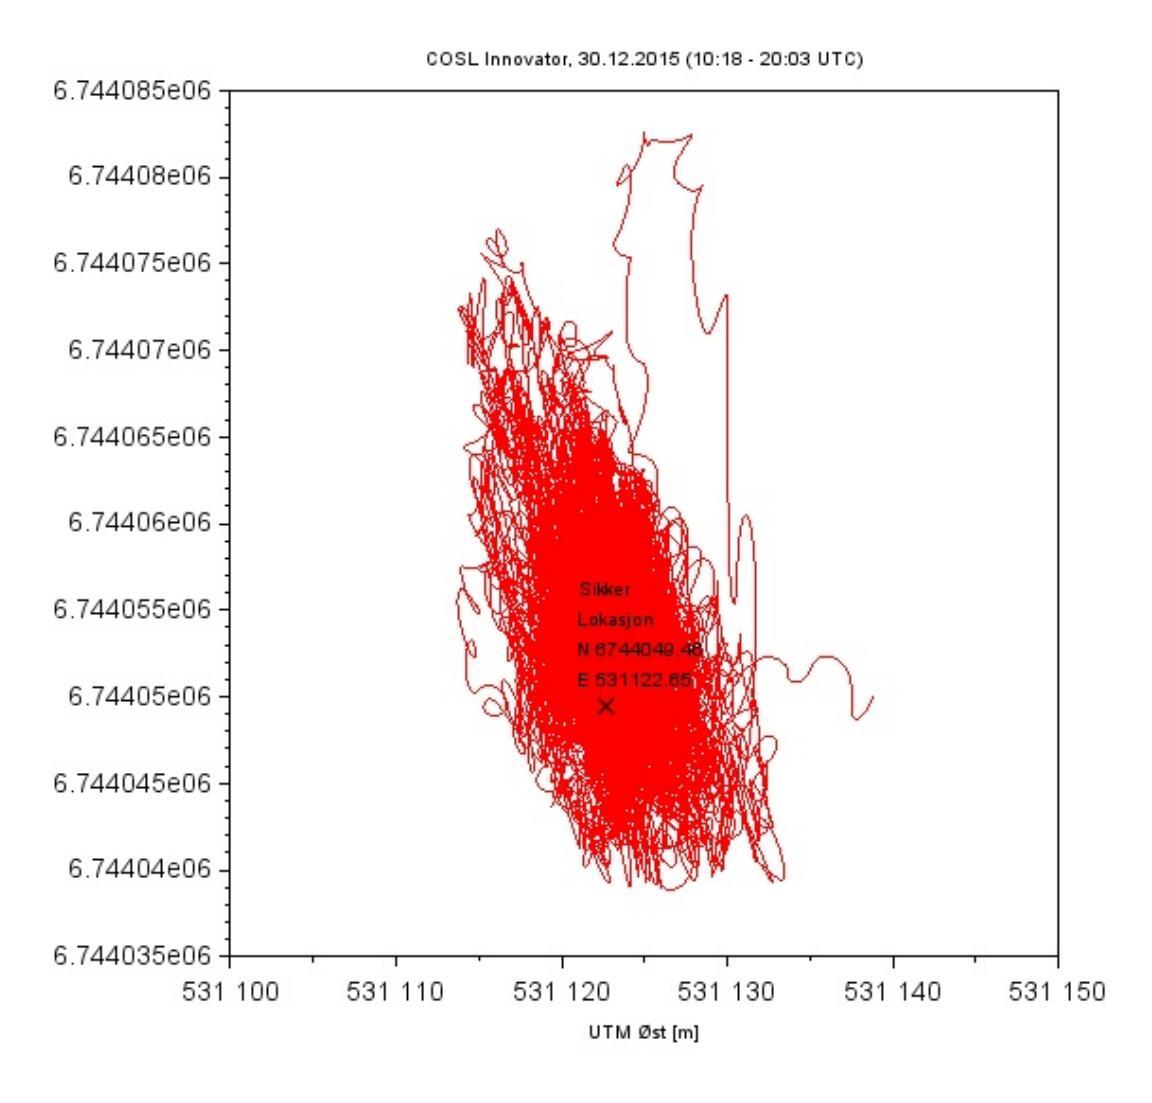
Figure 11 Motion trace for CI on the incident day. Data from Kongsberg DPS-4D.

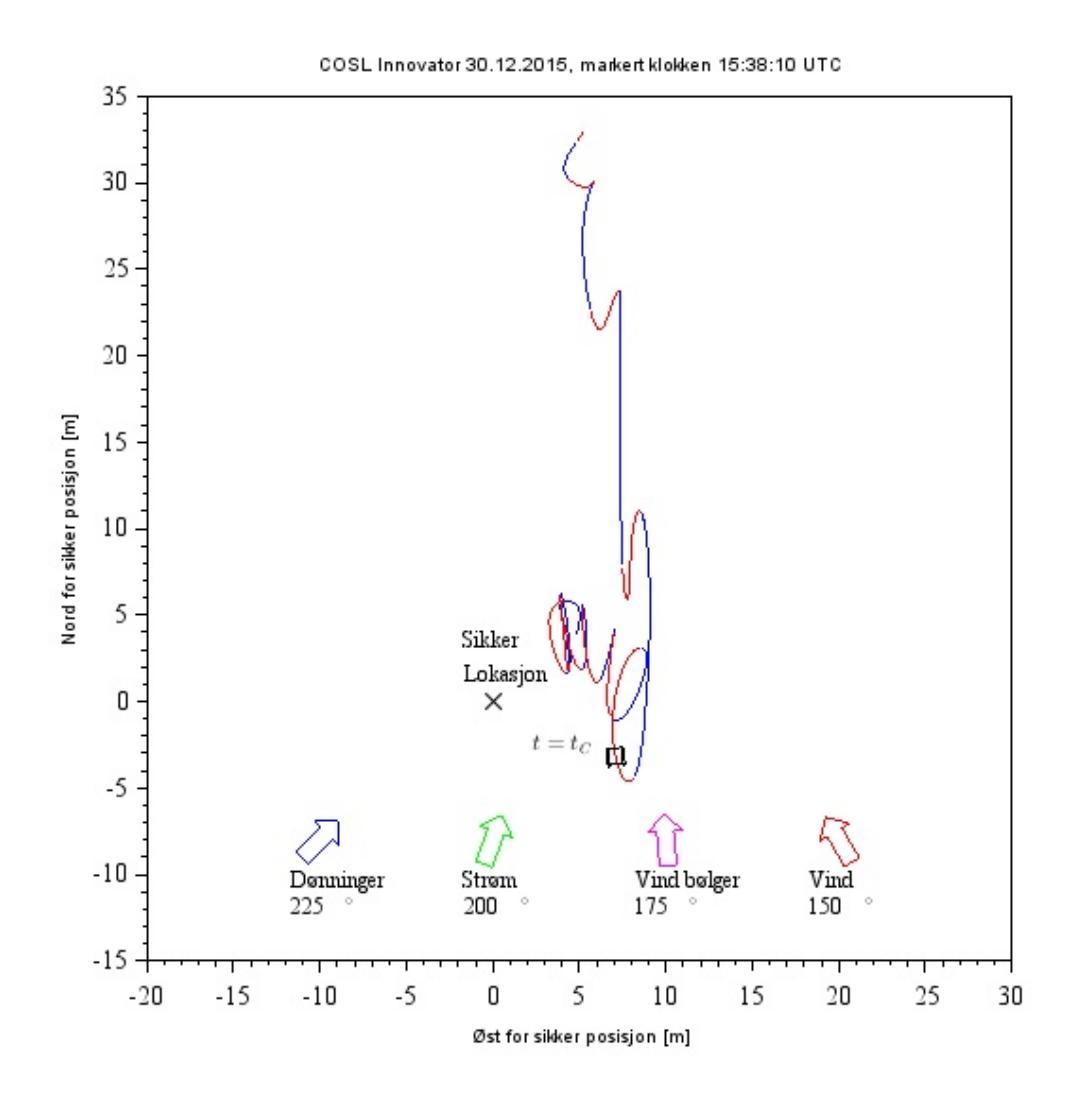
Figure 12 Position during the period around the incident, showing the general direction of the weather. The colours of the trace correspond with the description in Figure 5.
