# Investigation report

Report	
Report title Investigation of incident with personal injury on Johan Sverdrup	Activity number 001265069

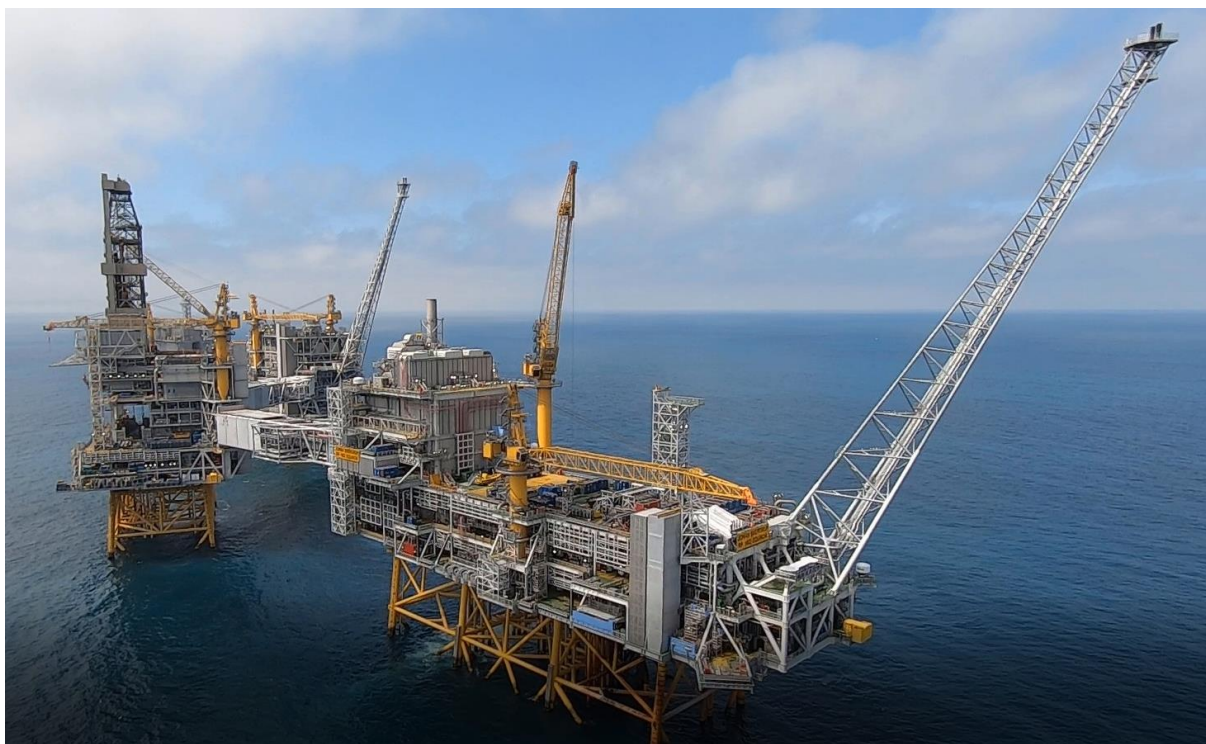
Photo 1 shows the Johan Sverdrup field with the RP in the foreground.

*Photo 1 has been received from Equinor and shows the Johan Sverdrup field.*

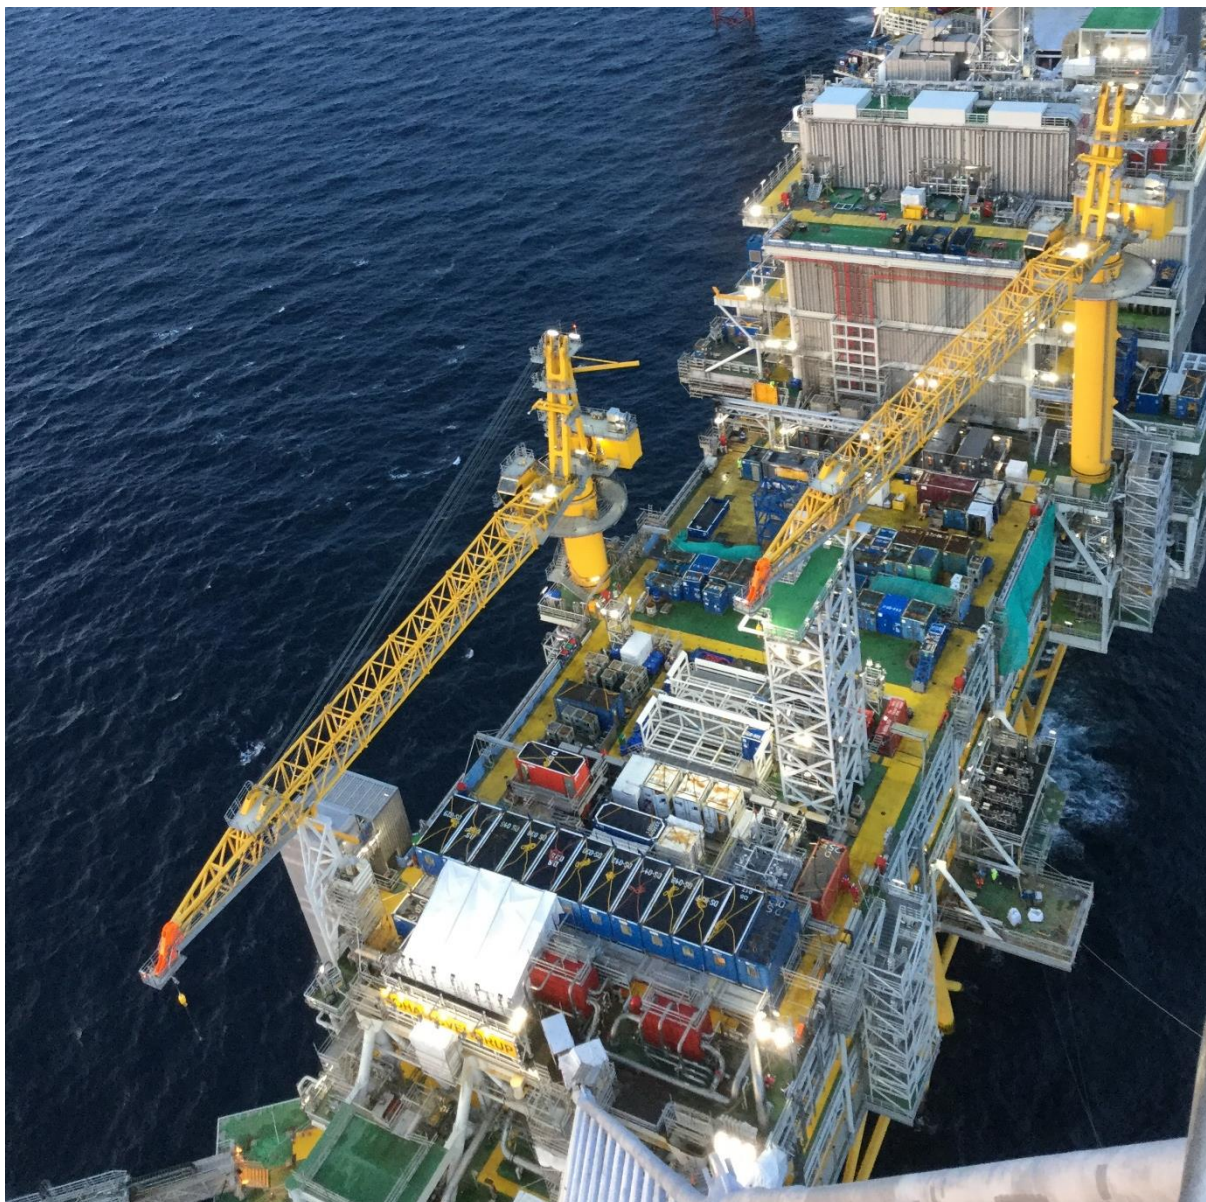
Photo 2 provides an overview of the RP weather deck before the frame removal job began. The frame is positioned centrally on the deck between the north crane on the right-hand side and the south crane to the left.

*Photo 2 has been received from Equinor and shows the RP.*
