Report title Investigation of an incident resulting in personal injury on Deepsea Nordkapp on 8 October 2025	Activity number 405007010
--	------------------------------

Team A-3	Approved by / date Ingvil Håland/15 April 2026
Investigation group participants [REDACTED]	Investigation leader [REDACTED]

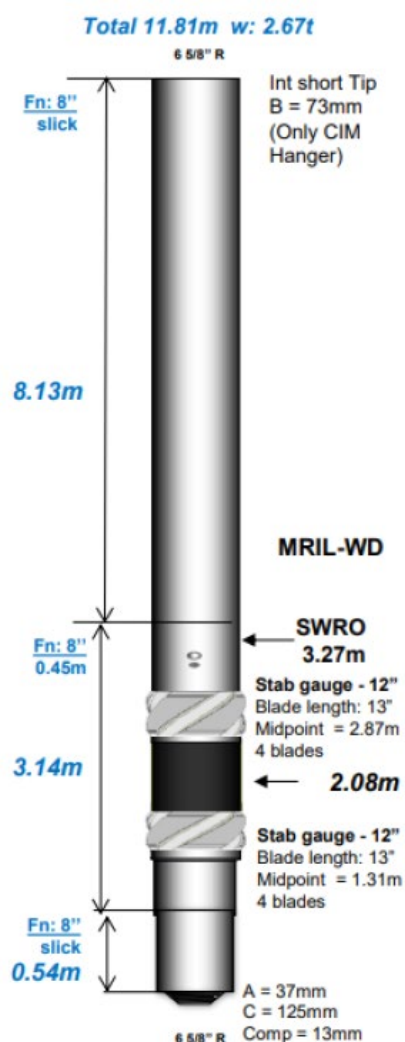
Figure 2: MRIL-WD (Magnetic Resonance Imaging Logging-While-Drilling Sensor), a BHA logging tool that was being lifted when the incident occurred (referred to in this report as the logging tool)

The second lifting operation involved moving the logging tool from the catwalk down to the cuttings deck. The logging tool was provided and owned by a third party. The logging tool was secured with two fibre slings that were to be attached to the crane hook. The way it was slung caused the logging tool to have an asymmetrical centre of gravity, so that it hung askew on the hook. The end that later struck IP was higher above the deck than the other end.

The direct cause of the incident was that, during a lifting operation, the load was not fully under control, and the injured person (IP) was standing in the travel path in front of and, at times, directly beneath the load. As a result, IP was struck by the load while the crane operator was trying to regain control.
