<b>Report</b>	
Report title Investigation of unwanted incident at the Brage field on 21 November 2023 involving personal injury	Assignment no. 2023-1556
<b>Classification</b>	
<input checked="" type="checkbox"/> Public	<input type="checkbox"/> Exempt from public disclosure
<b>Involved personnel</b>	
Team A-2	Approved by / date Bjarte Rødne / 8 May 2024
Participants in the investigation team [REDACTED]	Investigation team leader [REDACTED]

## 1 Executive summary

In the course of a scheduled 6-monthly valve test at Well A-20 at OKEA's Brage facility, a serious work accident occurred on 21 November 2023.

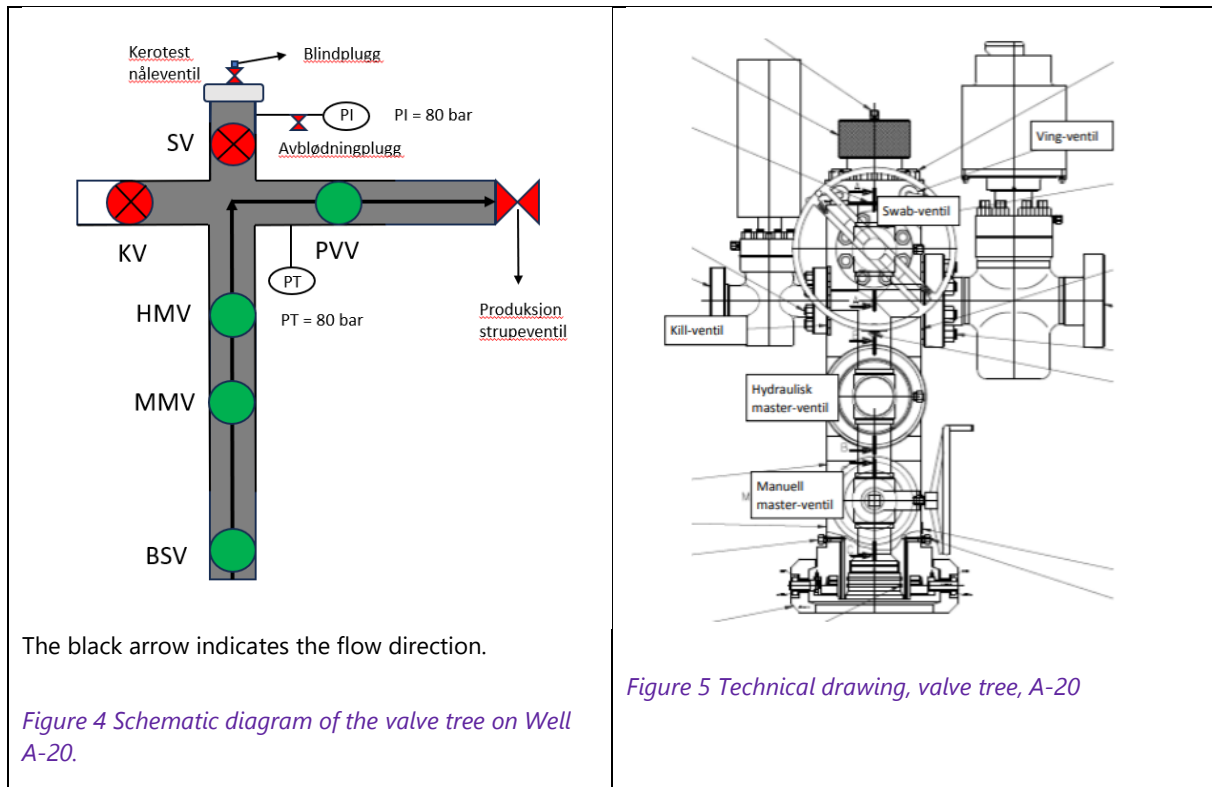
At this point the well had been shut down for some time. Several valve tests had been carried out in the preceding days and it was agreed that this was a suitable task for IP2, while IP1 could commence the usual inspection and supervise. In order to carry out the planned valve test there had to be differential pressure above the swab valve (SV). The pressure at the intersection beneath the SV (80 bar) was read off in the Central Control Room (CCR), while the pressure downstream of the SV needed to be read off manually at the valve tree (see Figure 4). IP2 read off the pressure as 80 bar also downstream of the SV and reported this over the radio to the CCR. It was discussed whether to bleed off the pressure above the SV using the valve at the pressure indicator (PI, see Figure 4) or through the needle valve in the tree cap. It was agreed that pressure release through the needle valve, draining to a closed system, should be possible. Figure 4 shows the valve status and read-off pressure in the valve tree before work commenced.
