Investigation report

Report	
Report title Investigation of overpressurisation in sludge cell 11 on Statfjord A on 26 November 2019	Activity number 001037047

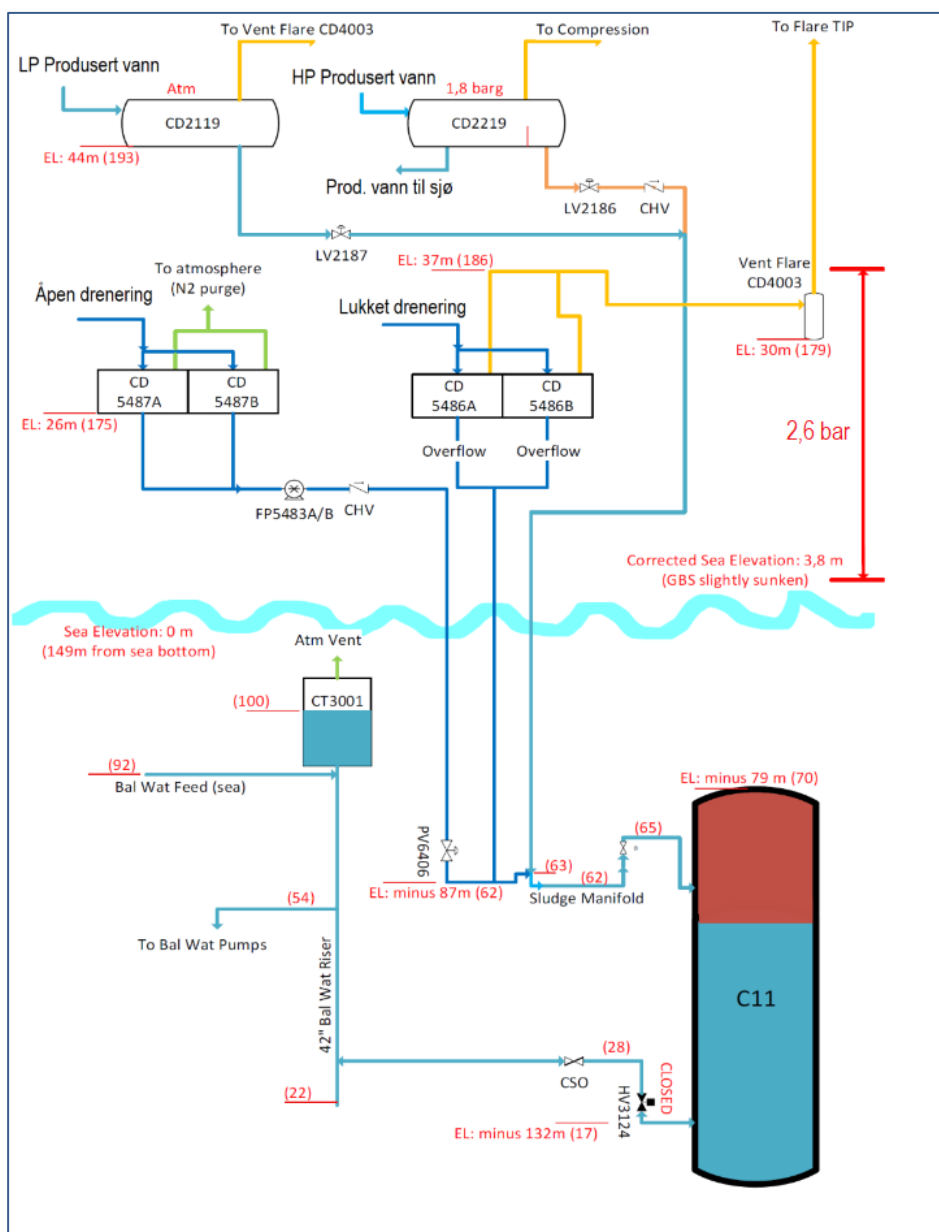
Figure 6: Process diagram for the oily water system (source: Equinor).

Maximum overpressure is calculated to have occurred at 07.40, when the level gauge in the vent knockout drum (CD4003) showed 23 per cent full. According to the information in figure 6, the underside of CD4003 is at the 179-metre level and the highest point of the inlet pipe to CD4003 is at 186 metres. That indicates the highest pressure was $186 - 152 = 34$ metres or 3.4 bar. Liquid was measured in the knockout drum from about 07.20 to 08.00 – in other words, with an overpressure of about three bar for roughly 40 minutes.

In its investigation report, the operator writes that the seabed has subsided by 3.8 metres since Statfjord A was installed and uses this to adjust the amount of overpressure. Equinor believes it was 2.6 bar, as shown in figure 6. The PSA has earlier been informed that the facility had a measured subsidence of 750 millimetres in 2018 (which corresponds with expectations in the DFI documentation from the design period).
