Investigation report

Report	
Report title Investigation of the incident on <i>Maersk Invincible</i> when tubular stands became detached from the fingerboard	Activity number 400012006

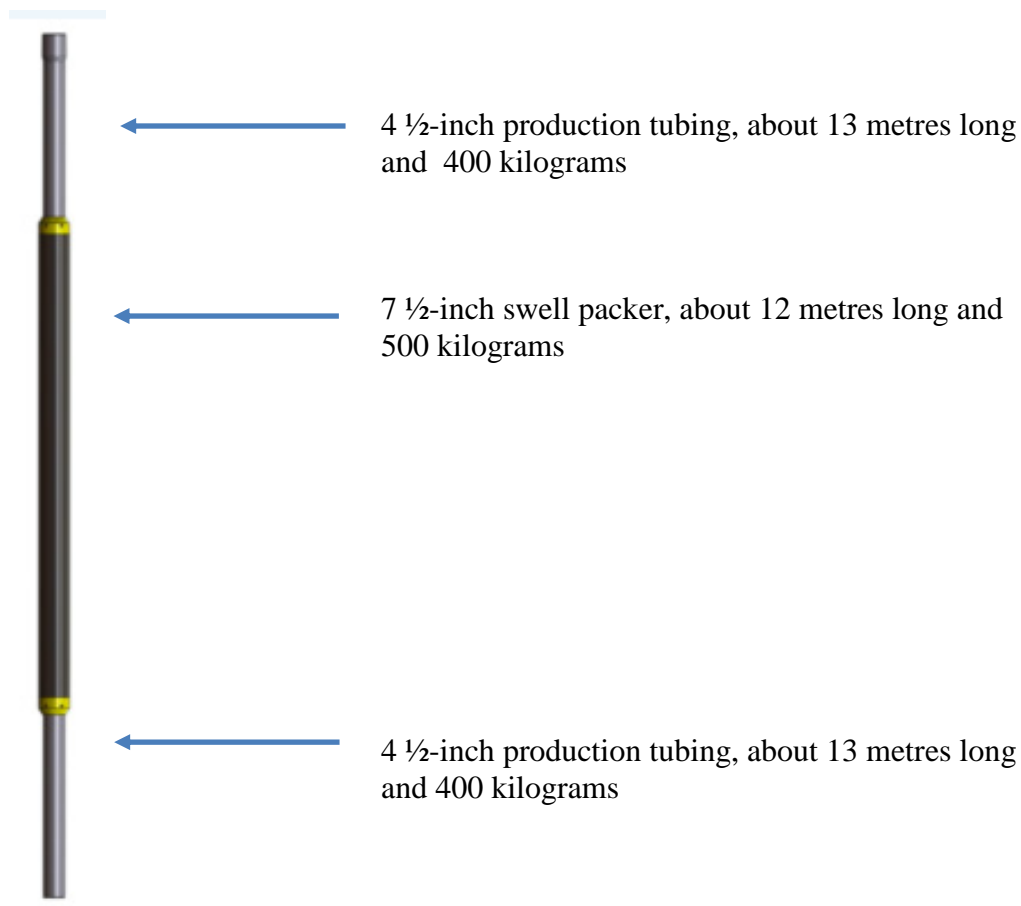
Fig 2: Illustration of a stand with swell packer (from Aker BP).

Maersk Invincible was conducting operations in the 2/8-N-4 injection well on 11 November 2018. Two made-up stands were placed in row three (3) on the fingerboard in the Aux derrick. These stands were 38 metres long and weighed about 1 300 kilograms. See figure 2.

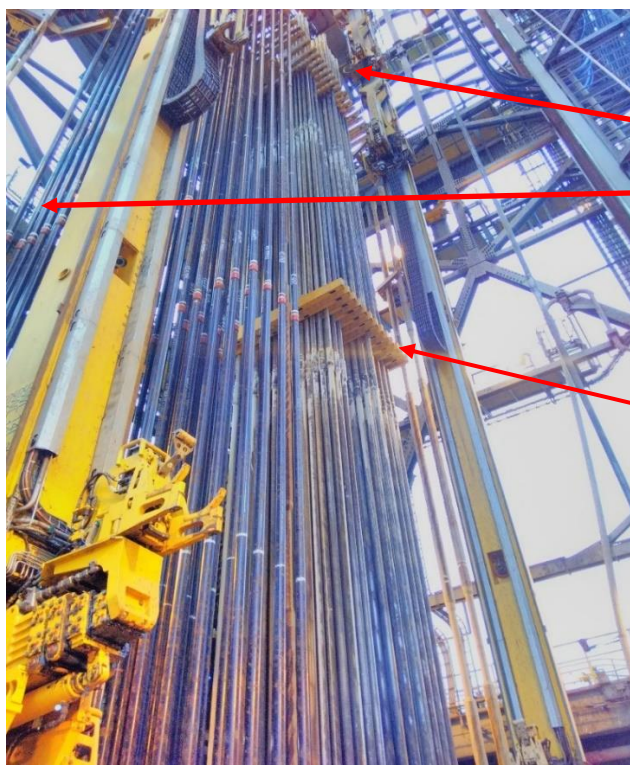
Fingerboard.
Stands in the Aux derrick.

Bellyboard.

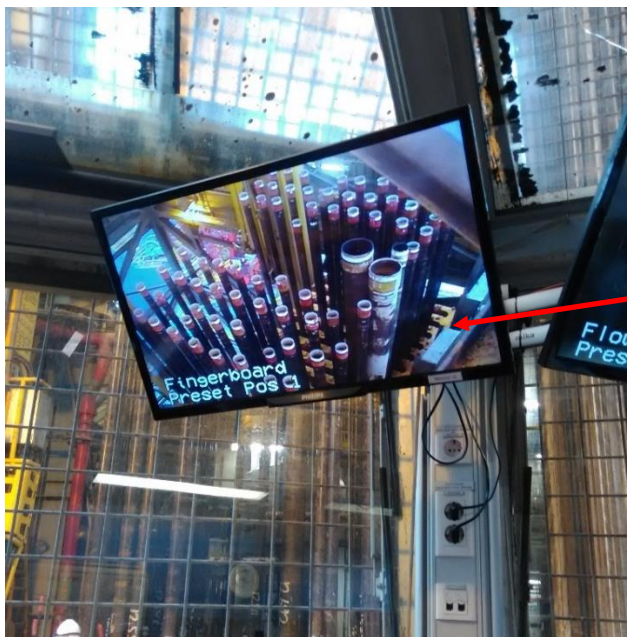
Fig 11:
Overview of parked stands. The fingerboard seen from above. The monitor in the driller's cabin viewed from the driller's position.
