# Investigation report

Report title Report from the investigation of the hydrocarbon leak from the S1 template on Åsgard A – 10 March 2017	Activity number 001094029
--	------------------------------

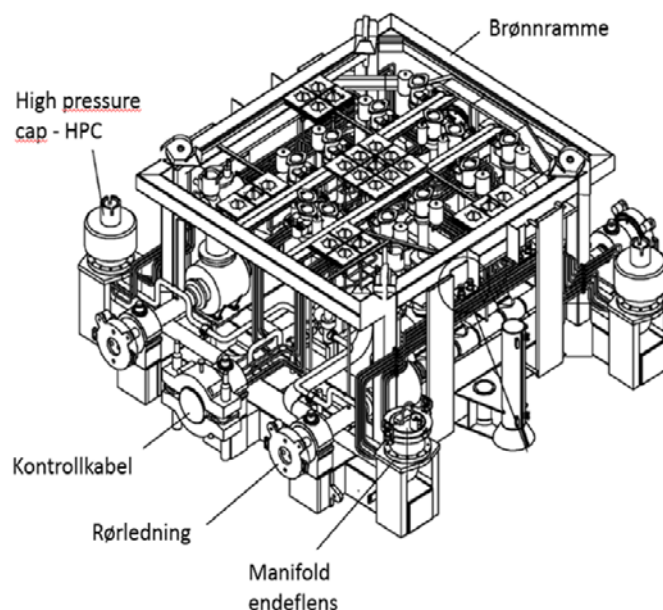
Figure 3 - The subsea template. (Source: Statoil)

The S template comprises four production wells with associated manifold, and stands in 300m of water 11km from Åsgard A. Production from the template is transferred to Åsgard A via two 10-inch flowlines tied together in a U configuration, each with a volume of 590m<sup>3</sup>. All four wells can be connected to each of the flowlines and are isolated from the template by a single valve.

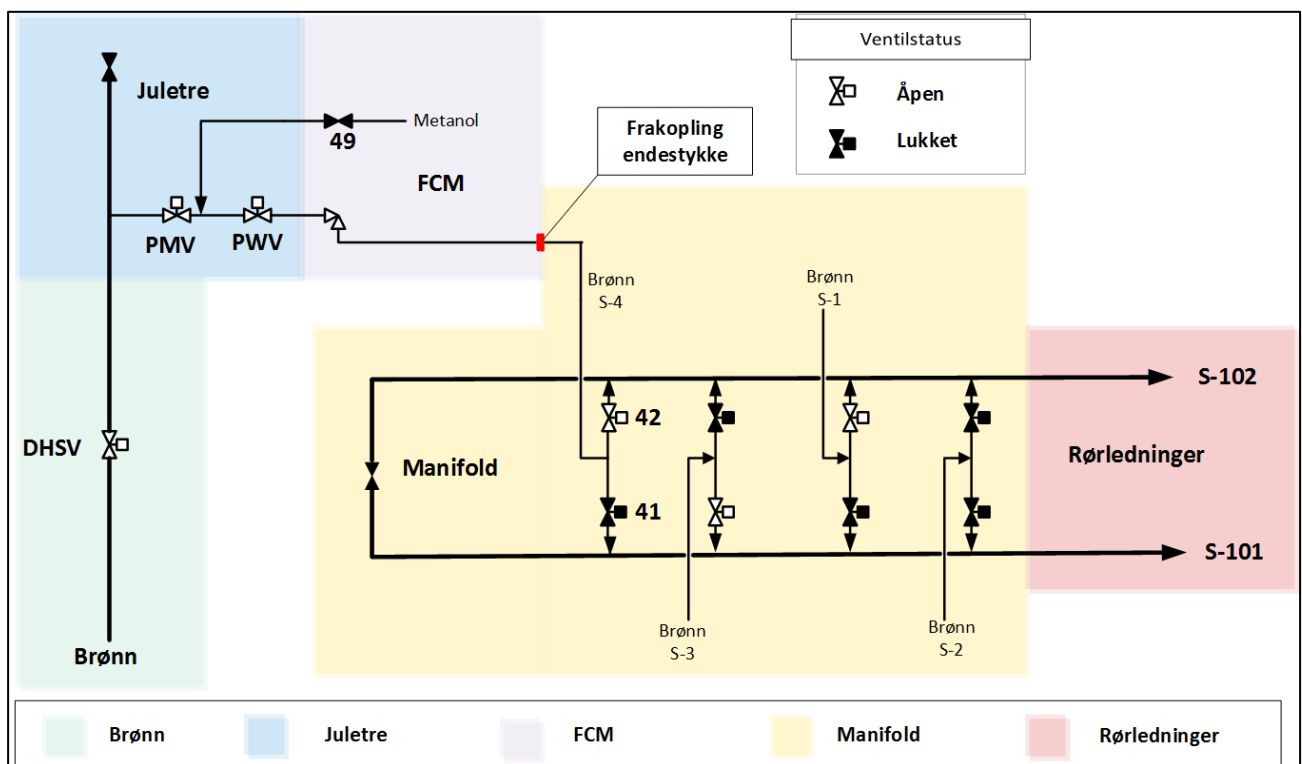
Figure 4 - Simplified diagram covering relevant parts of the subsea system.

During normal operation, the isolation valves on the template are used to control which flowline each well will produce to. When work operations call for disconnection of the flow control module (FCM)/Xmas tree, these valves function as barriers against discharges to the natural environment. As shown in figure 4, valves 41 and 42 are the isolation valves for S-4. The diagram also shows the isolation valves for the other wells. These valves are hydraulically operated and can be locked in position using an ROV. This is described in more detail in section 3.2.1

Hydraulics, scale inhibitor and methanol<sup>1</sup> are supplied to the template by umbilical. The methanol injection point is placed between the production main valve (PMV) and the production wing valve (PWV). When work operations require FCM disconnection, the isolation valve (49) on the methanol line is closed. This valve can only be operated by ROV.

Normal operating pressure in the flowline is about 80 bar, and production from this template primarily comprises gas with some condensate. Figure 4 presents a simplified diagram of the system.

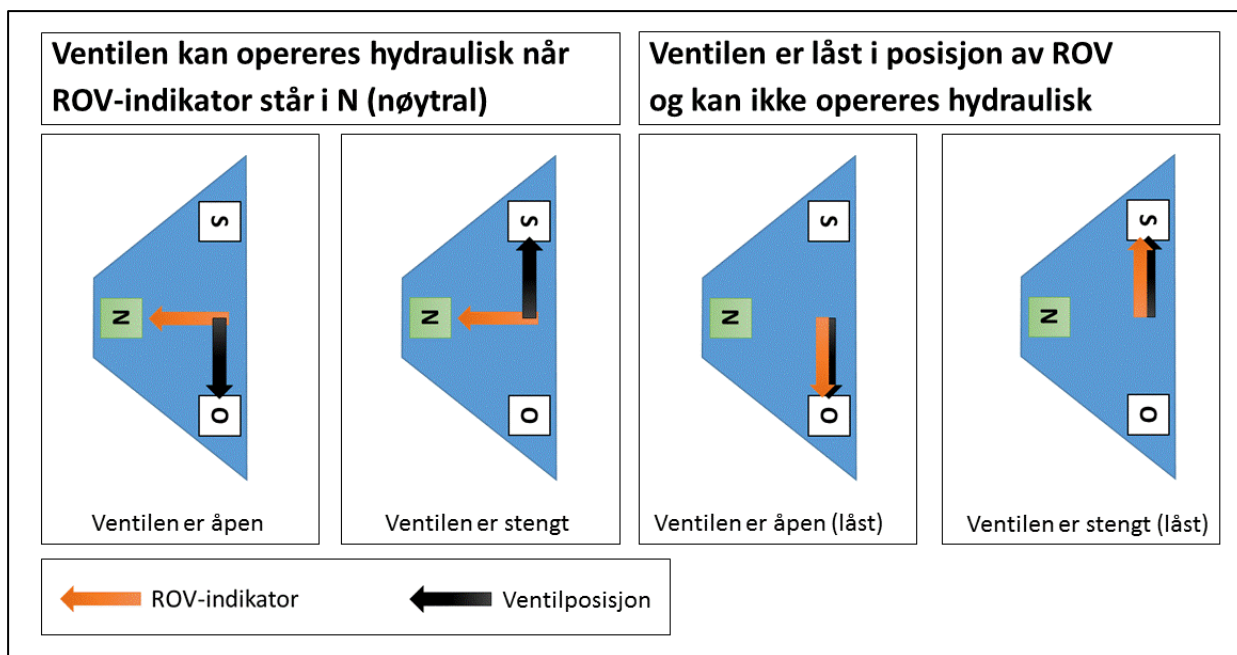
Figure 7 - Possible positions for indicators.

position by an ROV. This indicator will read open, neutral or closed, as shown in figure 6. If the ROV indicator shows open or closed, it is not possible to change the valve's position hydraulically from the Åsgard A control room. During work on the well, the umbilical for communication with Åsgard was disconnected and the workover control system (WOCS) umbilical was connected to the drilling facility (SENC/DSB). According to Statoil, a block was inserted in the control system to prevent the isolation valves being operated via the WOCS. Possible combinations of valve and ROV lock are shown in figure 7.

Key: (left) Valve can be operated hydraulically when the ROV indicator is in N (neutral); Valve is open; Valve is closed. (right) Valve is locked in position by ROV and cannot be operated hydraulically; Valve is open (locked); Valve is closed (locked). (bottom) ROV indicator; Valve position

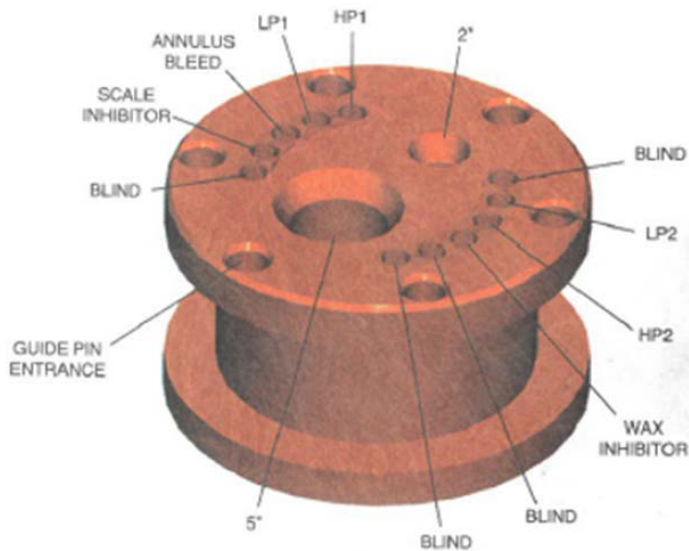
Figure 8 - Manifold hub (Source: Statoil)

In connection with pulling the Xmas tree and/or FCM, the production flowline from the isolation valve to the manifold hub will be exposed to seawater.

A five-inch main flowline for production, a two-inch methanol line and 11 small lines for hydraulics and other chemicals are connected to the manifold. The FCM has a connection to each of these lines, assembled in the manifold hub.

On the S template, the pressure between the isolation valve and the manifold hub cannot be established. Nor is a pressure gauge provided on the HPC itself, which means it is not possible to determine the pressure behind the HPC before it is unscrewed. A special procedure has been established for pulling the HPC in order to check whether a possible leak has arisen in the isolation valve before completely removing the HPC. In addition, a separate line is provided on the HPC for bleeding off possible hydrocarbons behind it. This line is narrow, which means it could be blocked by small impurities.
