Investigation report

Report		
Report titleActivity numberInvestigation of incident on 31 January 2024 involving a cabin001094054window on Åsgard A being forced in by green water		Activity number 001094054
Classification		
⊠ Unclassified	Exempt from p	publication
Parties involved		
Team	Approved by / date	
A-1	Elin S. Witsø / 28 M	May 2025
Investigation team participants	Investigation leader

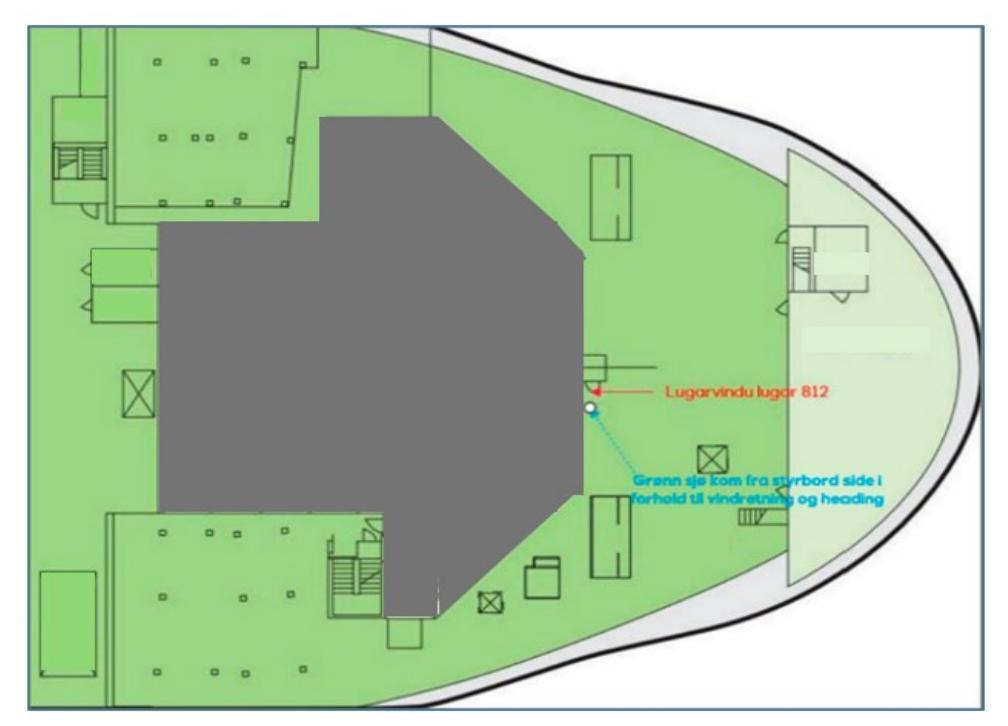
Figure 5: Living quarters, weather decks and outdoor areas on deck 8 (Source: Equinor)

Deck 8 at the foreship consists of weather decks (in front of and on both sides of the living quarters) and storage areas at the back of the living quarters. An emergency evacuation shaft is positioned at an angle to the window of cabin 812.
