Investigation report

Report	
Report title Investigation of incident on 31 January 2024 involving a cabin window on Åsgard A being forced in by green water	Activity number 001094054
Classification	
<input checked="" type="checkbox"/> Unclassified	<input type="checkbox"/> Exempt from publication
Parties involved	
Team A-1	Approved by / date Kjell M. Auflem / 8 January 2025
Investigation team participants [REDACTED]	Investigation leader [REDACTED]

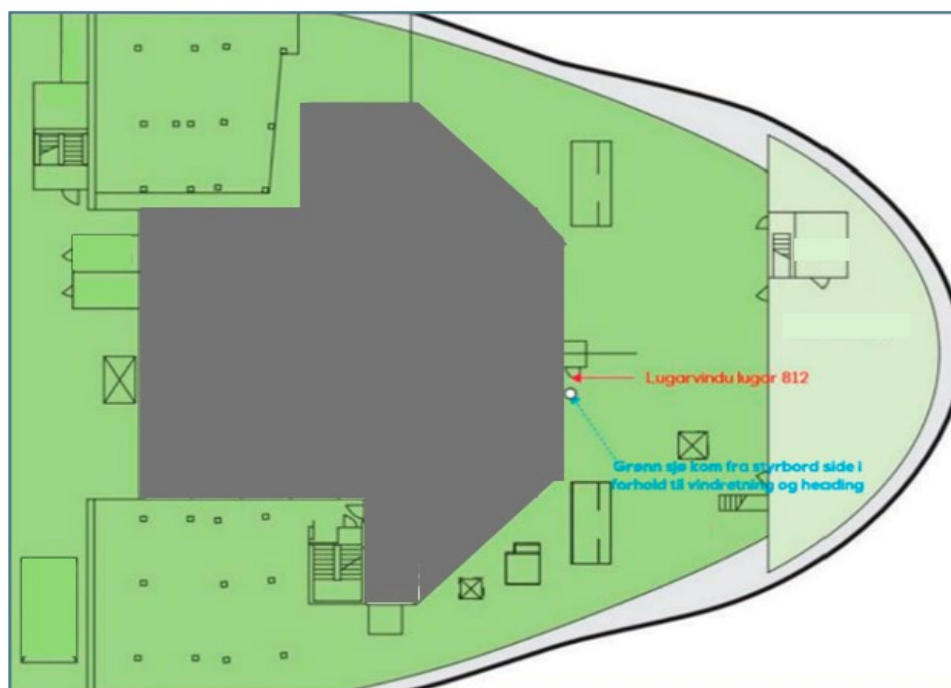
Figure 5: Living quarters, weather decks and outdoor areas on deck 8 (Source: Equinor)

Deck 8 at the foreship consists of weather decks (in front of and on both sides of the living quarters) and storage areas at the back of the living quarters. An emergency evacuation shaft is positioned at an angle to the window of cabin 812.

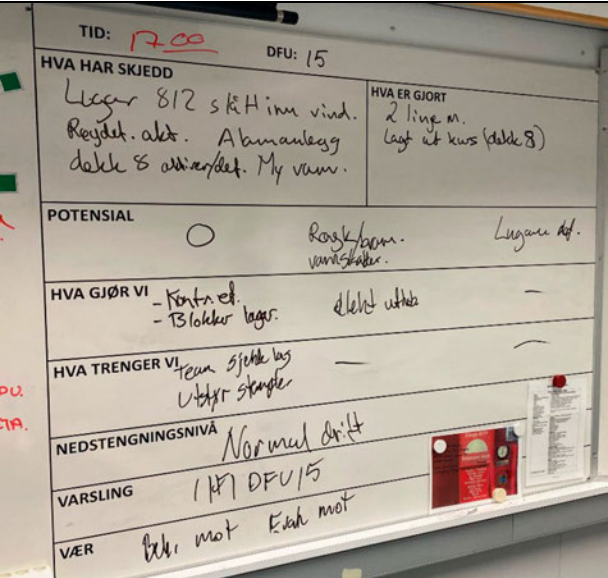
<p>Source: Equinor - extract from whiteboard in emergency room</p>

<p>Report by radio of sighting of loose objects out on deck.</p> <p>Search and rescue teams clear and secure loose items on deck.</p>																																					
<p>Time 17.05</p> <p>Other windows checked. Damage to neighbouring cabin 811 from water that has come through the ceiling.</p>																																					
<p>Time 17.12</p> <p>POB check, no one injured.</p>

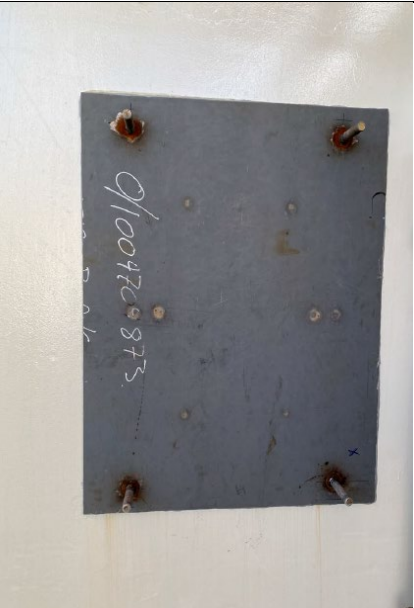
<p>Overview of water damage on deck 7 established.</p>	
<p>Time approx. 19.30 Cover plate installation plan approved. No attempt was made to install the cover plate with personnel located inside and outside due to the weather conditions. Cover plate modified to enable installation from the inside.</p>	
<p>Time approx. 20.30 Steel plate installed to cover the cabin window opening. Work team muster on deck 10.</p>
