Report	
Report title Investigation of an electrical incident with serious personal injury at the Kårstø plant on 25 July 2020	Activity number 003912038

Involved	
Team T-L	Approved by/date Kjell A Anfinsen, by authority, head of supervision 10 March 2021
Members of the investigation team Jan Sola Østensen, Irene B Dahle, Eivind Sande and Bård Johnsen	Investigation leader Bård Johnsen

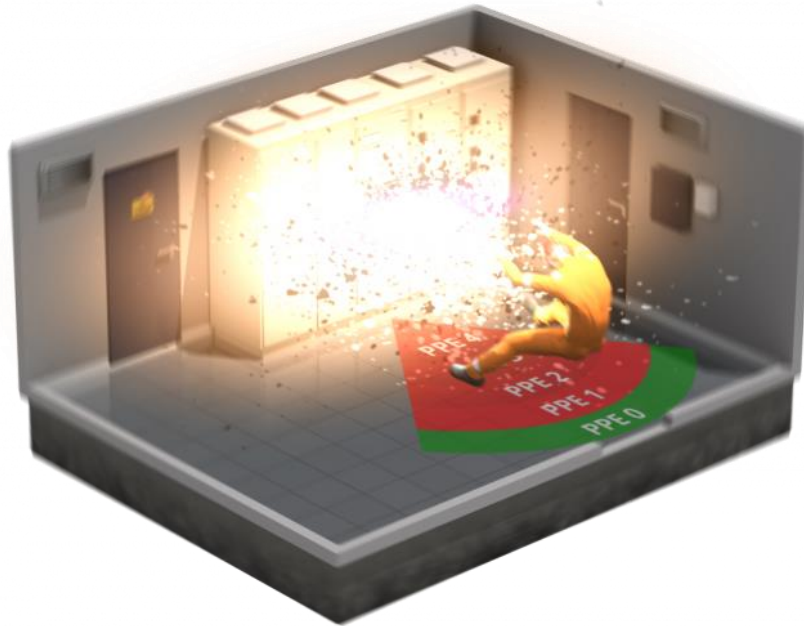
Figure 6 illustrates an arc flash incident in an electrical distribution switchboard.

Figure 6 Incident with short circuit and arc flash in a switchboard (illustration). Source: Trainor

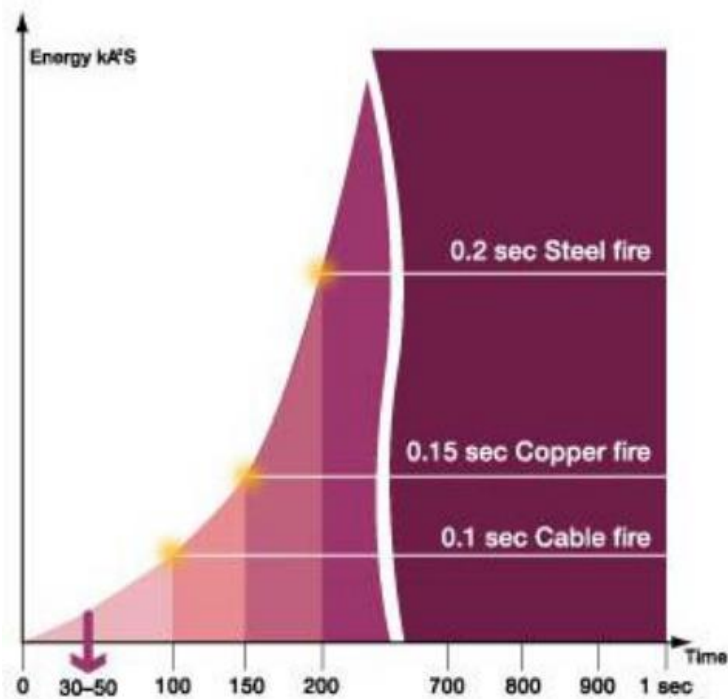
Figure 7 Incident energy as a function of time.

Figure 7, which presents incident energy as a function of time, shows that it rises exponentially from $t=0$ to about $t=0.5$ seconds, where it reaches its peak value.

To compensate for the high level of incident energy from a fault while operating/working on the switchboard, jobs to be done before the operation/work began were incorporated in the WO. These involved adjusting down the protection device in the incomer circuit breaker for the relevant switchboard, so that it would trip the circuit breaker faster than normal to limit the incident energy. See figure 7.

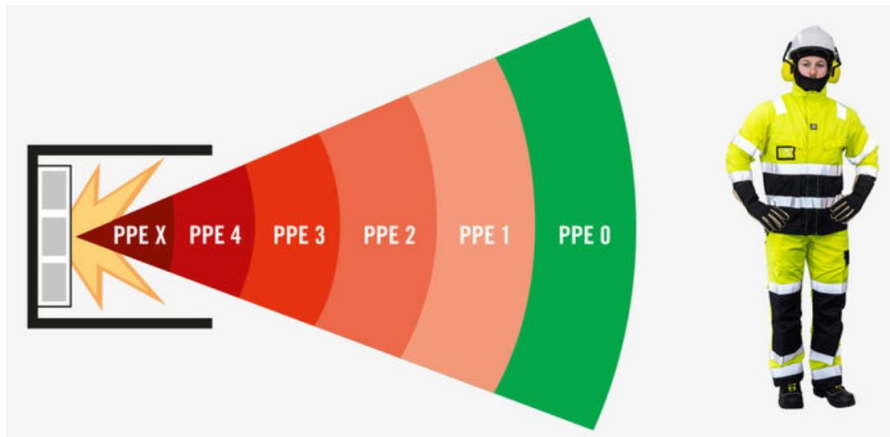
Figure 8 Arc flashes and PPE levels.

- PPE 0 ≤ 1.2 cal/cm² (no clothing to protect against arc flash required)
- PPE 1 ≤ 4 cal/cm²
- PPE 2 ≤ 8 cal/cm²
- PPE 3 ≤ 25 cal/cm²
- PPE 4 ≤ 40 cal/cm²
- PPE x > 40 cal/cm² (extreme hazard)

Pursuant to the WO, trip time was to be adjusted down ahead of operating/working on the switchboard to zero/0.2 seconds in order to reduce the calculated incident energy level from PPE 4 to PPE 2. See figures 7 and 8 on incident energy.

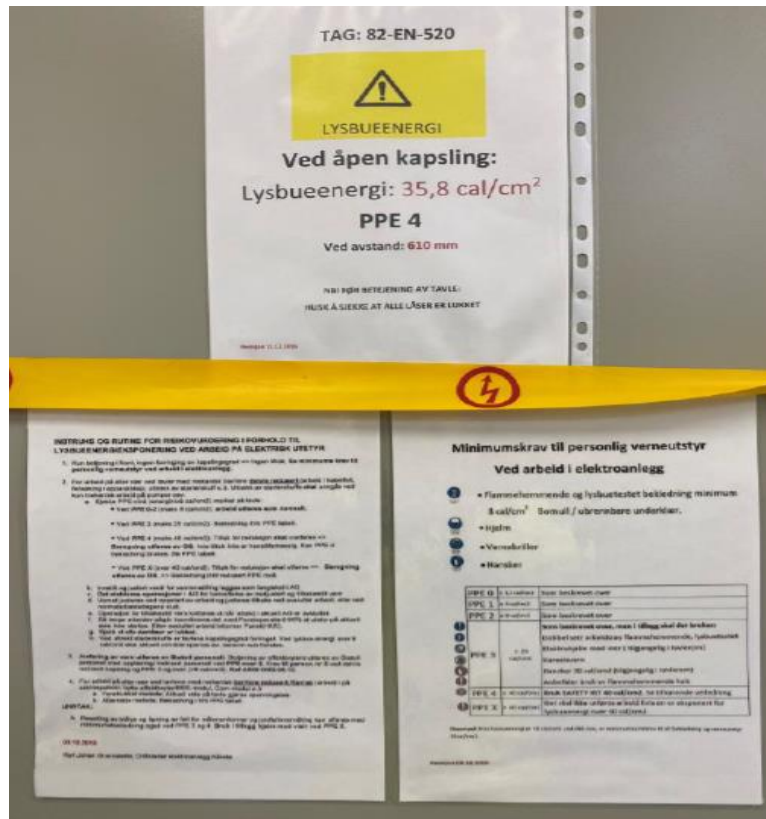
Figure 15 Arc flash information and procedure on the short wall of switchboard 82-EN-520. Source: Equinor

Such a risk assessment is intended to ensure, for example, that an AFA is appointed, a suitable working method has been chosen, safety measures are identified (such as adjusting the protection device down and ensuring necessary PPE), and relevant procedures have been reviewed. The procedure posted on the short wall of the distribution switchboard was not reviewed before the job. See figure 15. Necessary information on such aspects as potential incident energy was not acquired or assessed. Nor was the work team aware that the test panel was not fully compatible with the relevant starter drawers.

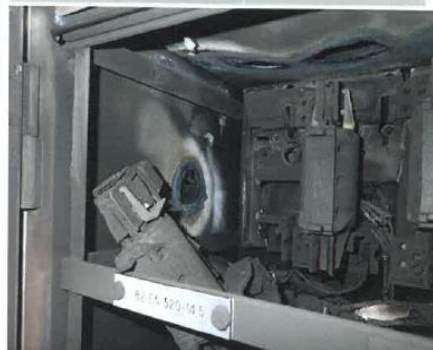
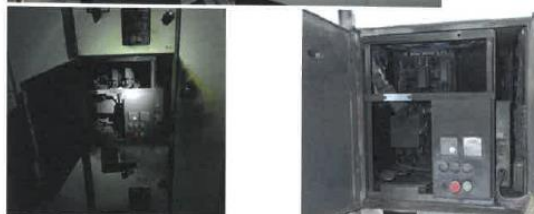
Beskrivelse av hendelse
Arbeidslag på 2 personer utførte planlagt vedlikehold på 690 V starteskuffer i substasjon i T-200. Det oppsto lysbue ved innsetting av starterskuffe i garasje i driftsposisjon. 1 person i arbeidet ble eksponert for lysbue. Hendelsen har ført til en personskade måtte behandles gjennom innleggelse på sykehus med sykehusopphold av flere dagers varighet for å behandle brannskader.
Årsaker og barrierer
Årsak til at det oppstod kortslutning og lysbue er foreløpig ikke kjent. Feilen ble utkoblet av forankoblet vern.
Tiltak og lærdom
Umiddelbare tiltak: Kårstø har midlertidig stoppet tilsvarende arbeider på spenningsatte tavler av typen Siemens S404. Det anbefales at andre anlegg med denne type tavler i påvente av resultater fra granskningen vurderer begrenset aktivitet og arbeid som krever åpning av kapsling til startere/brytere. Ved nødvendig arbeid/betjening som krever at kapsling åpnes, benyttes verneutstyr for lysbue i henhold til lysbueenergi-nivå for tavla. Det bør være to personer tilstede. Prosess for å innlede granskning iverksettes mot COA/MMP SSU CC.

Equinor's safety alert no 1
