Report	
Report title Investigation of fractured coiled tubing on Gullfaks C	Activity number 001050090

Involved	
Team T1	Approved by/date Kjell M Auflem/12 October 2023

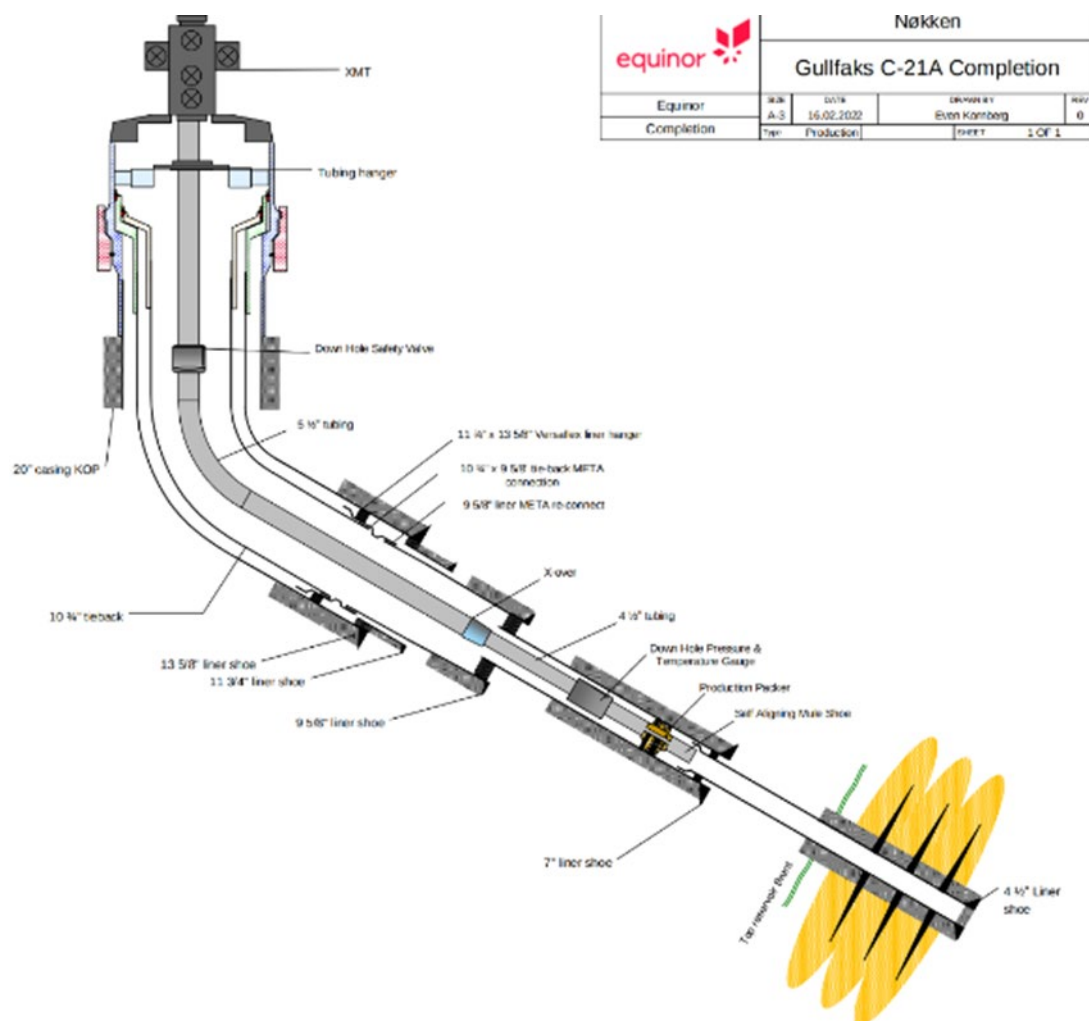
Figure 1 - Well diagram for C-21 A (Nøkken).

The well was completed with a 4 ½-inch liner through the reservoir and 4 ½- x 5 ½-inch production tubing.

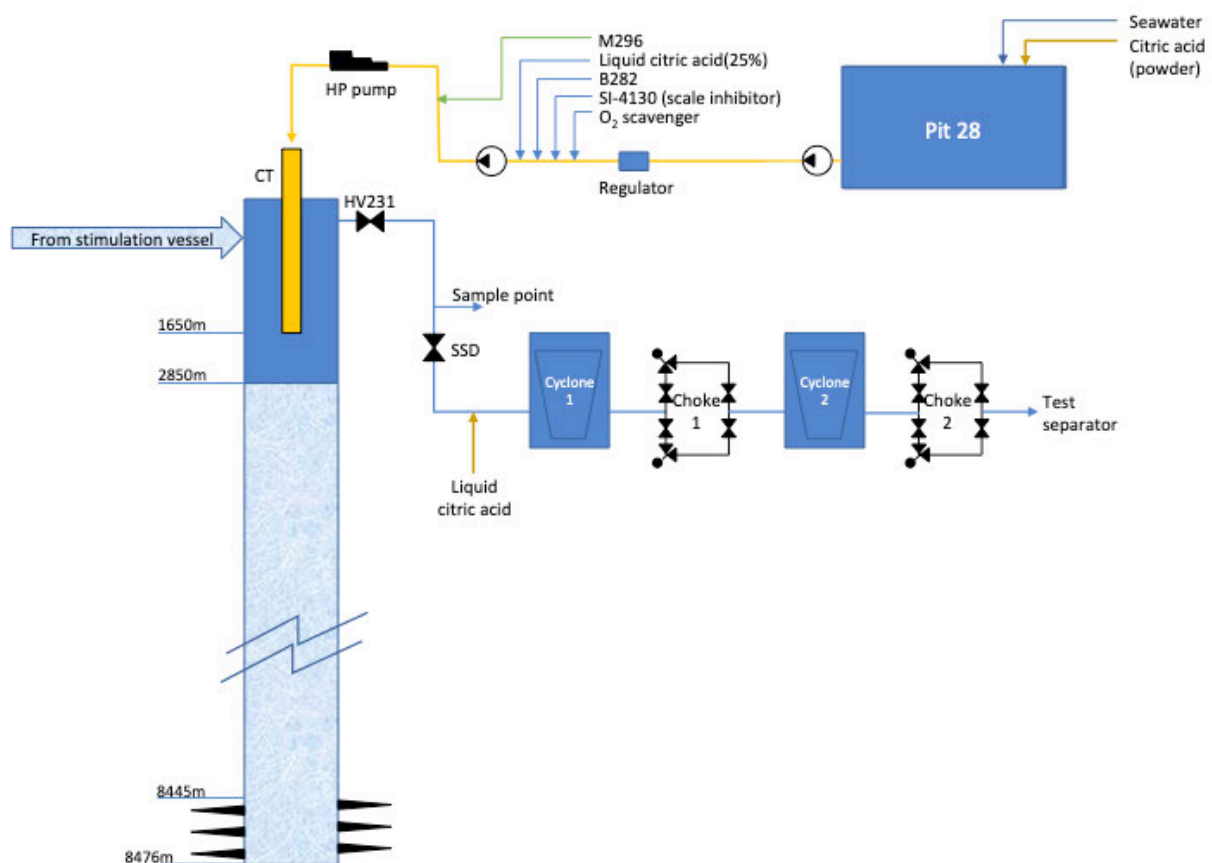
Figure 2 - Simplified circulation diagram for cleaning out proppants.

The subsequent clean-out began on 21 January 2023 through CT, using seawater, 0.2 per cent citric acid and oxygen scavenger. The citric acid concentration was later increased to 0.4 per cent. See figure 2. The B282 chemical was used to reduce fluid friction.

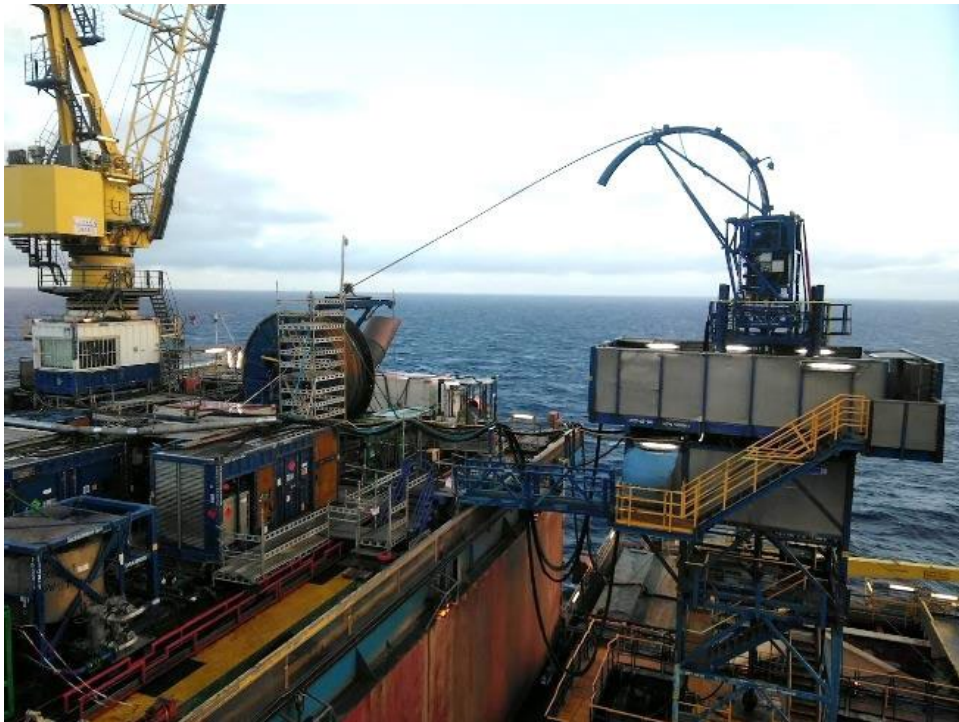
Image 3 - CT rig-up.

During operation, two opposed chains of crescent-shaped friction blocks are pressed by the injector head against the CT to move it from the reel and down the well. This subjects the CT to bending moments when it is uncoiled from the reel, when it is bent over the gooseneck and when it is straightened between the injector-head chains. This process is reversed when pulling the CT from the well. Image 3 illustrates how the CT was rigged up on Gullfaks C. The CT undergoes plastic deformation in each bending and straightening sequence, and the fatigue stress gradually increases. Down the well, the CT is exposed to compression and tensile stresses. HSLA steel is particularly vulnerable to corrosion in an acidic environment. See section 4.7.

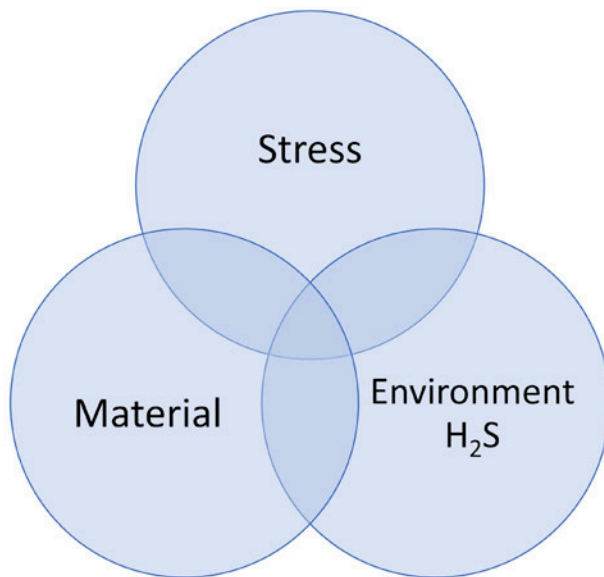
Figure 3: Preconditions for SSC.

SSC is considered to be a corrosion-driven form of HE, and three factors must occur simultaneously for it to arise. These are often illustrated as in figure 3.
