Investigation report

Report	
Report title Investigation of an arc flash and fire in a switchboard room on Statfjord B	Activity number 001037054

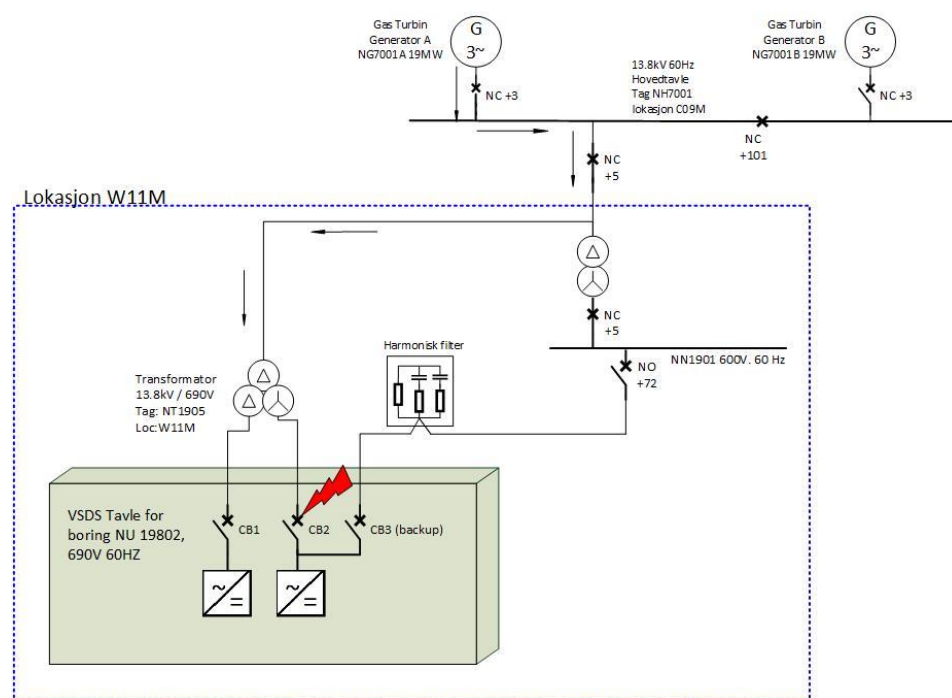
Figure 4 Simplified diagram of equipment involved in the arc-flash incident.

According to its declaration of conformity, the switchboard was manufactured in April 2007 and installed on Statfjord B in 2009 as part of a drilling upgrade programme. The installation also included a $\Delta/\Delta/Y$ transformer which supplies the switchboard with AC from the Statfjord B grid. This transformer is ungrounded, and the biggest significant fault currents are thereby limited to phase-phase faults or faults on the DC side of the rectifier. The switchboard has ground fault monitoring which continuously measures leakage currents to ground.

The switchboard was arc-flash tested, but failed the approved test. Compensatory measures were implemented to reduce the probability of an internal arc flash, while

On the night of the incident, Statfjord B was powered by generator A (NG7001A). The VSDS switchboard (NU19802) for drilling was supplied from the 13.8kV main switchboard (NH7001) via outgoing feeder +5 and transformer NT1905 (13.8kV AC/690VAC) (NT1905). See Figure 4 for a diagram of the installation.

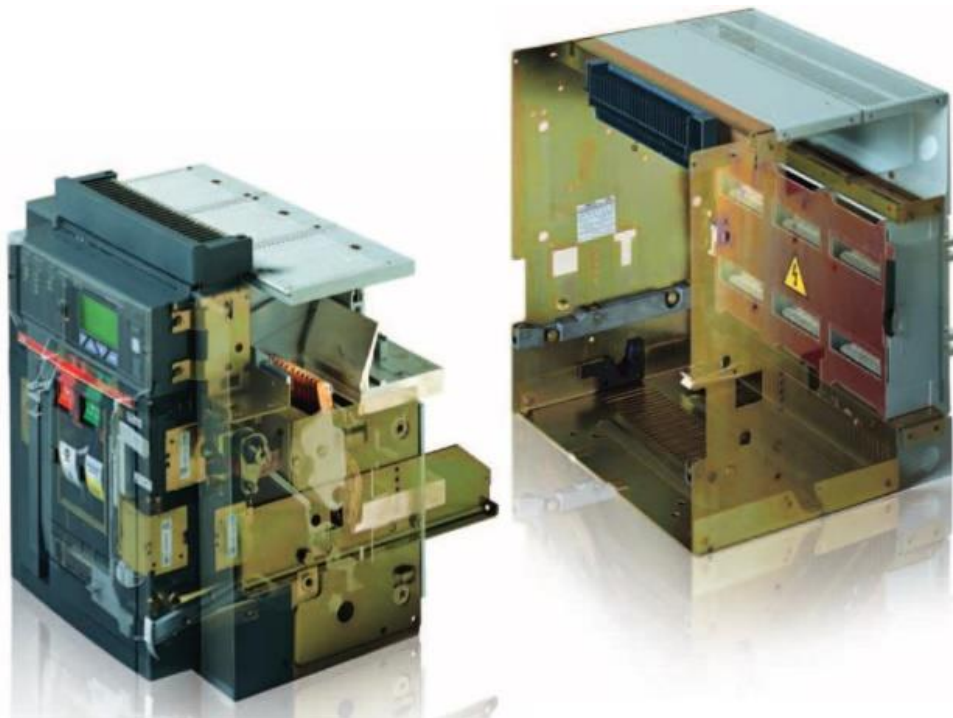
Figure 5 Photomontage ABB. E3 Circuit breaker with associated cassette.

The breaker to be replaced was a withdrawable Emax E3H 32 type (690V, 3 200A, I_{cs} = 75kA). It can be placed in three different positions:

The position is indicated at the lower right-hand side of the breaker's front panel. A breaker can only be manoeuvred between different positions when in open position. To change from test to operating position, it is wound in with a dedicated tool. Contacts on the breaker then engage with contacts in the cassette. Neither the breaker which was removed nor the one inserted had its own tag number. No service or maintenance is registered either for the breaker which was in service or the one kept as a spare since 2006.

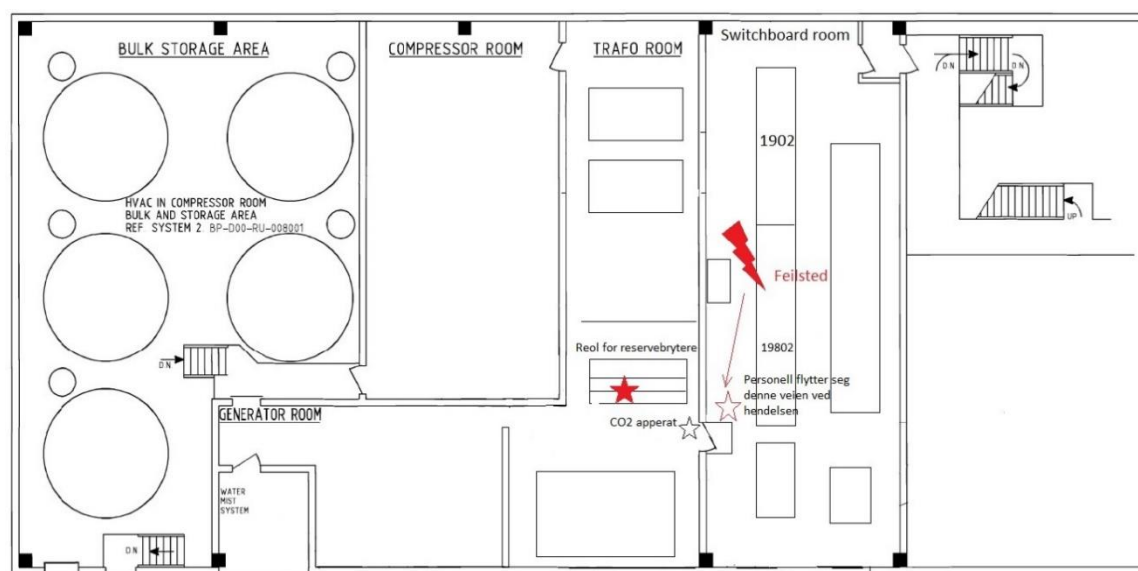
Figure 7 Simplified diagram of module W11 on Statfjord B, with relevant locations highlighted.

The electrician saw a fire inside the switchboard and decided to fetch the CO₂ extinguisher from the neighbouring room (see Figure 7) to fight the flames. The mechanic was despatched to notify the control room by phone. After seeking to extinguish the fire through the grille in the switchboard door, the electrician quickly saw that this was having little effect. He therefore opened the door, allowing black smoke to pour out. After emptying the extinguisher, the electrician left the room. Interviews with the people involved established that this took about three-five minutes.
