# Investigation report

Report	
Report title Investigation of the unintentional disconnection of the LMRP on <i>West Mira</i>	Activity number 404010004

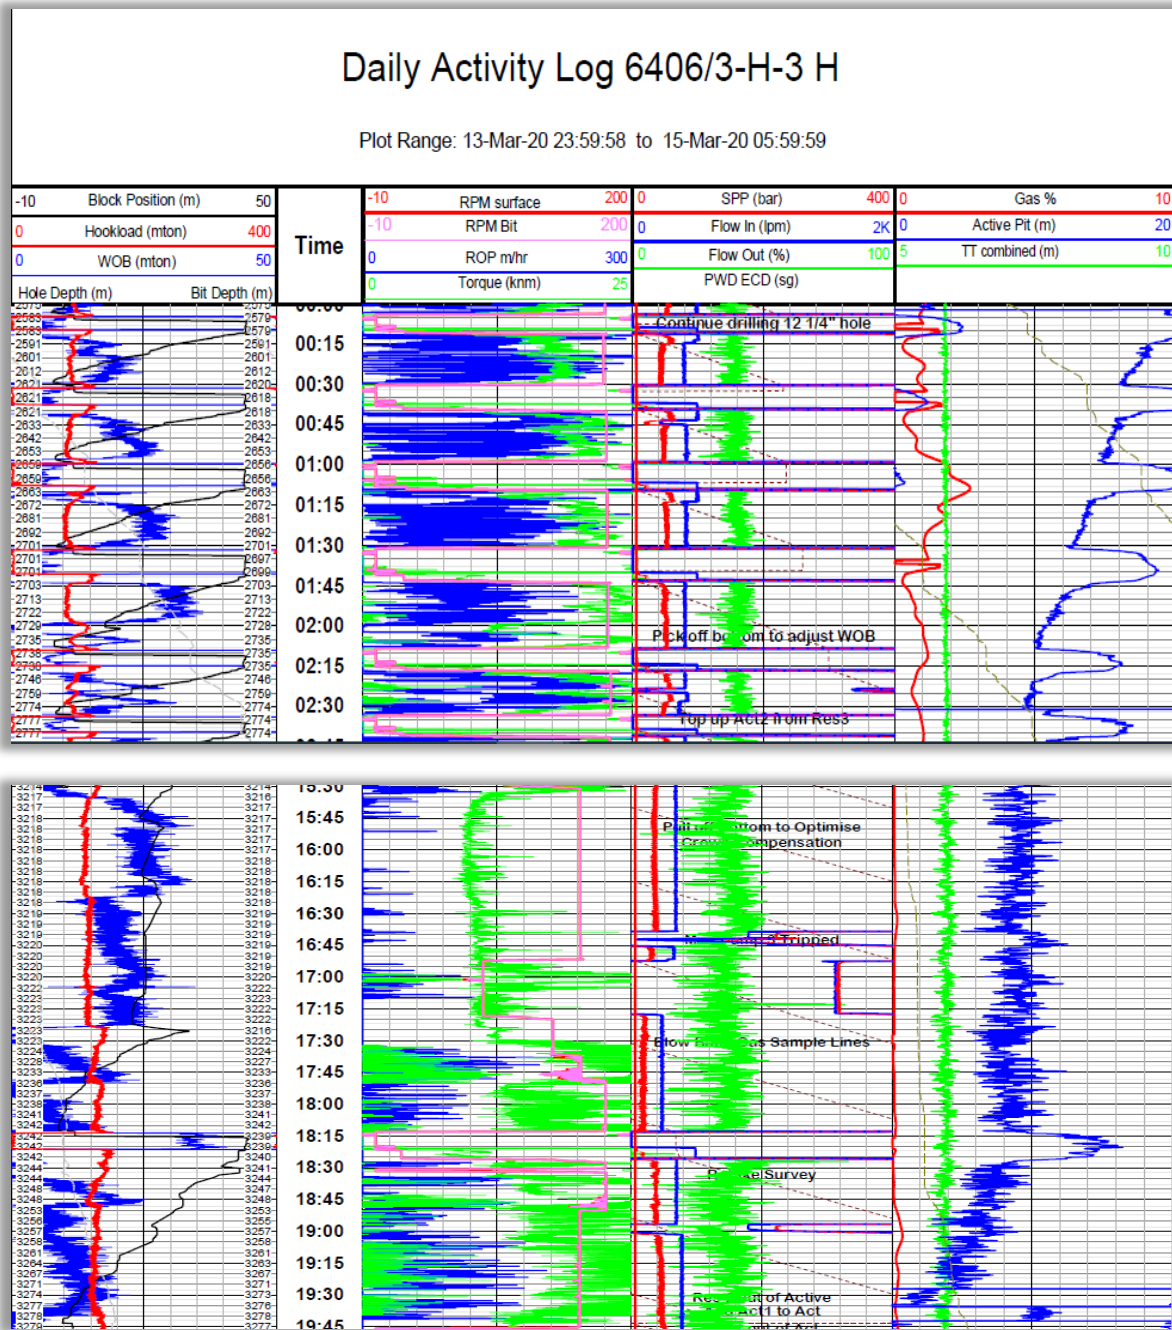
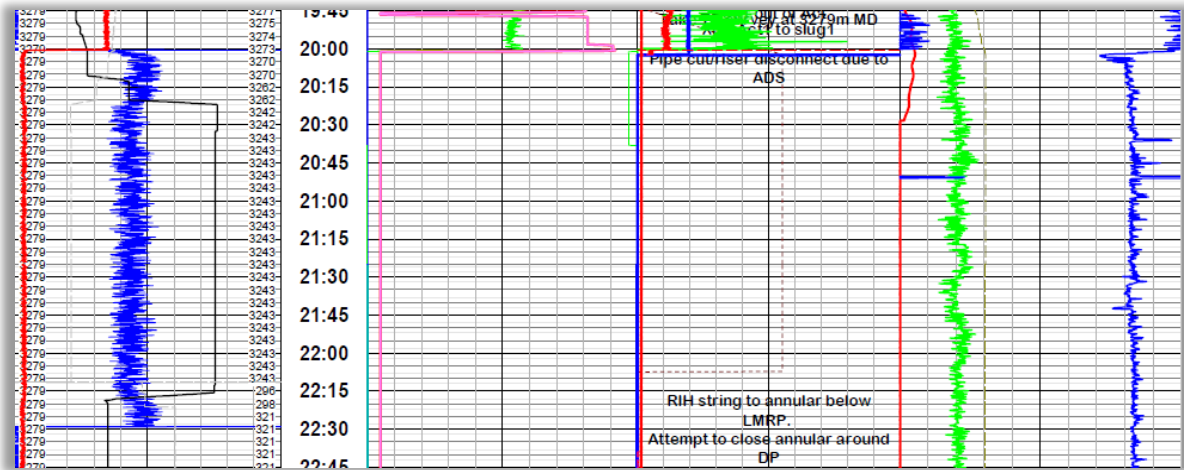
The main activity on 14 March was drilling the 12 ¼-inch well section. From midnight until minutes before the incident, the facility had drilled about 700m.

Figure 4: Extracts from the activity log on 14 March 2020 and up to the time of the incident.

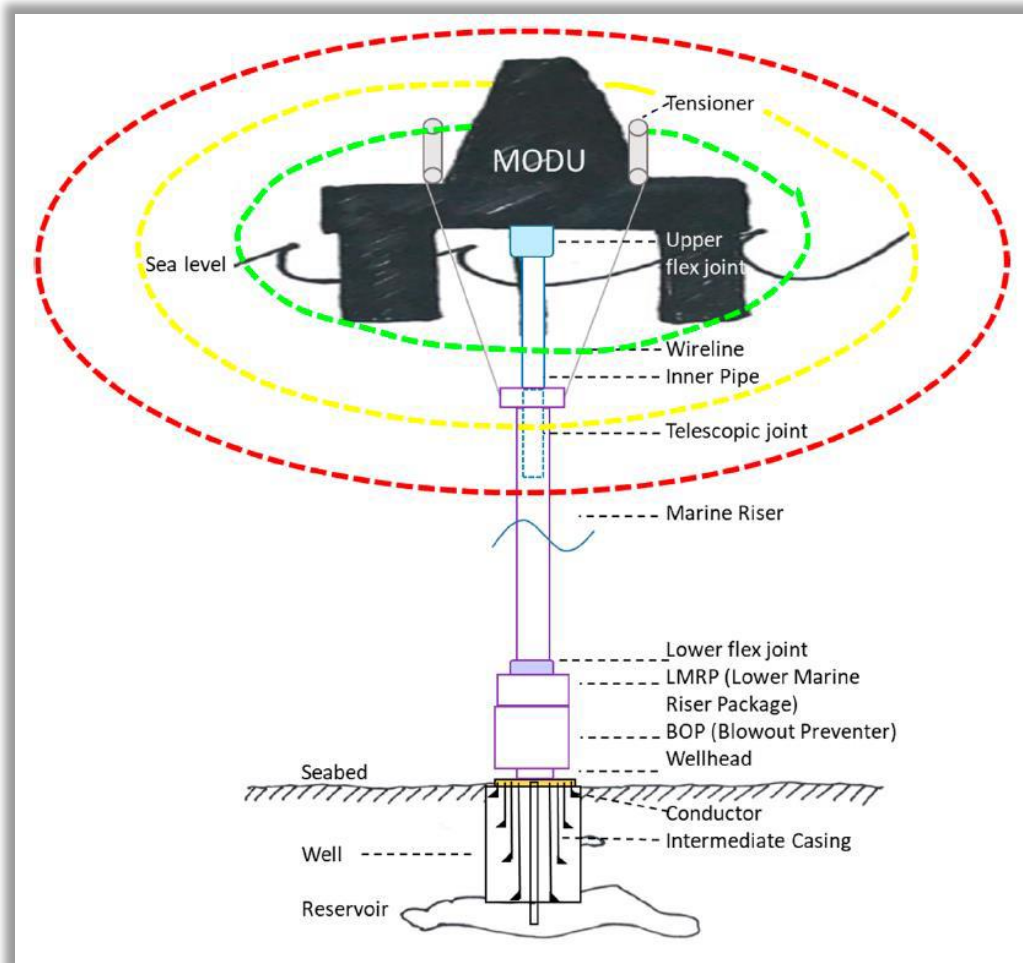
Figure 10 The green circle in the diagram shows the safe working area, while yellow shows where the EDS initiates disconnection.

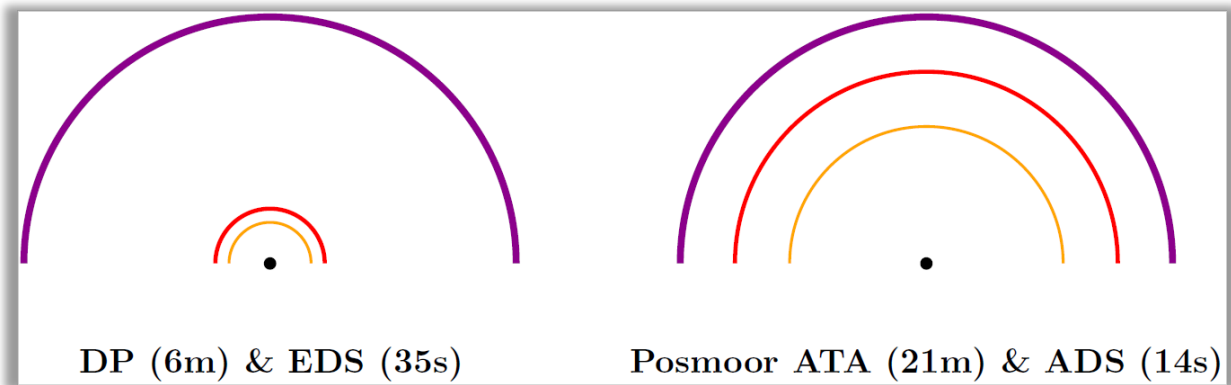
The riser analysis was prepared by Stress Engineering Services Inc for using *West Mira* to drill at the Maria H location. This referred to calculations of maximum drift-off of the facility over the sea surface with regards to limitations in the upper and lower flexjoint (UFJ/LFJ). The summary of the analysis describes the required ADS setting to ensure timely disconnection before the upper limit is exceeded (90 per cent of contact). The analysis includes the influence of the time taken to activate the ADS and thereby the margin required to initiate timely disconnection in the event of an excursion away from the DP set point. To ensure disconnection within a 27m excursion (corresponding to 90 per cent of the angle for collision), the analysis concludes that the offset for ADS initiation is 14.7m and that the angle required is less than six degrees if considering a fast drift-off.

Figure 14: Summary of the riser analysis (disconnection completed at 27m shown as the outermost purple semicircle). Two possible circumstances are shown. Left: with DP and EDS function at 35 seconds action time, which gives a radius of about 6m for the red “watch” circle where disconnection must start. Right: Posmoor ATA and ADS with 14 seconds action time, giving a red “watch” circle of about 21m.

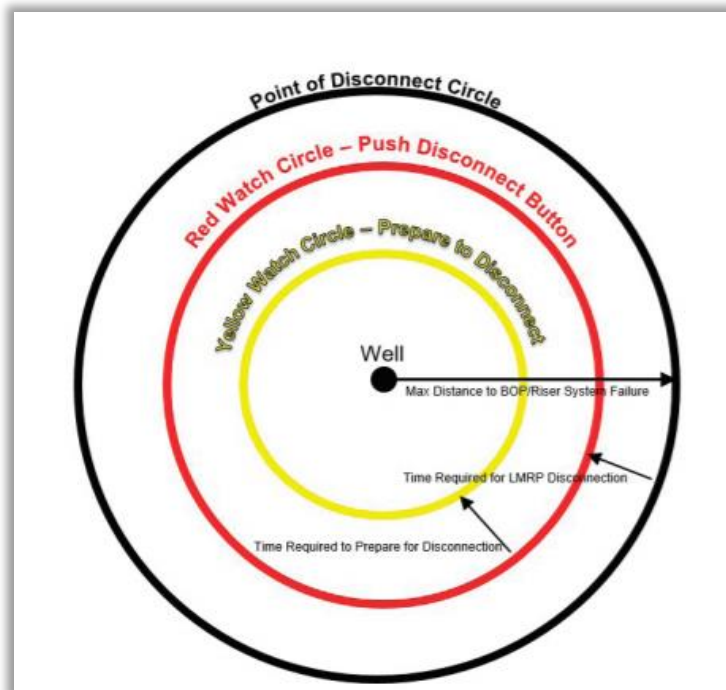
Figure 17: The various WSOG colour levels for the "watch" circle.

The reference point (centre) is the well location and the outermost perimeter is disconnection, where the ADS function should ideally coincide with the black circle. In normal DP operation, the facility's set point in the drilling centre will be positioned over the well centre, so that DP-alarm and watch-circle radii coincide.
