Investigation report

Report from the investigation of a hydrocarbon leak on Heimdal, 26 May 2012

Activity number
001036006

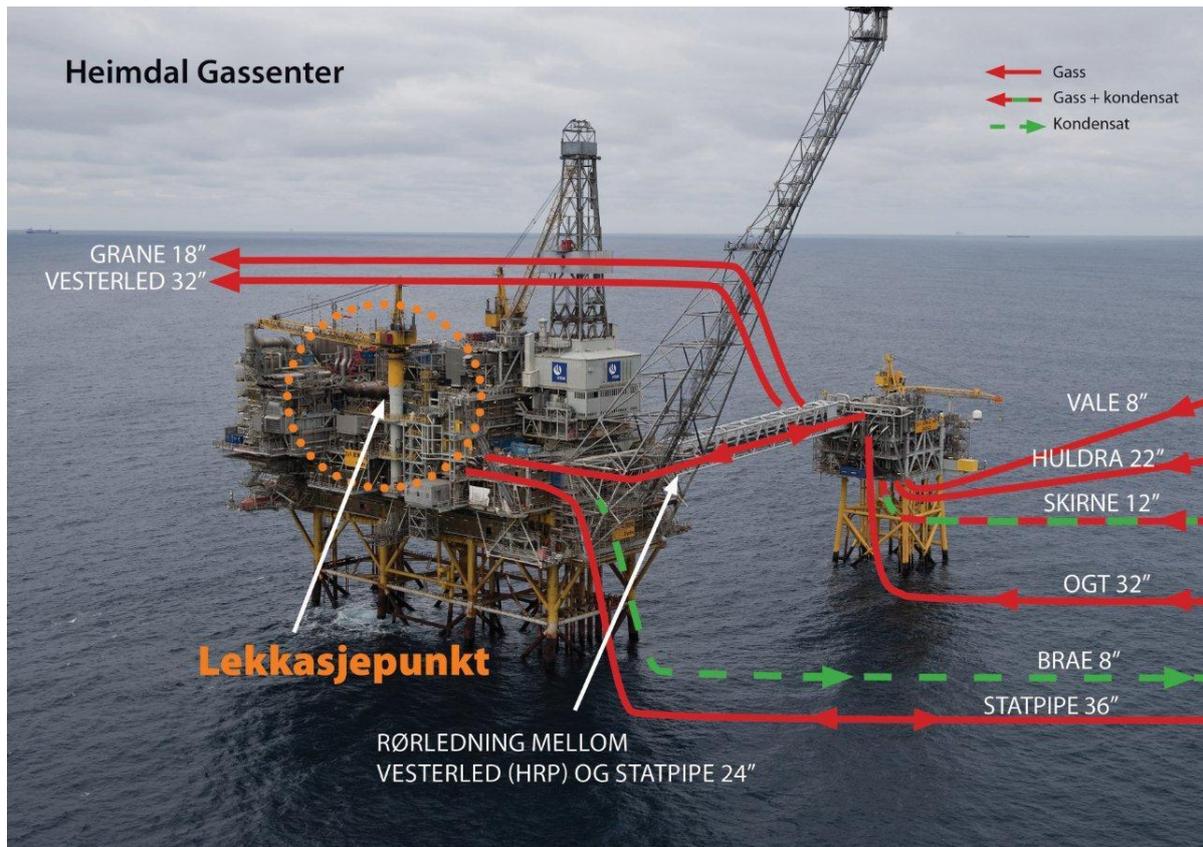
Figure 3: The Heimdal gas centre.

Key: Lekkasjepunkt: Leak site; Rørledning mellom Vesterled (HRP) og Statpipe 24”: Pipeline between Vesterled (HRP) and Statpipe 24”.

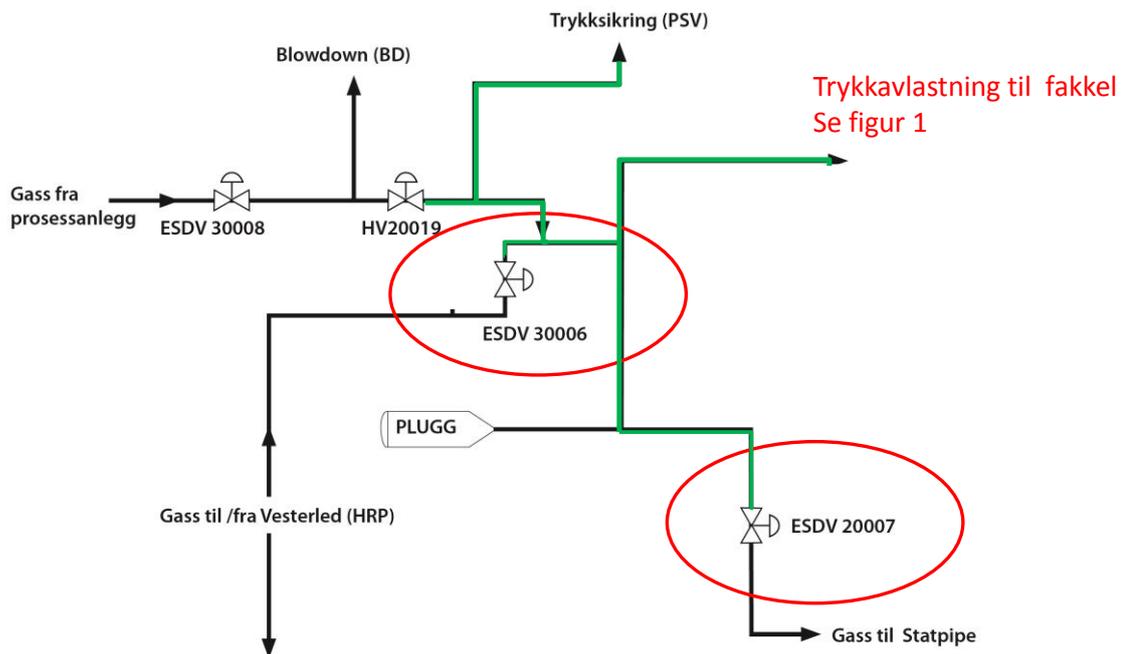
Figure 4: Simplified illustration of the pipe segment with valves. The gas volume for blowdown is shown in green.

From **07.30**, the CCR operator prepares for leak testing of ESDV 30006 and ESDV 20007. The test involves isolating the pipe segment (coloured green in figure 3) by closing the ESDVs, (and all manual valves connected to the pipe segment) and isolating from the HMP process. The procedure thereafter specifies only blowing down to the flare in order to identify possible ESDV leaks when the segment is depressurised. The procedure for ESDV 30006 states that it must be blown down via HCV 20021, while that for ESDV 20007 calls for blowdown to the flare. It emerged from interviews that that the blowdown valve was isolated (HV 20019 closed), so that the natural blowdown route was via HCV 20021 to the flare (see figure 4).

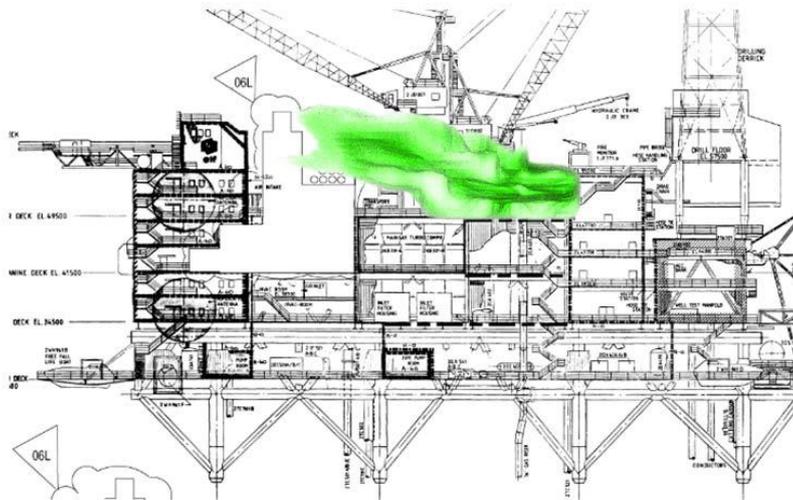
The incident, a gas leak in the M40 area, is estimated to involve the release of 3 500 kg of gas over 252 seconds, with an estimated initial emission rate of 16.9 kg/s. The gas spread to several neighbouring areas (M20, M30 and M50) on the weather deck. Ignitable concentrations in the gas cloud lasted about seven minutes, and escaped gas had been ventilated away after about 30 minutes. Total gas volume in the pipe segment was 53.49 cu.m at 129 bar 9°C, calculated to be about 7 000 kg.

Figure 9: Facade drawing with a projected gas cloud, viewed from south to north. (Source: Statoil's Flacs analysis)

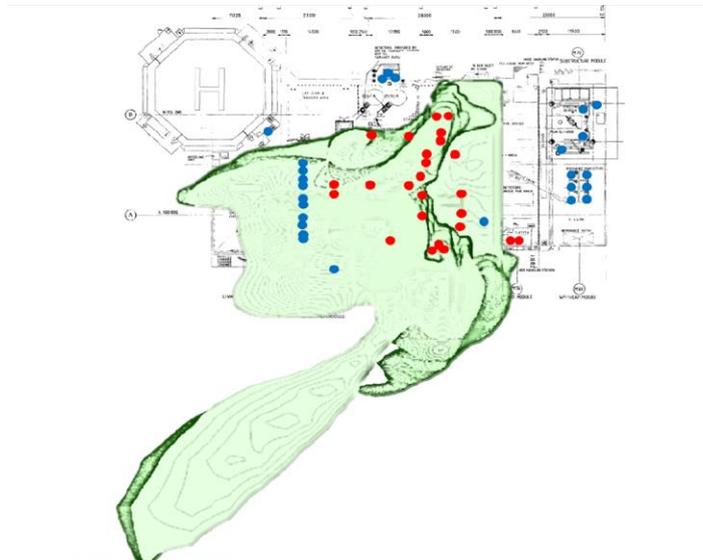
Figure 10: Gas cloud projected down to the weather deck at 230 seconds into the incident. Red dots show detectors, which activated at 20 per cent LEL. Blue dots show detectors which did not detect gas during the incident. (Source: Statoil's Flacs analysis)

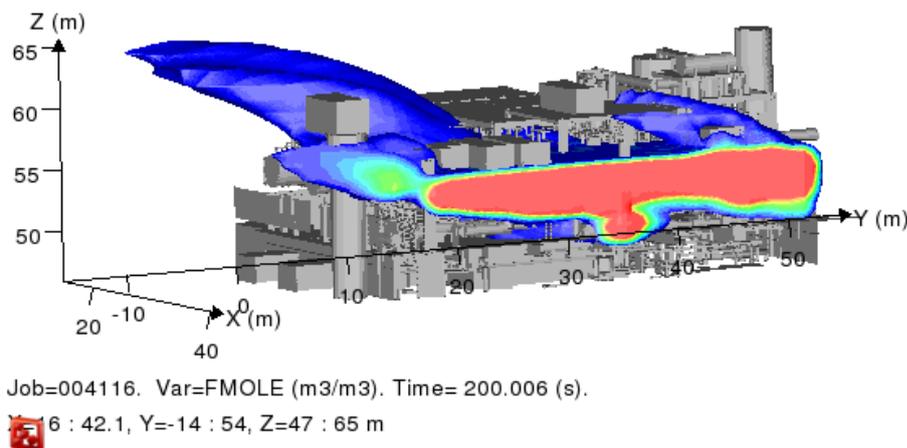
A gas volume of 7 000 kg under high pressure and with a high flow rate would have created a large gas cloud, but this scenario has not been risk-assessed by the PSA or Statoil. Two fire walls would have been exposed to the explosion. One of these, to the living quarters, is designed according to Statoil for 0.1 bar and the other, to the drilling area, has a design pressure close to 0.3 bar. Drilling has ceased on Heimdal, which means that the biggest threat for an explosion escalating is that the wall to the living quarters could not withstand it.

Figure 12: Gas cloud with the ignitable gas area shown as a green band around the red area, which has too high a density to ignite. (Source: Statoil's Flacs analysis)

Other ventilation conditions and/or a lower leak rate could have increased the explosion risk because the gas cloud might have increased in size and/or acquired a more favourable composition for the explosion phenomenon.

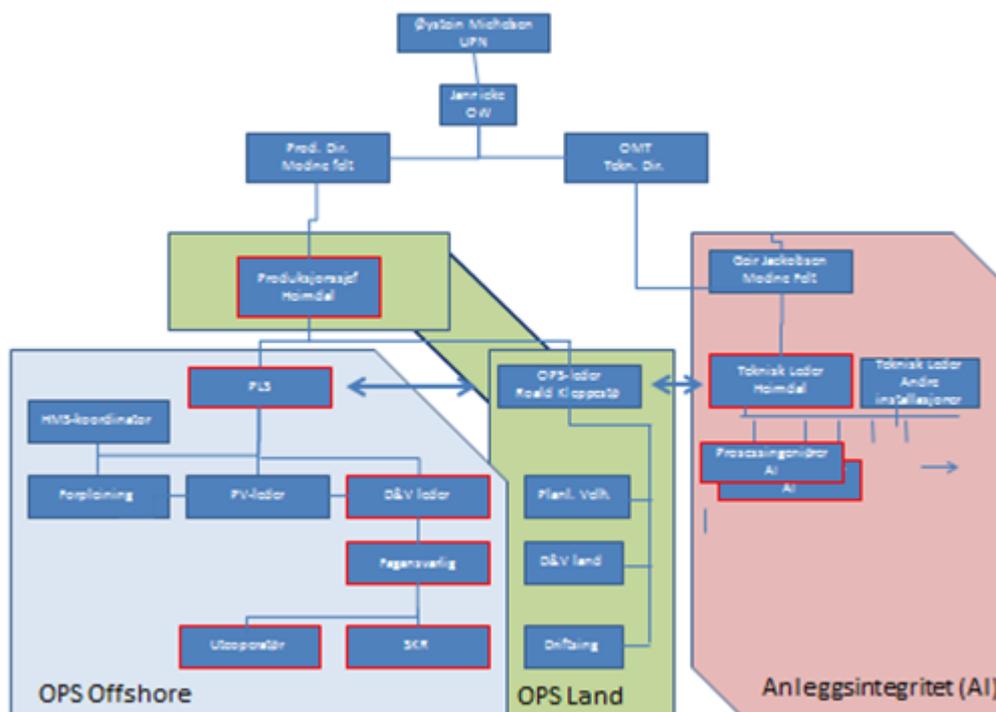
An organisational division has been established between AI, responsible for technical integrity on the installation, and the OPS department with responsibility for selecting methods to operate the process facilities, for instance. AI is the “owner of” and has responsibility for the process plant, but has no budget authority and must go via the production manager to get technical measures taken offshore. It emerged during interviews that OPS and AI do not always have the same priorities. Statoil’s investigation report identifies a big workload in AI. A combination of an aging installation with substantial maintenance challenges, the intention to apply for an extension of producing life to 2034, a lack of budget authority and a high workload accordingly constrain working conditions of AI personnel.

Figure 17: Outline in principle of the organisation, with the AI/OPS interface.

In addition, it is clear that AI also depends on information from the offshore organisation about deficiencies in the plant. According to our information, notifications represent the most important and perhaps the only contribution to verifying P&IDs against the plant. There are signs that the offshore organisation does not contribute sufficient information to AI on necessary changes.
