# Investigation report

Report	
Report title Investigation of lifeboat incident of 14 January 2015 on <i>Mærsk Giant</i>	Activity number 400003004

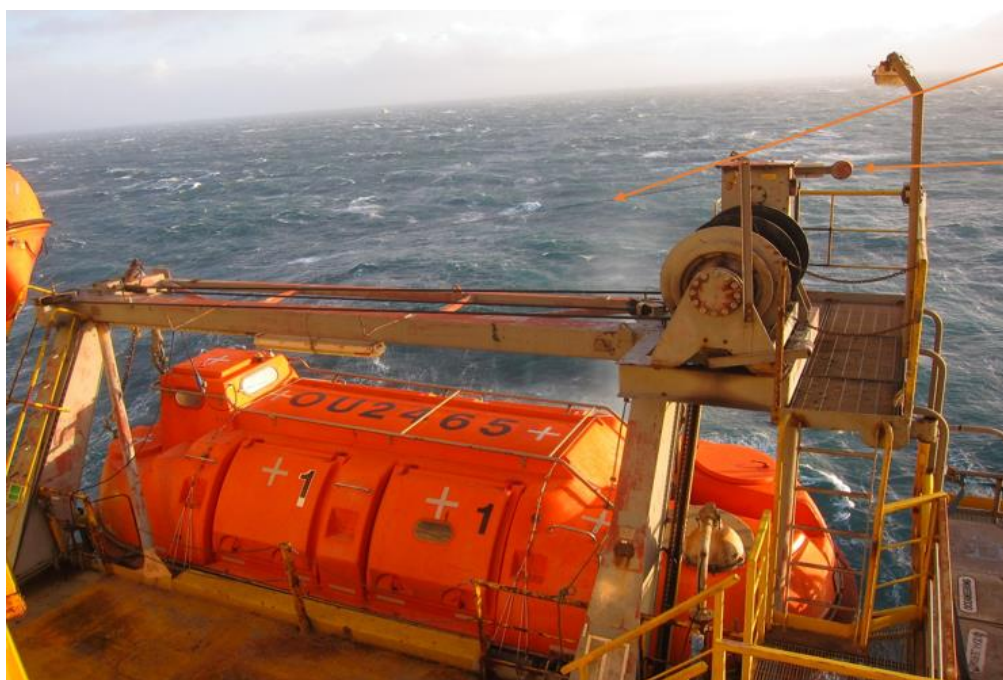
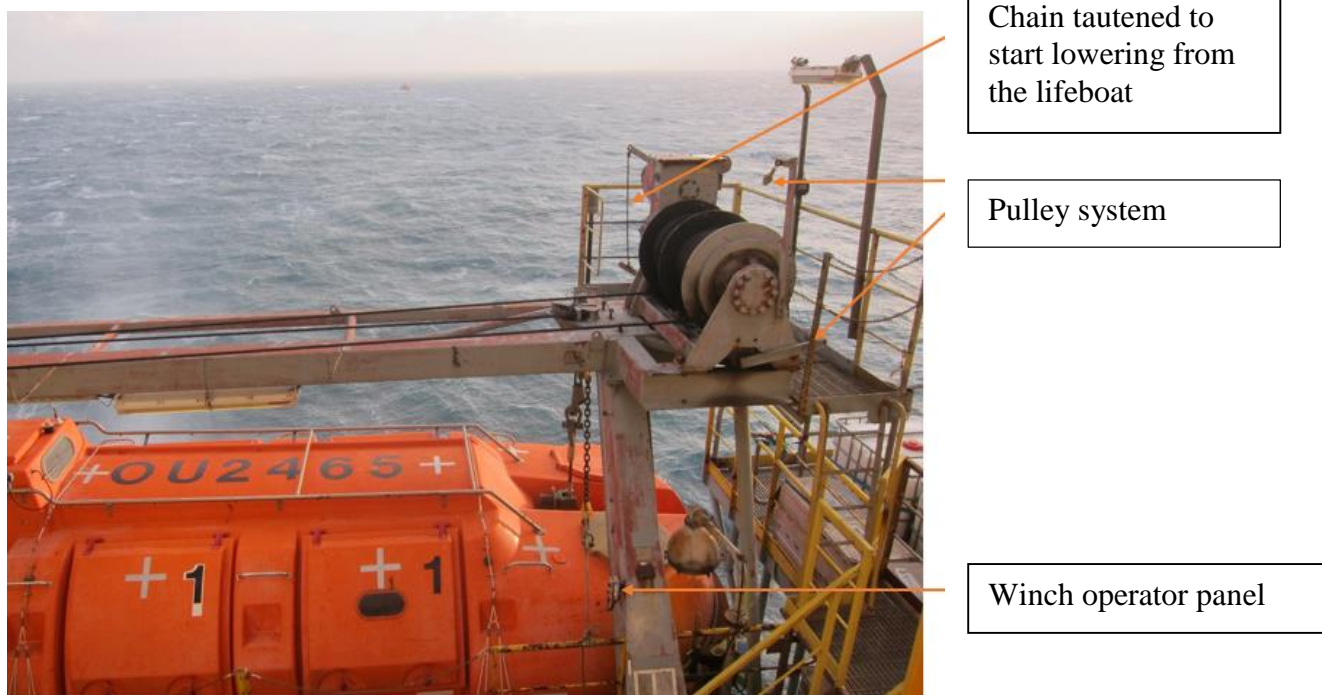
Manual brake control handle

Lifeboat number 2 is lowered with the aid of gravity. A manual brake normally holds it in the correct position in the davit. When the brake is released, the lifeboat is lowered. The manual brake can be released either from the lifeboat with the aid of a dedicated steel wire, which connects to the manual brake control handle via a pulley system, or directly using the manual brake control handle. The latter is positioned on the rig above the lifeboat system (see figure 2). A governor brake ensures a controlled lowering speed in the event of an evacuation.

Figure 2: Two photos of the corresponding port-side lifeboat and winch system on *Mærsk Giant*.

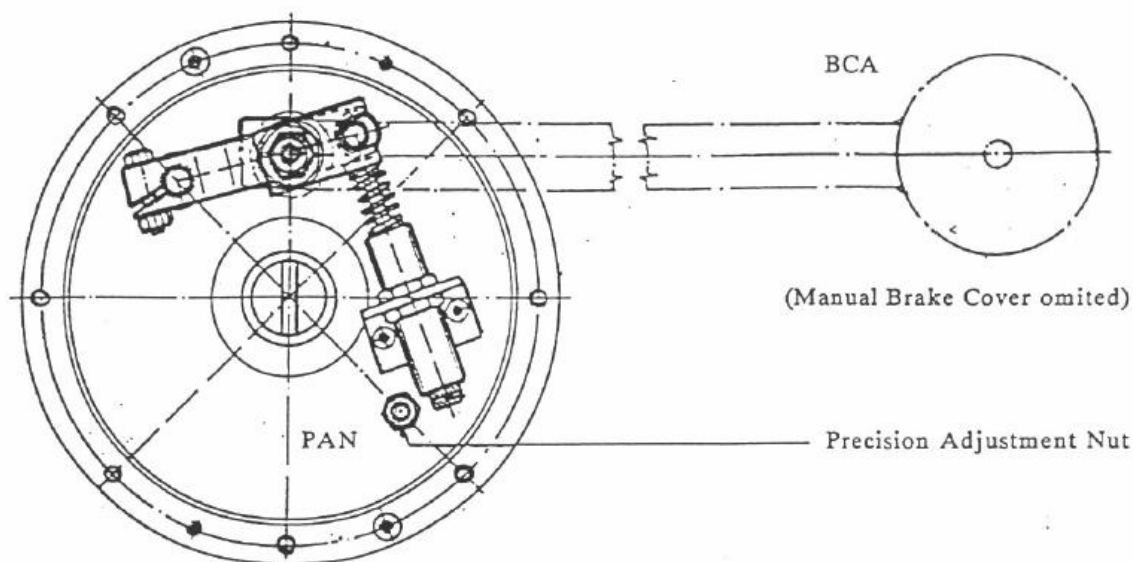
Figure 7: Cross-section of the relevant davit from the user manual.

A properly adjusted brake is characterised by a horizontal or slightly (up to 10 to 15 degrees) raised position of the BCH control handle.

The brake needs to be re-adjusted as soon as the weighted handle extremity drops below the above horizontal level or the brake starts to develop a slipping tendency.
