REVIEW OF AVAILABLE MATERIAL ON USABILITY AND SUITABILITY OF  
HIGH-STRENGTH MOORING CHAIN (PSA)

# Usability and suitability of high strength mooring chains

Petroleum Safety Authority Norway

**Report No.:** P261.1C-54693, Rev. 1

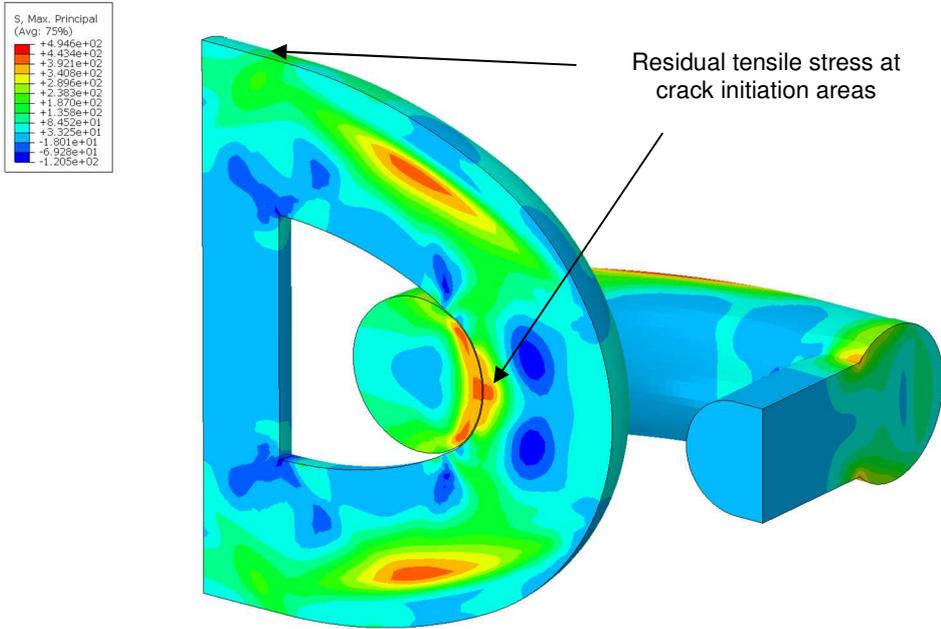
Figure 2-4 Residual stresses at the two crack initiation locations observed in the failure reports

The proof load was applied and relieved. The resulting residual maximum principal stresses can be observed in Figure 2-4.

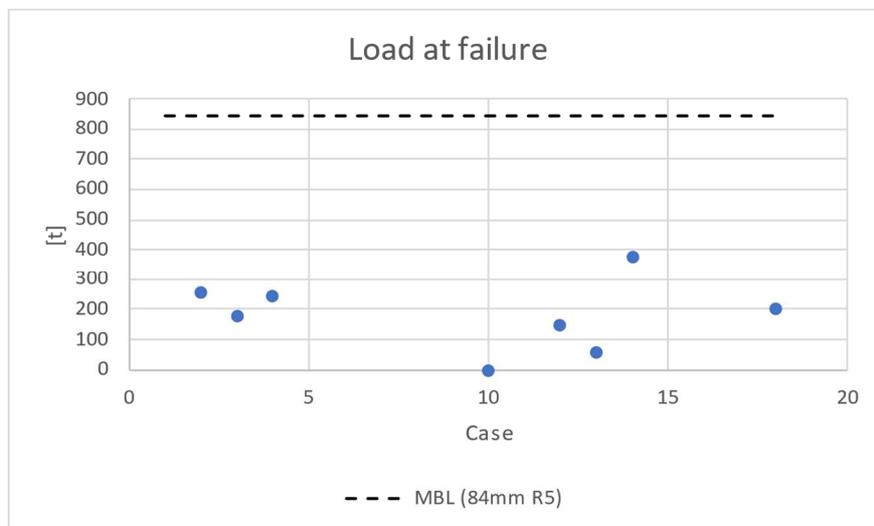
**Figure 7-1 Known chain load at failure**

The reported load level at failure, see Figure 7-1, can only be taken as indicative since in most cases the instrumentation is not reliable, specially loads in chain handling which are taken from bollard-pull settings.

The reported cases occurred all at relatively low loads.

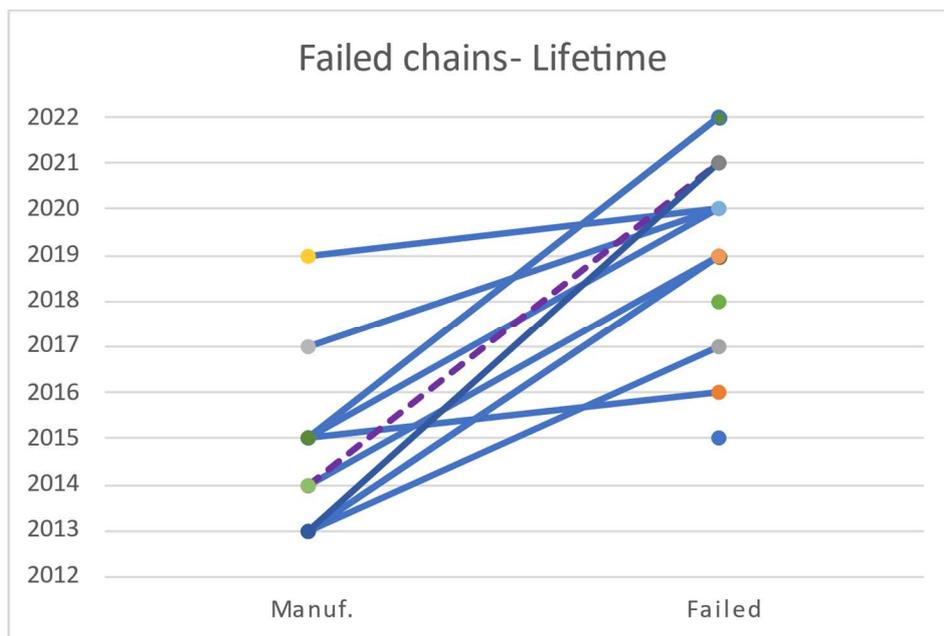
**Figure 7-2 Failed links lifetime representation. Thirteen full date pairs available.**

The age of the chains at failure is represented in Figure 7-2. Given the intermittent use of mobile mooring chains which correspond to the totality of the reported failures, this parameter does not represent an actual service time.

The cases with chains with very little use are highlighted, indicating the potential for very fast crack growth in both the straight and crown areas:

- In one case occurring in 1 year old chain, the failure was at the straight part with friction marks and detectable untempered martensite.
- The other case with 1 year old chain occurred in the crown and is most likely hydrogen induced cracking. The main failed link was located above the cable lifter and at least 3 other neighbouring links had detectable cracks in the same area. The failure occurred during chain handling.

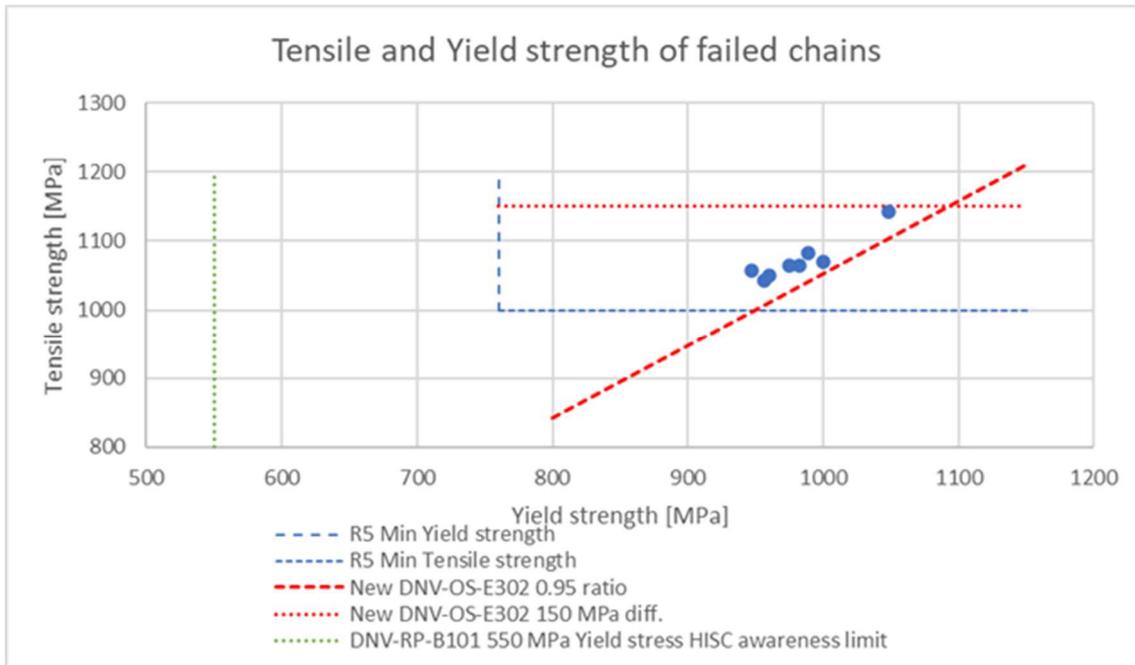
**Figure 7-3 Failed chains mechanical properties- eight cases with measured composition on the failure report.**

The mechanical properties of the chain links reported in the failure investigation reports are presented in Figure 7-3. The R5 yield and tensile strength limits per DNV-OS-E302 are also presented along with the DNV-RP-B101 HISC awareness limit of 550 MPa Yield strength limit. All chains comply with the R5 definition limits.

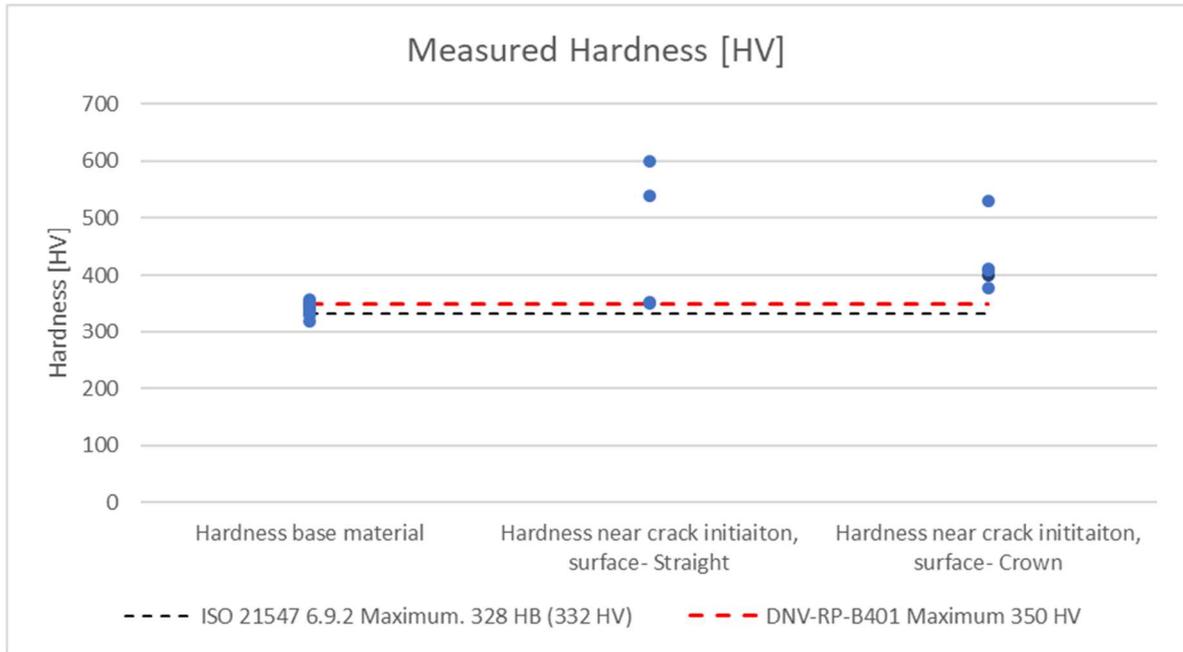
**Figure 7-4 Hardness measured available from the failure reports.**

Most failure reports included measurement of material hardness in base material (12 cases), and in the vicinity of the crack initiations, near the surface in straight part failures (4 cases) and near the surface in crown failures (5 cases), which are presented in Figure 7-4. It is noted that the base material hardness is close or just above the recommended limits by ISO21457 (332 HV) and DNV-RP-B401 (350 HV). For reference the minimum tensile strength specified for R5 chains (1000 MPa) corresponds to an expected hardness of 311 HV.

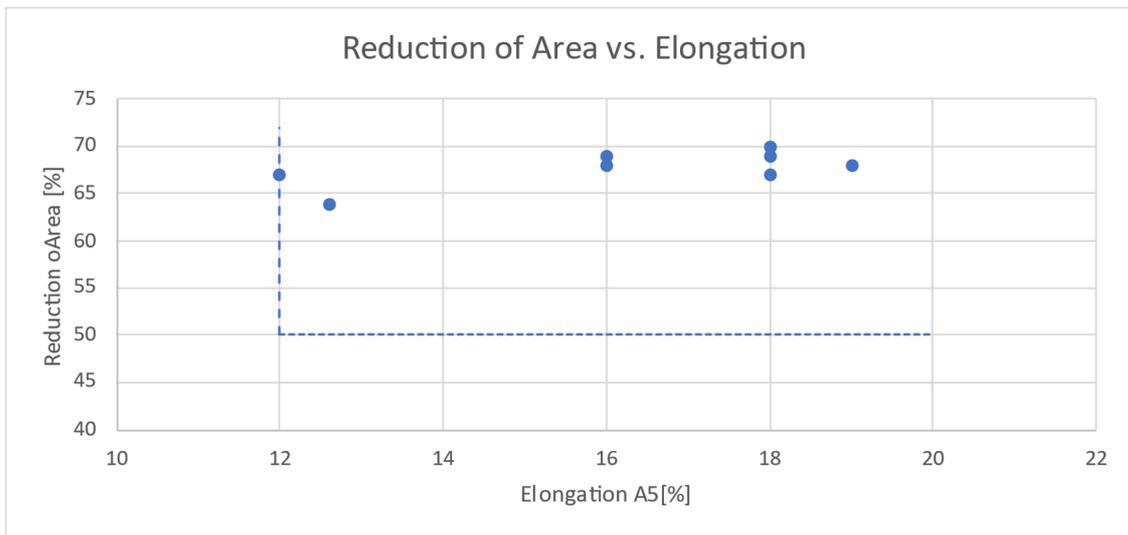
**Figure 7-5 Reduction of area and elongation at failure measured in failure reports. Included DNV-OS-E302 R5 limits.**

The reduction of area and elongation at failure from tensile tests performed in base material on eight failure reports is presented in Figure 7-5. The limits defined by DNV-OS-E302 for R5 chains are also presented. All chains comply with the specification.

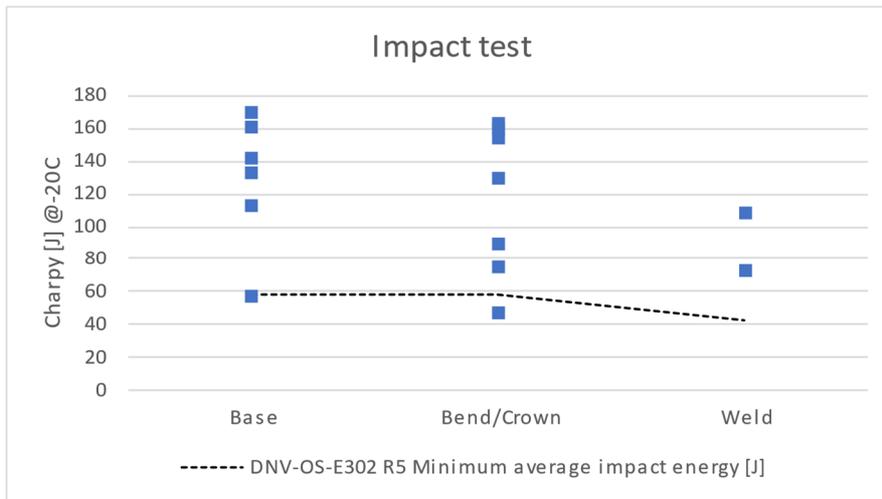
**Figure 7-6 Impact test results of failed links.**

Eight failed links were tested for impact energy per Charpy test at -20°C, as presented in Figure 7-6. Test samples were taken at different parts of the link as presented: base material (straight part opposite the weld), crown (or bend) and straight part on the side of the weld.

Only one failed link does not comply with the average energy limit defined per DNV-OS-E302 Table 3.

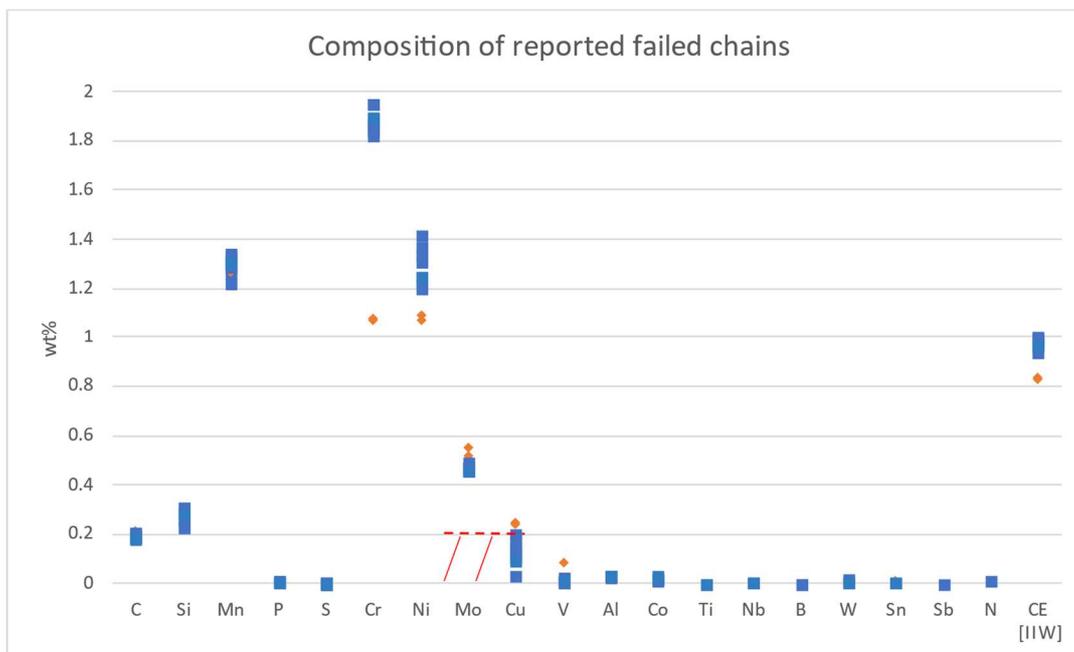
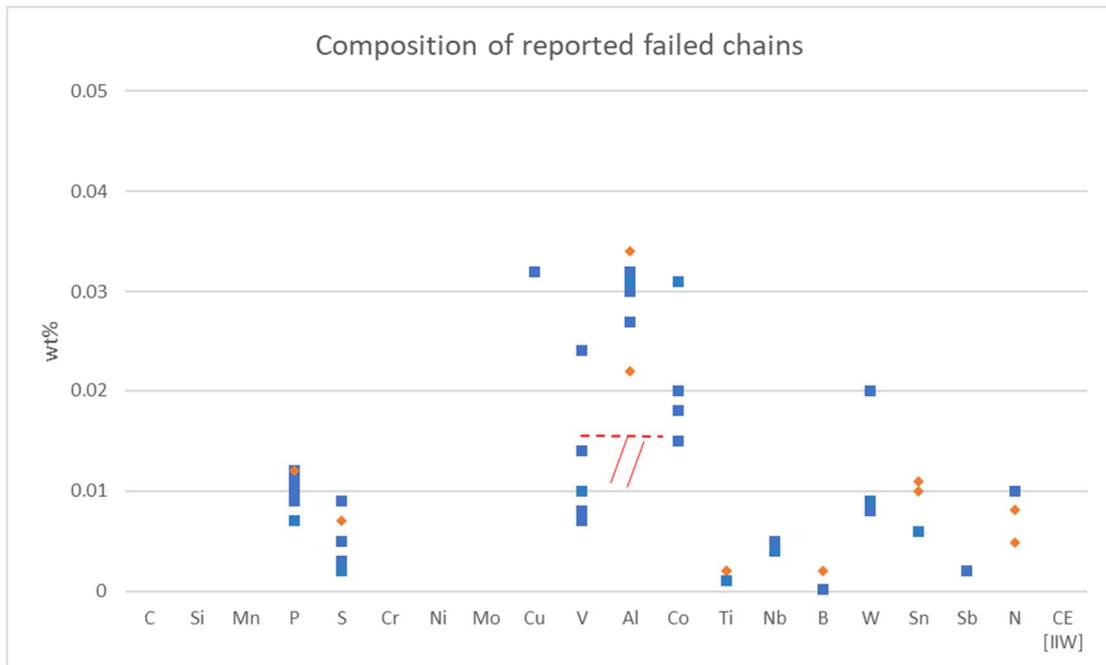
**Figure 7-7 Composition of failed links, blue squares- 7 reports available. Orange diamonds correspond to a chain manufactured in 2008 and still in service without reported failures. Note Mo minimum content specified per DNV-OS-E302.**

Seven failed links were tested for composition contents as presented in Figure 7-7 and Figure 7-8. All links comply with the composition limitations for:

- Mo, minimum 0.20% per DNV-OS-E302 Ch.2 Sec. 1 [1.3.1] for R5;
- Al, minimum 0.020% per DNV-OS-E302 Ch.2 Sec. 1 [1.2.2].

In the figures it is also shown the composition for a chain manufactured in 2008 and still in service without failures. It is noted a different composition compared to those reported in the failure reports. This parameter shall be further investigated in the proposed test program.

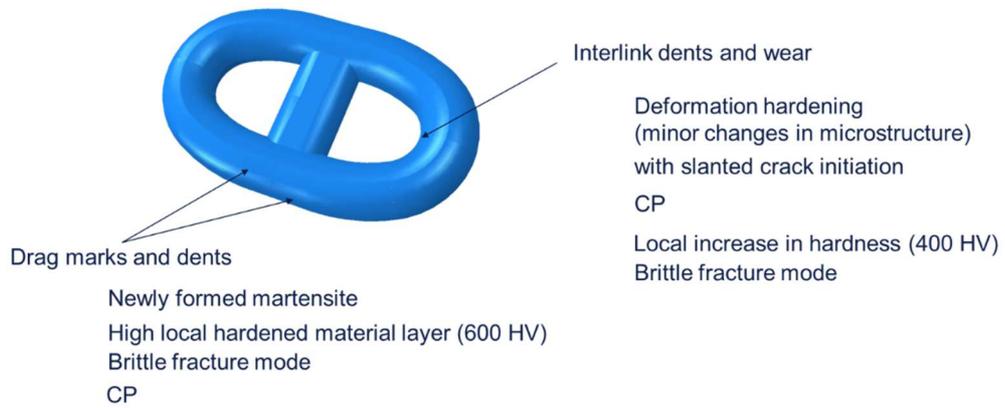
**Figure 7-19 Summary of main crack characteristics.**

A simple summary of failure conditions and observations is presented in Figure 7-19.

The chain material complies with the specifications with exception to:

- Hardness on locations subject to wear and contact stress conditions.
