## Investigation report

| Report | |
|---|---|
| Report title<br>Revised investigation report following fire on Sleipner B on 22.10.2024 | Activity number<br>001046030 |

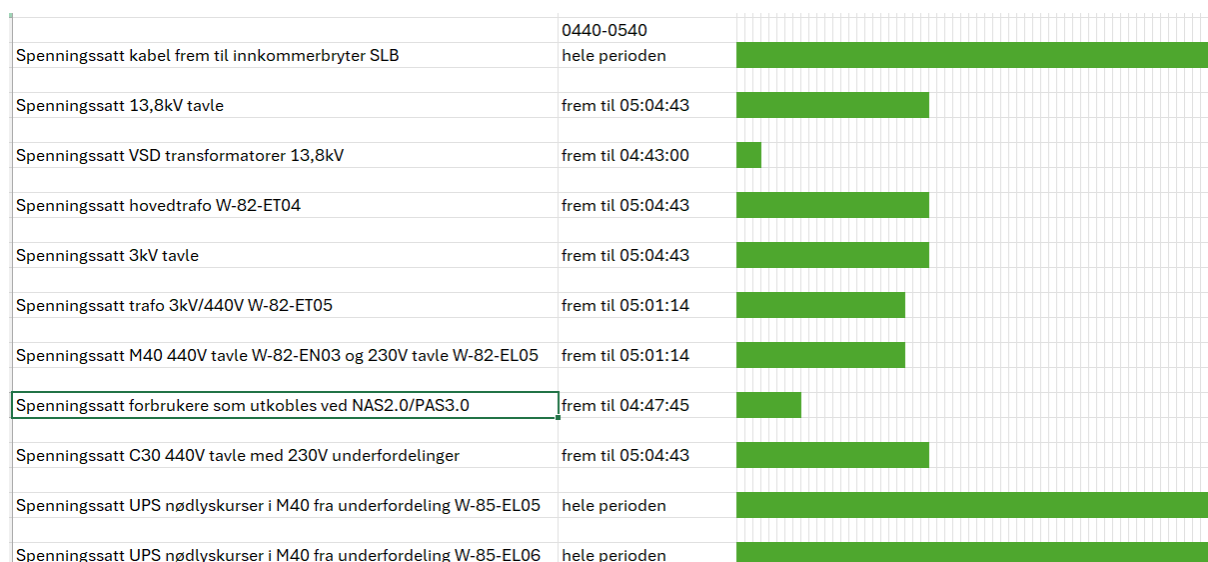
Figure 3 Energised parts of the facility 04:40-05:40

- Main voltage of 13.8kV from switch W-80-EF06. This was automatically isolated by the protection system at 04:43:00, as shown in Figure 3. This was not re-energised at any time.
- Power supply of 440V to the "pre-charge transformer" from switchboard W-82-EN03. This is normally only closed when switch W-80-EF06 is activated in order to limit the inrush current when the VSD transformers are magnetised. There have been no observations which suggest that this was connected at any time during the incident.

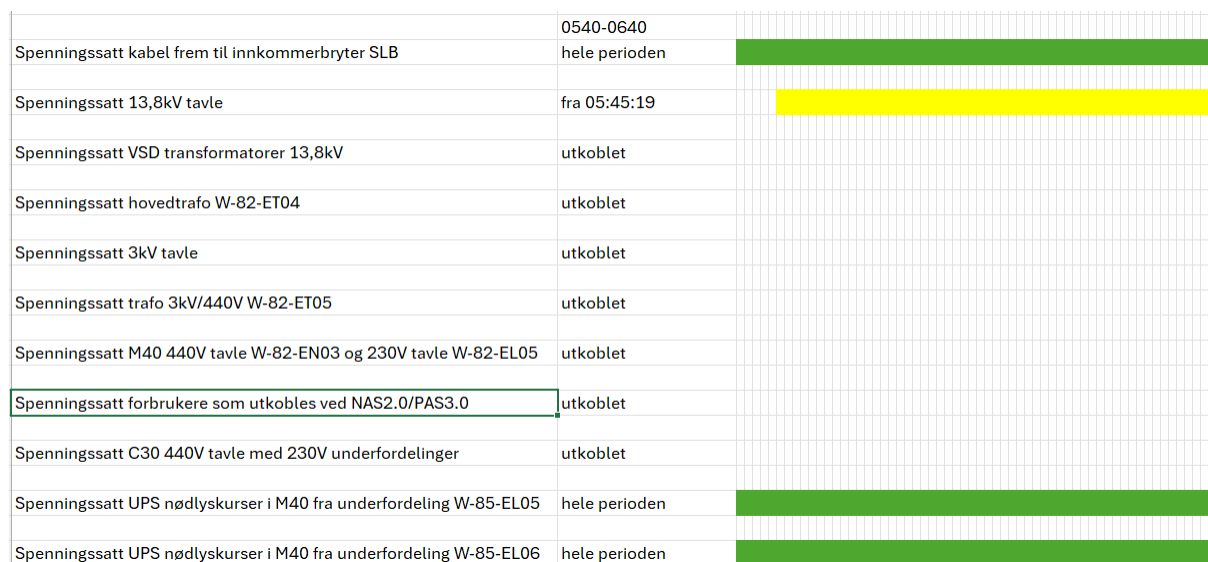
Figure 4 Energised parts of the facility 05:40-06:40

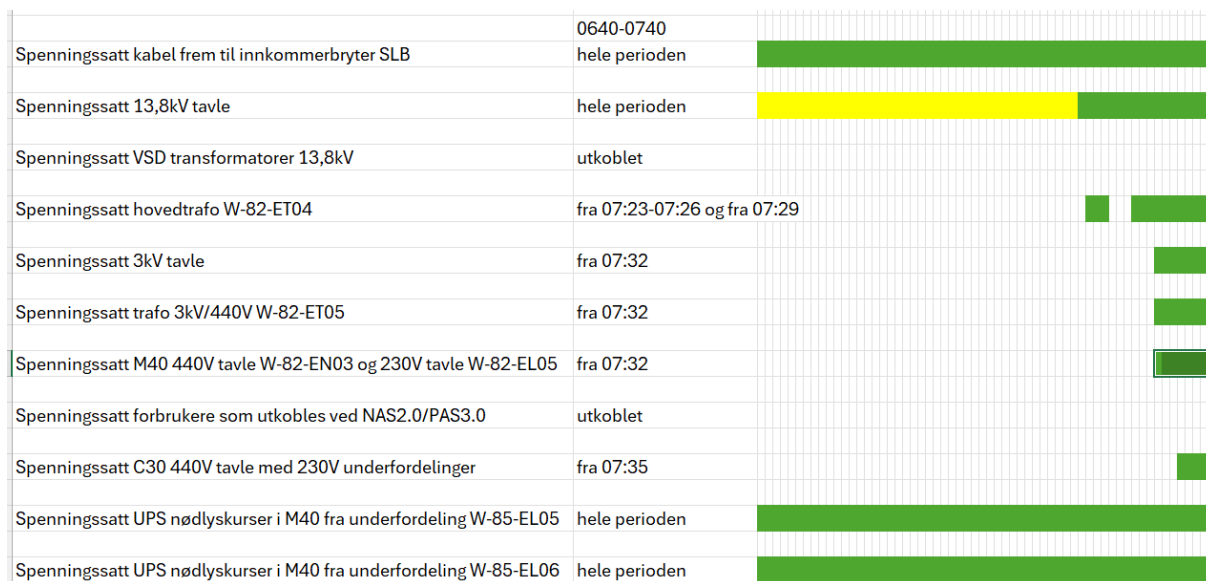
Figure 5 Energised parts of the facility 06:40-07:40

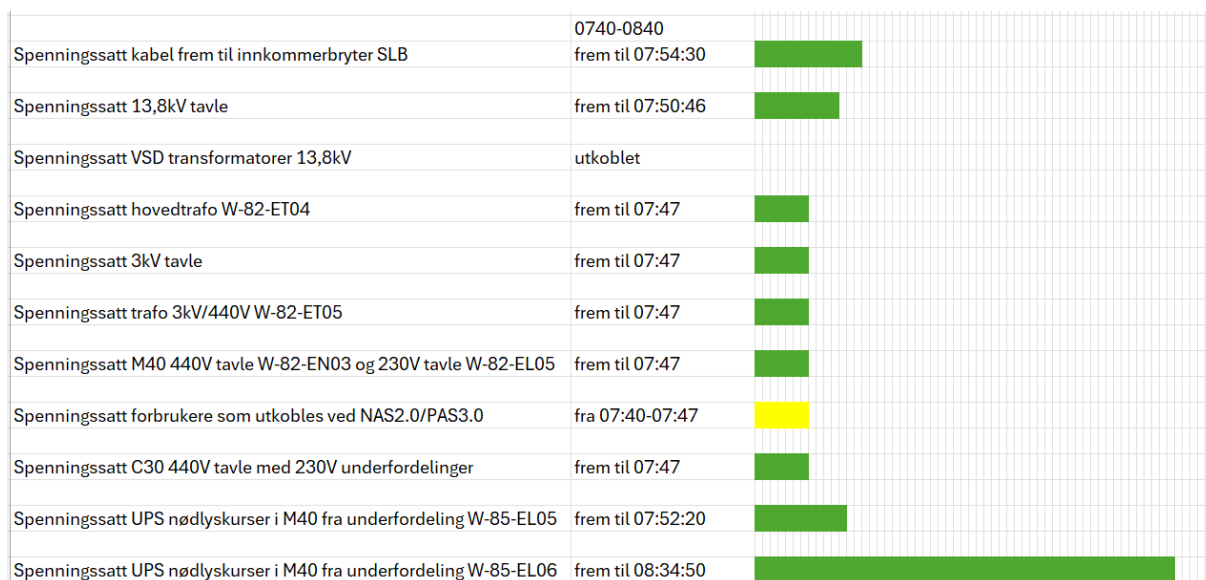
Figure 6 Energised parts of the facility 07:40-08:40

During the investigation, we also obtained confirmation that the supply of power (energy) to electrical equipment in the high voltage room was not isolated at any stage during the entire sequence of events (see Figure 3 to Figure 6). The following equipment was energised:

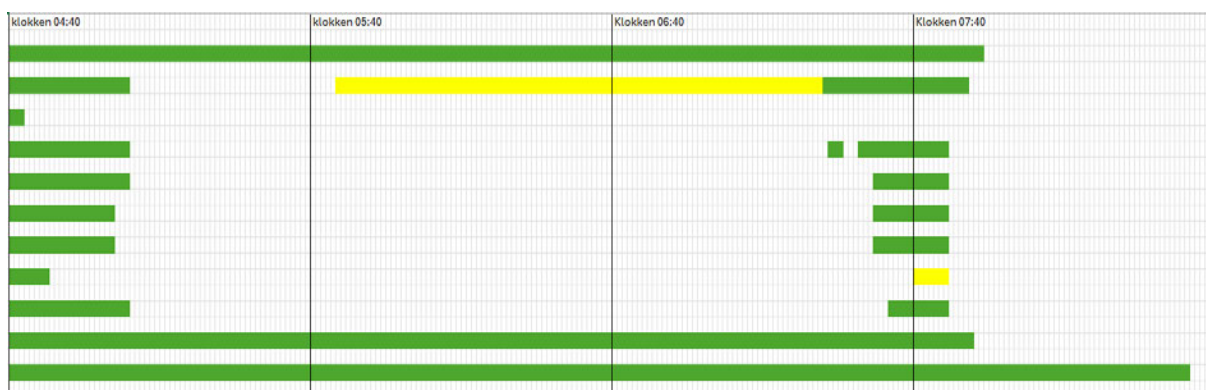
Figure 7 Energised parts of the facility 04:40-08:40 combined into one figure

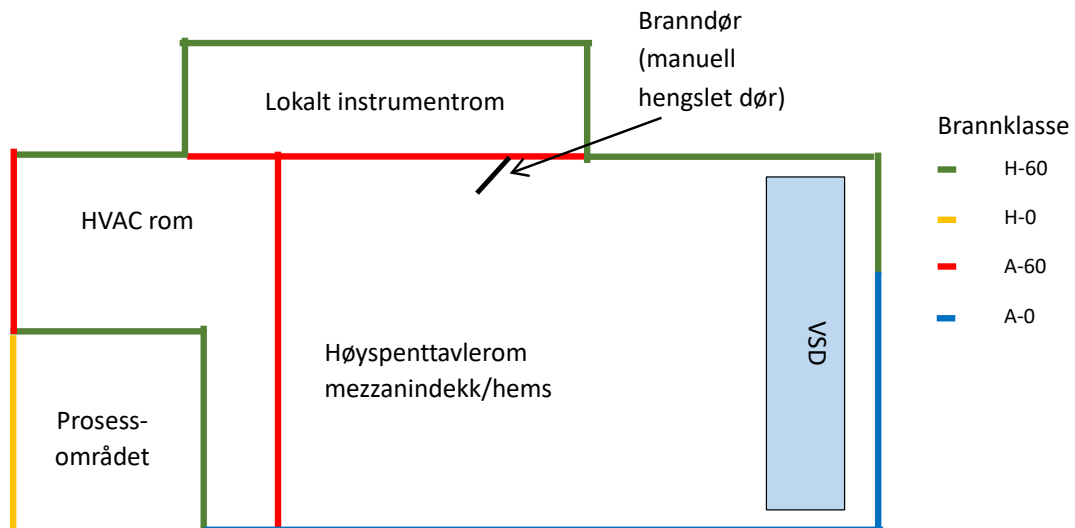
Figure 15 Overview of fire divisions, including fire doors in M40 mezzanine deck.

As Figure 15 shows, there is a fire division with fire rating A-60 between the high voltage room and the local instrument room (LIR room). Fire divisions with a rating of A-60 are intended to prevent the spreading of smoke for at least one hour. A smoke detector located in LIR triggered an alarm indicating smoke 25 minutes after the first smoke detector in the high voltage room was triggered, resulting in the spreading of smoke to neighbouring rooms (thus, the fire division did not meet the requirement to prevent the spreading of smoke for at least one hour). The photograph below was taken in the LIR room and shows soot penetration through a small gap in the fire division.

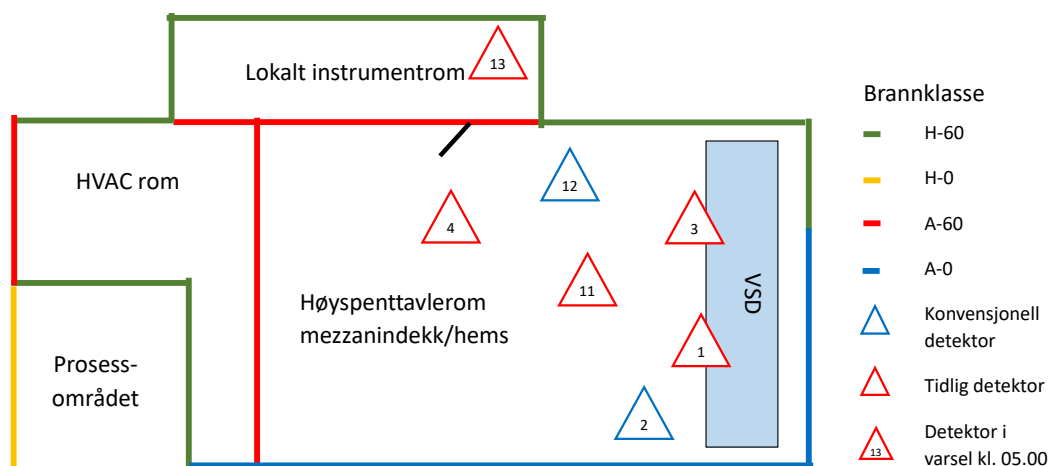
Figure 19 Drawing showing the smoke detectors on the mezzanine deck in the high voltage room and LIR room, and the sequence in which the various detectors triggered a warning/alarm.

As the table shows, the first smoke detector (early detector no. 1) switched to alarm mode at 04:35. The detector was located above the part of the VSD which consisted of inverters (IGBTs) (cabinet no. 6, ref. Figure 8). Smoke detector no. 2 (conventional) switched to warning/alarm mode at 04:42. This detector was located at height above the inverter (IGBTs) (cabinet nos. 6 and 7 in Figure 8). Smoke development continued, and two additional detectors (early detectors 3 and 4 shown in Figure 19) on the mezzanine deck switched to warning/alarm mode. Smoke detectors (detectors nos. 5, 6 and 7) located below the VSD on (the main deck) switched to warning/alarm mode between 04:43 – 04:50. The table shows that the smoke continued to spread and all smoke detectors in the high voltage room triggered a warning/alarm signal during the period 04:35:48 – 05:03:41.

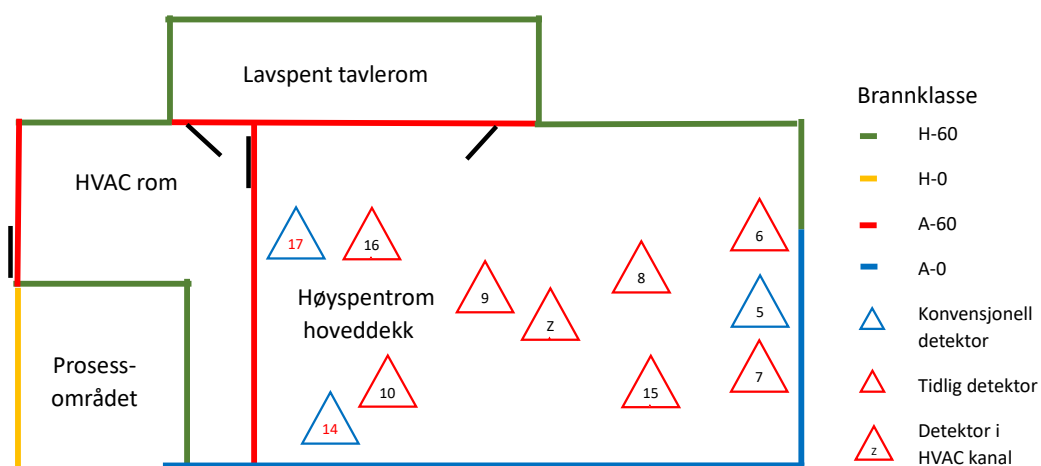
Figure 20 Drawing showing the smoke detectors on the main deck in the high voltage room and LER room, and the sequence in which the various detectors triggered a warning/alarm.
