Kneler A Workover Project

| Skandi Arctic Port Bell Investigation Report | | | | | |
| 3203-S-TKP-U-RA-7006-00-00 | | | | | |

Investigation Report

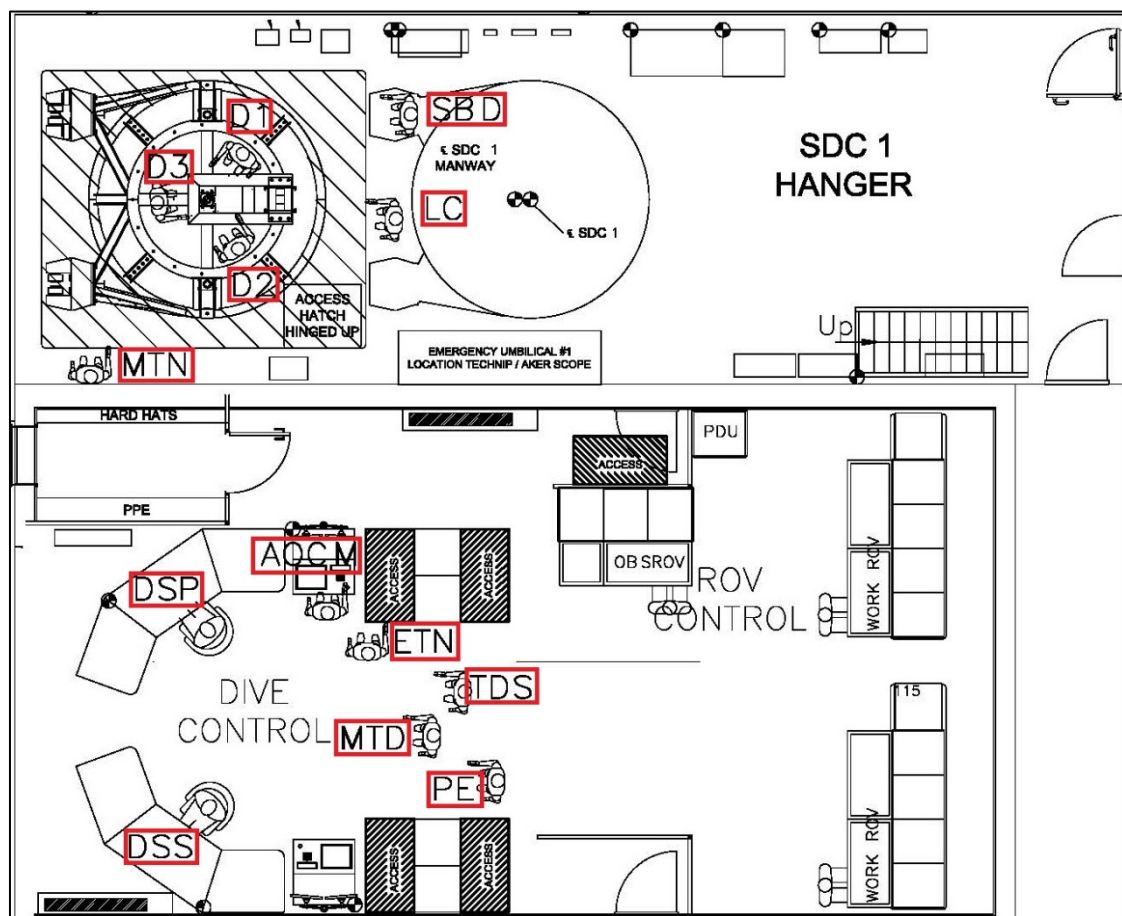
Figure 4-2: Dive control personnel movements when the vertical pin sensor sent an alarm signal to the LARS HMI

Selection of maintenance mode overrode all safety interlocks and effectively locked the winches into an incorrect and unsafe configuration. The Electrical Technician does not know why he activated maintenance mode in order to override the faulty locking pin sensor as the override could have been selected without the activation of maintenance mode.

It was a combination of the two actions in that specific order that placed the system in an unsafe configuration. No winch was configured to take its normal part of the full bell/stand-off frame/cursor weight present during normal launch and recovery winch operations. Because maintenance mode was active the selection of either winch or traverse mode on the LARS HMI Trolley & TUP screen had no effect on the actual configuration of the winches.

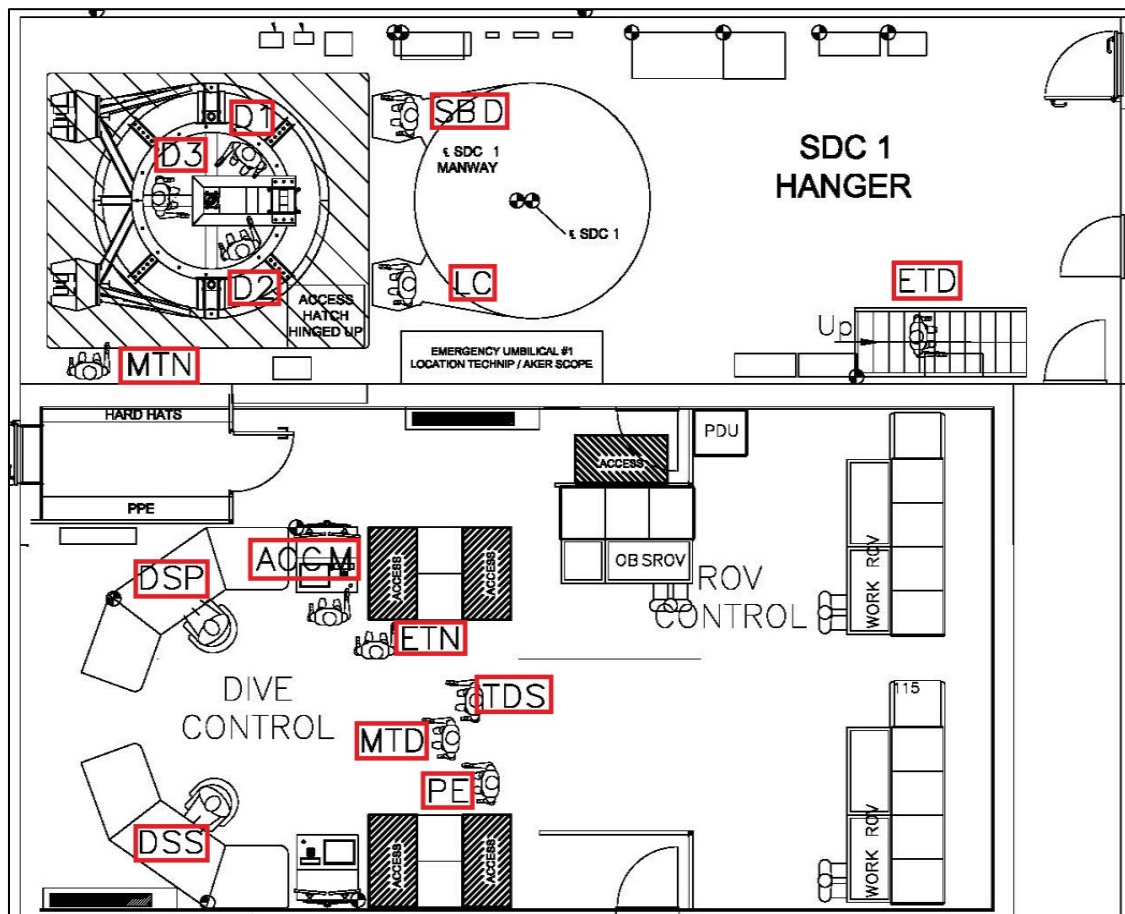
Figure 4-3: Dive control personnel movements during the 1st uncontrolled lowering

The AOCM depressed the deadman’s trigger on the port LARS control joystick (Figure 0-10) and the bell began the first uncontrolled descent. The bell descended because all four winches were in constant tension mode and thus configured to pay out wire & umbilical when the weight of the bell exceeded the constant tension maximum setting.

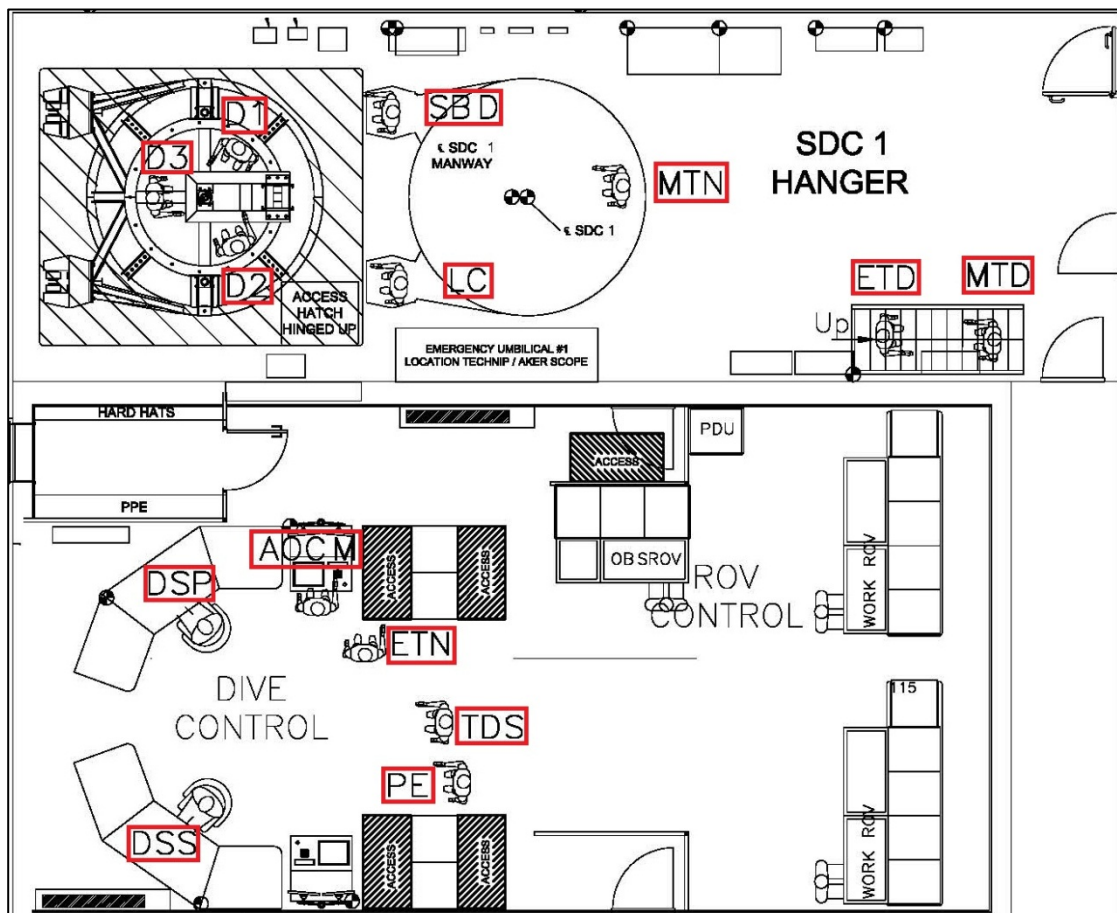
Figure 4-4: Dive control personnel movements during the second uncontrolled drop

The Electrical Technician placed his hand over the emergency stop and the AOCM depressed the deadman’s trigger on the port LARS control joystick (Figure 0-10) in order to recover the bell. The bell began the second uncontrolled descent. This was because the relevant winches were still in the same, incorrect mode as for the first uncontrolled descent. The AOCM released the deadman’s trigger and the Electrical Technician activated the emergency stop and simultaneously the winch motor over speed alarms initiated the braking sequence.

already fully collapsed and alarms were sent to the port LARS control panel. Umbilical load warnings were also sent to the port LARS control panel. The umbilical was over tensioned resulting in breaking of the chinese finger securing system which was intended to take a normal load of 0.5 Te and a maximum design load of 1.5 Te. Once the chinese finger had failed, gas connections at the umbilical termination plate were ripped off. A hot water supply hose was also broken off at its bell hull penetration point. The bell began to lose pressure through the open ended connections. The second uncontrolled descent of the bell stopped after 6 seconds with a movement of approximately 4 meters. Once again the bell accelerated to at least 3 times the normal speed when descending through the moonpool.

The bell descended at much higher than normal speeds during the uncontrolled descents. The umbilical winch motors are significantly less powerful than the wire winch motors as they are designed to manage a much smaller load. It is probable that as the umbilical winch has a much larger rotational inertia compared to the wire winches, combined with the significantly less powerful motors it was not able to pay out the umbilical fast enough and maintain the nominal 0.5 Te tension. Consequently the maximum design load was exceeded leading to failure of the chinese finger and main umbilical connections.

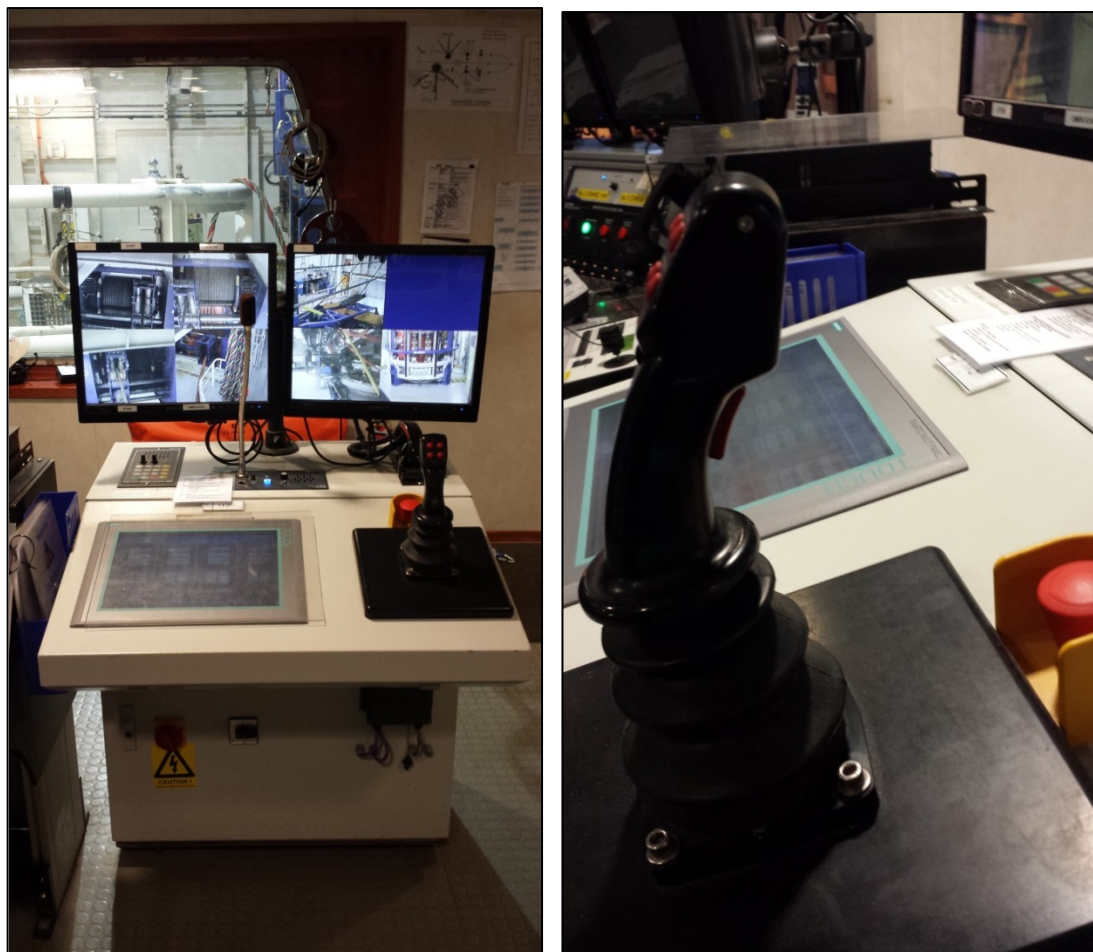
Figure 0-10: Port bell LARS station with cctv & HMI (left) and joystick with dead man trigger (right)

| Barrier | Status during incident | Comment |
|---|---|--|
| Deadman's trigger. | Intact | But perceived as failed by operators because it is a slow acting 'soft stop' and not immediate. |

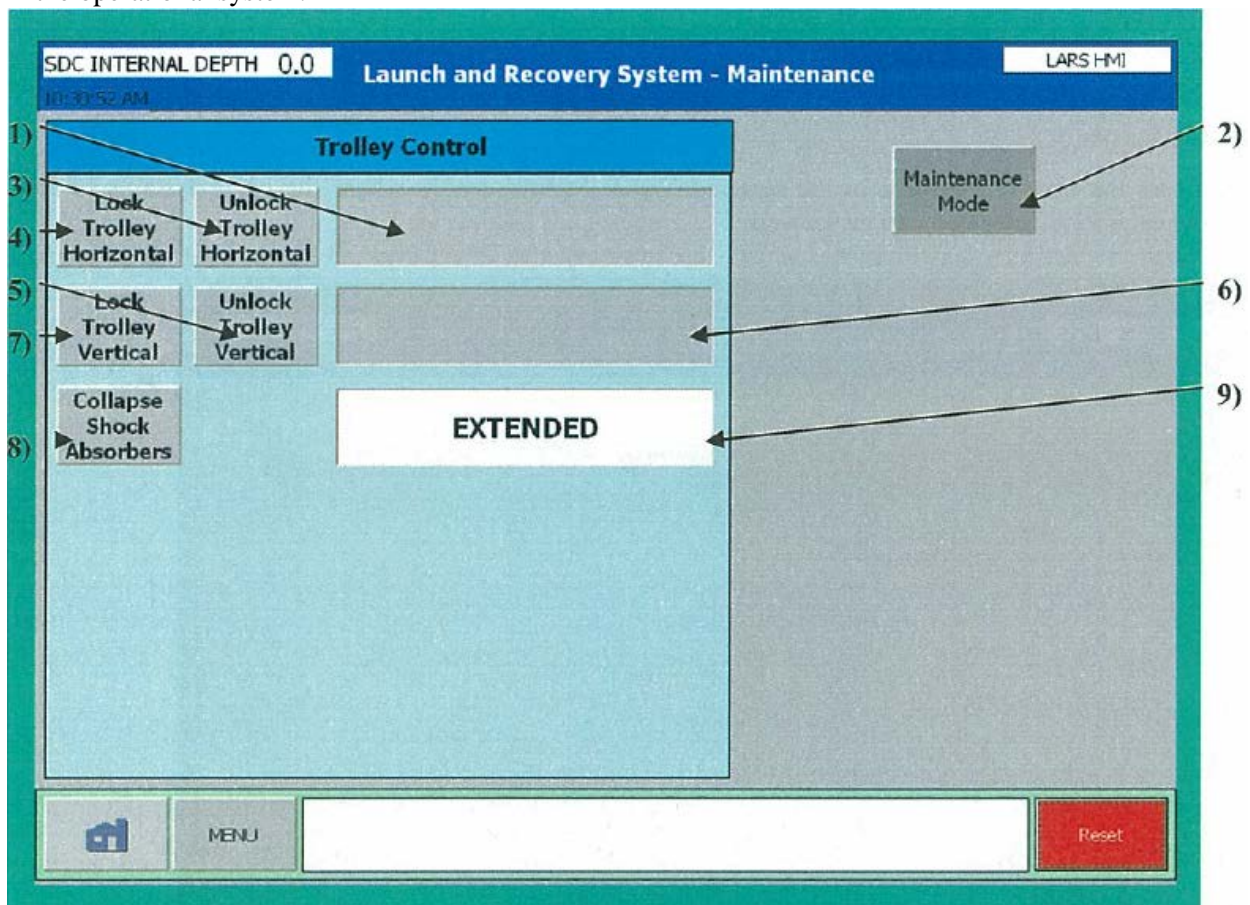
Fig F-1 Maintenance Screen from design document

At section 2.19 it details the Maintenance screen where it states that ‘ This screen is used by a supervisor or authorised person to place the system into Maintenance Mode. Maintenance Mode bypasses some of the PLC interlocks to allow completion of various maintenance tasks that the PLC would otherwise inhibit.’ There is reference to the LARS Operation and Maintenance manual but this document was not found by the Investigation team and not actual document reference could be found. Maintenance mode as detailed in this manual has extremely limited functionality compared to the one actually implemented in the operational system.

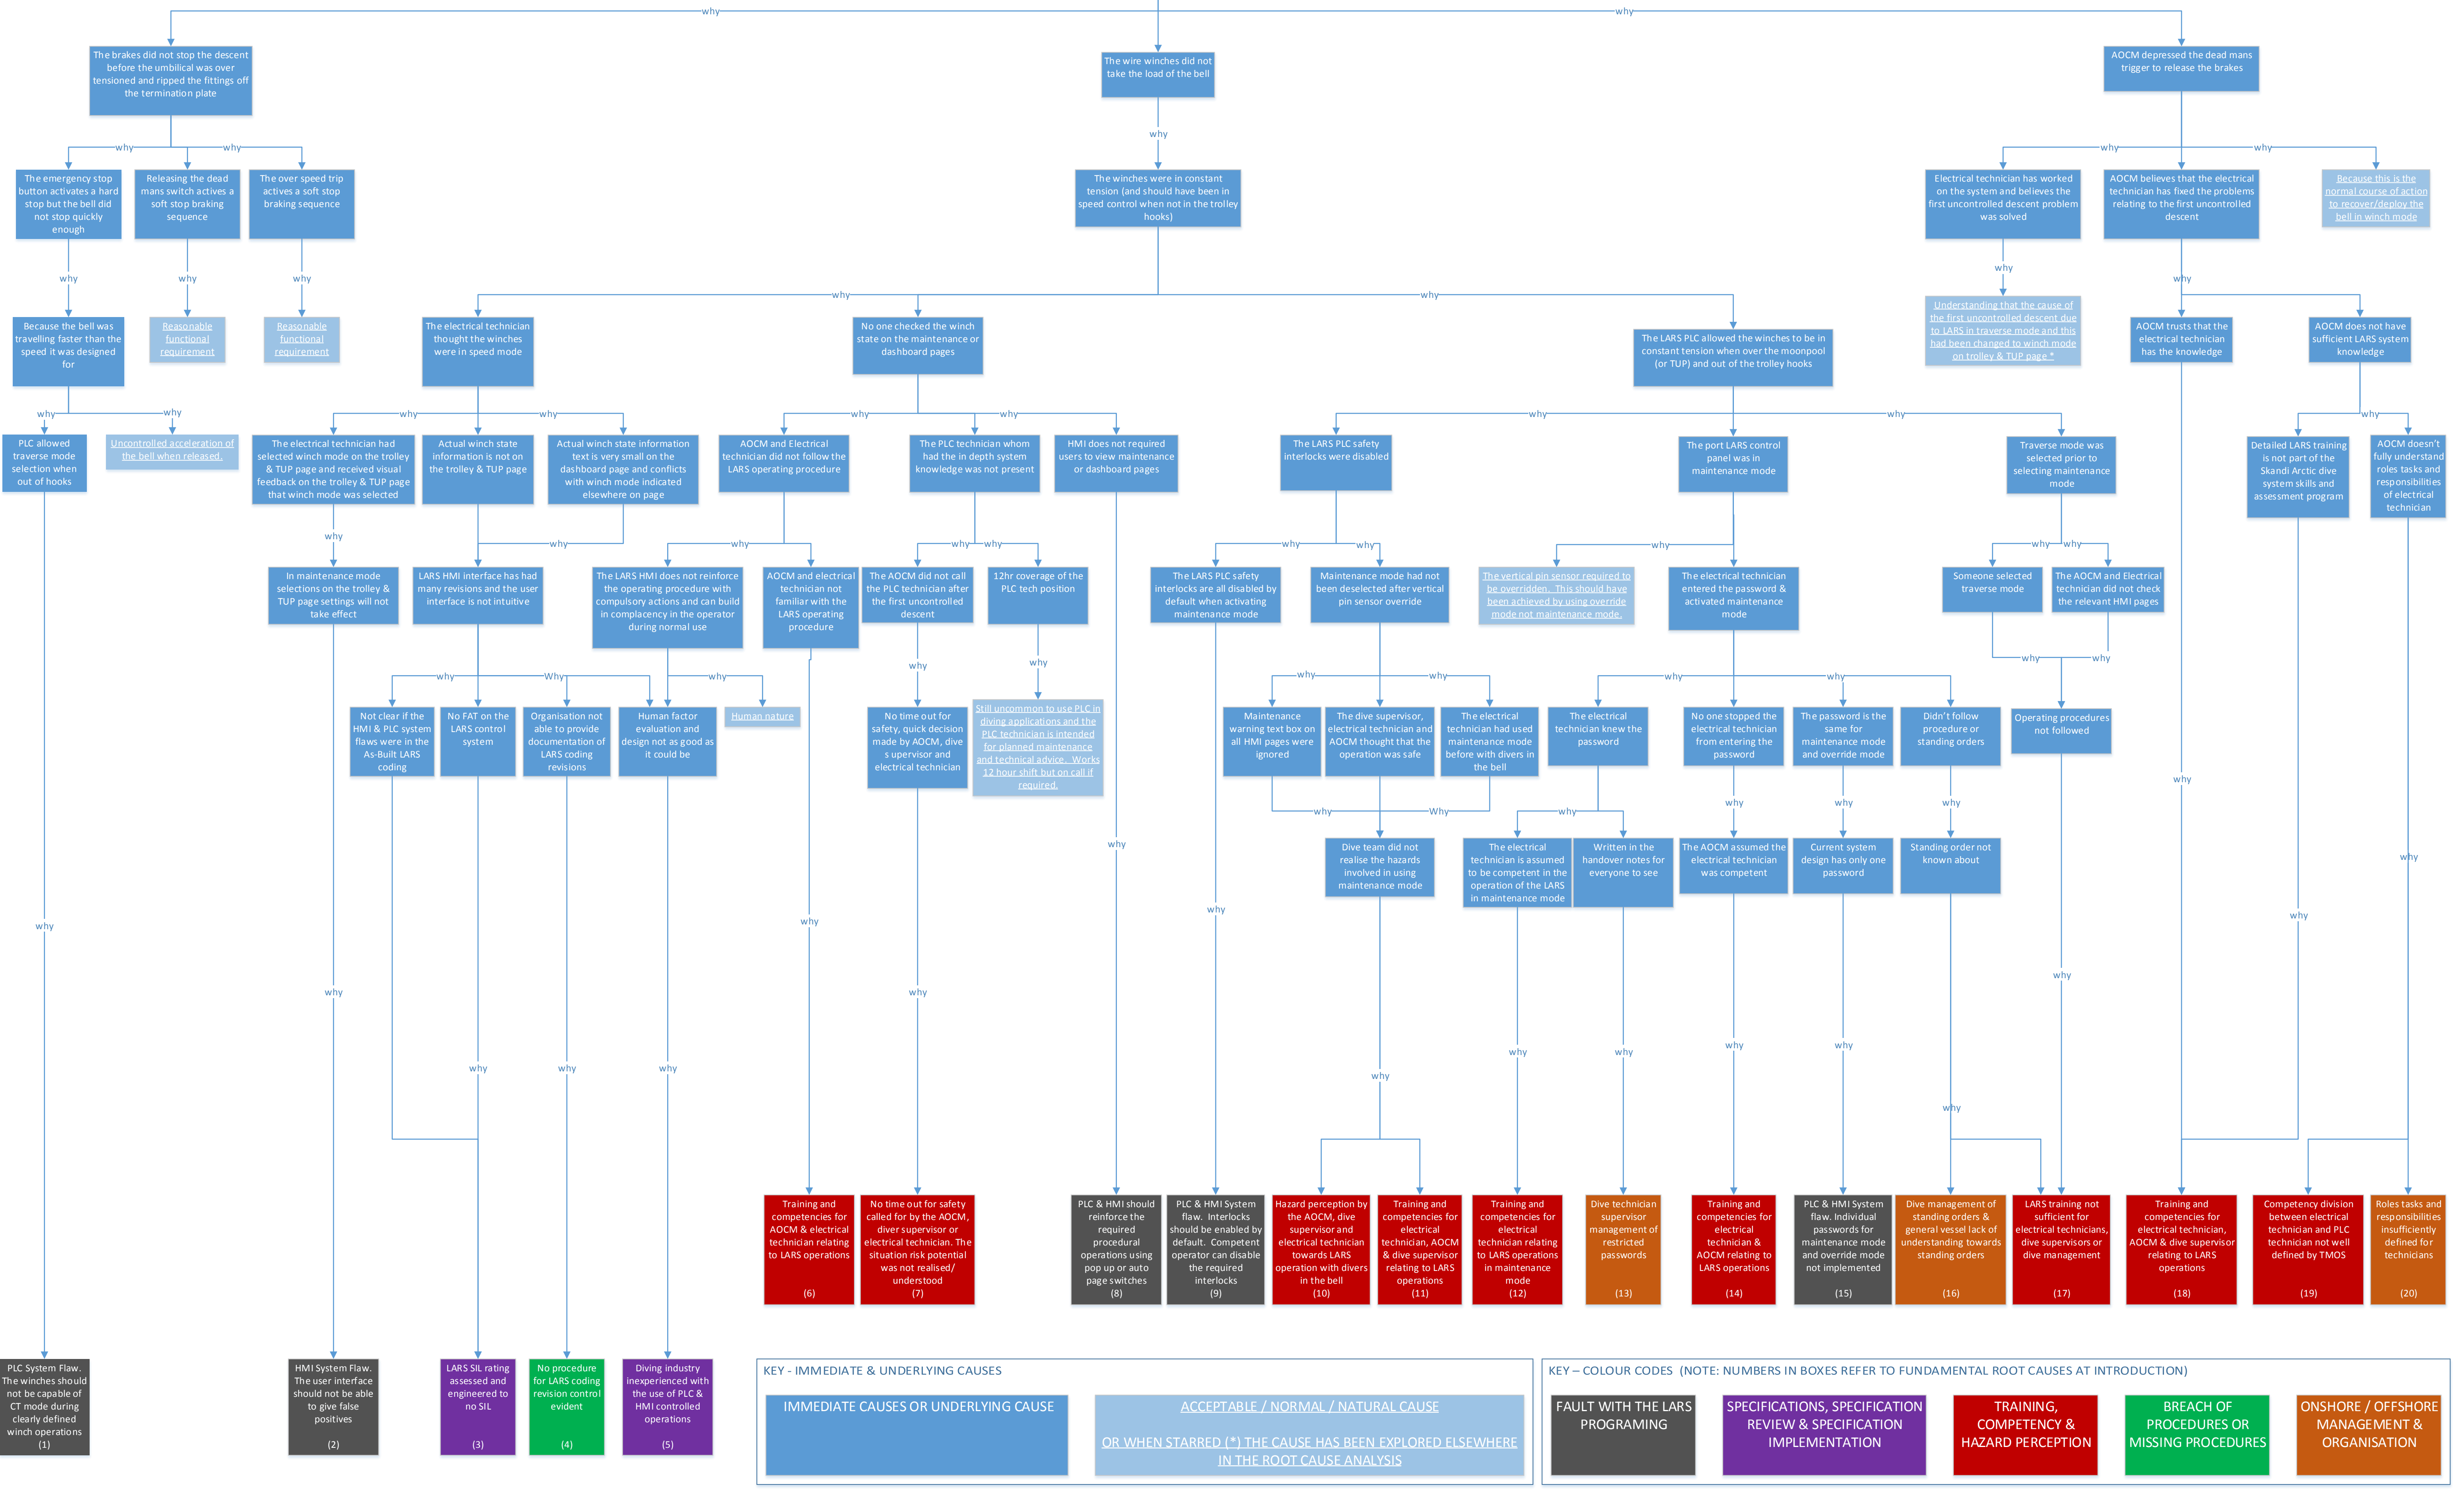
The Skandi Arctic DSV had an uncontrolled descent of the port diving bell
