Investigation report

Report	
Report title Report of the investigation of the well control incident in well 31/2-G-4 BY1H/BY2H on the Troll field with the <i>Songa Endurance</i> drilling unit	Activity numbers 001054029 001054030

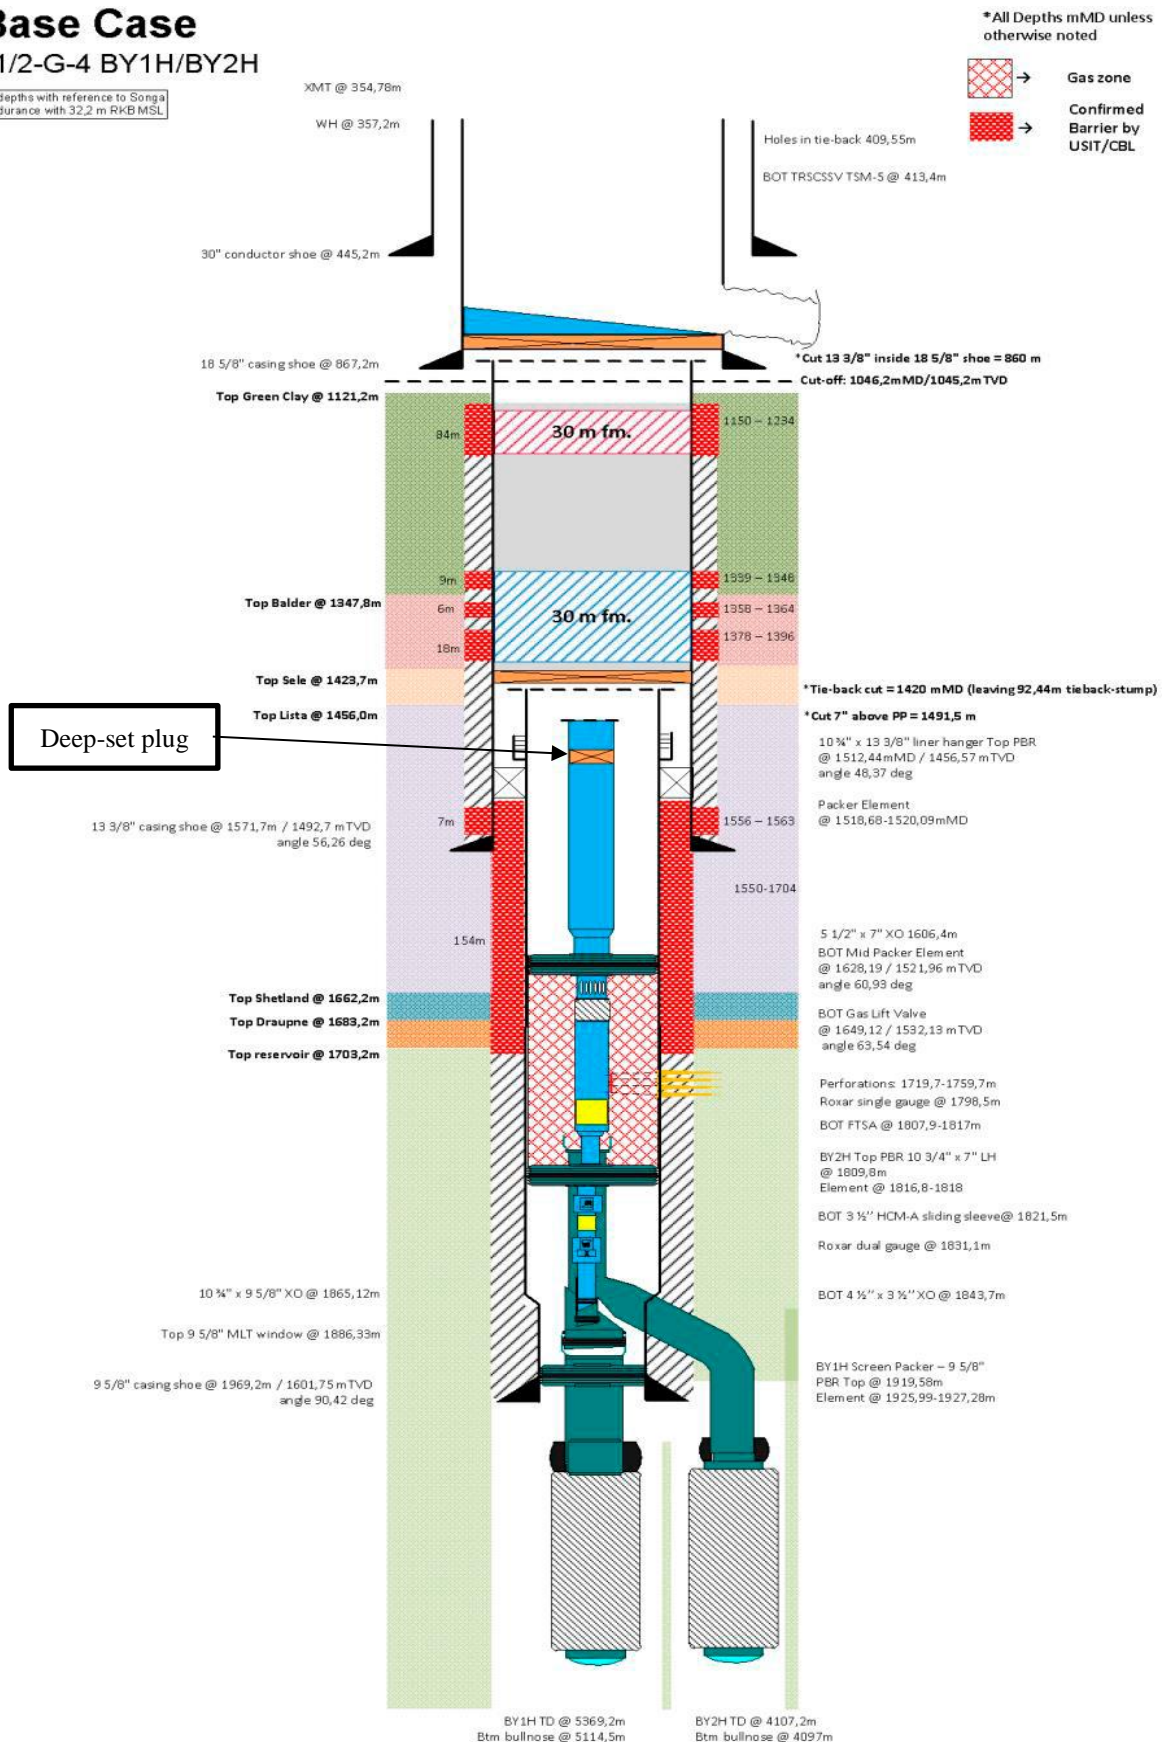
Figure 9 Diagram from the concept selection report.

The activity programme for PP&A Well: 31/2-G-4 BY1H/BY2H approved in June 2016, on the other hand, leaves out the use of a deep-set plug without management of change (MOC). See also the section below. Well diagrams with and without a deep-set plug are shown in figures 9 and 10.
