Investigation report

Report	
Report title Investigation report on a steam leak at Mongstad on 8 November 2012	Activity number 001902023

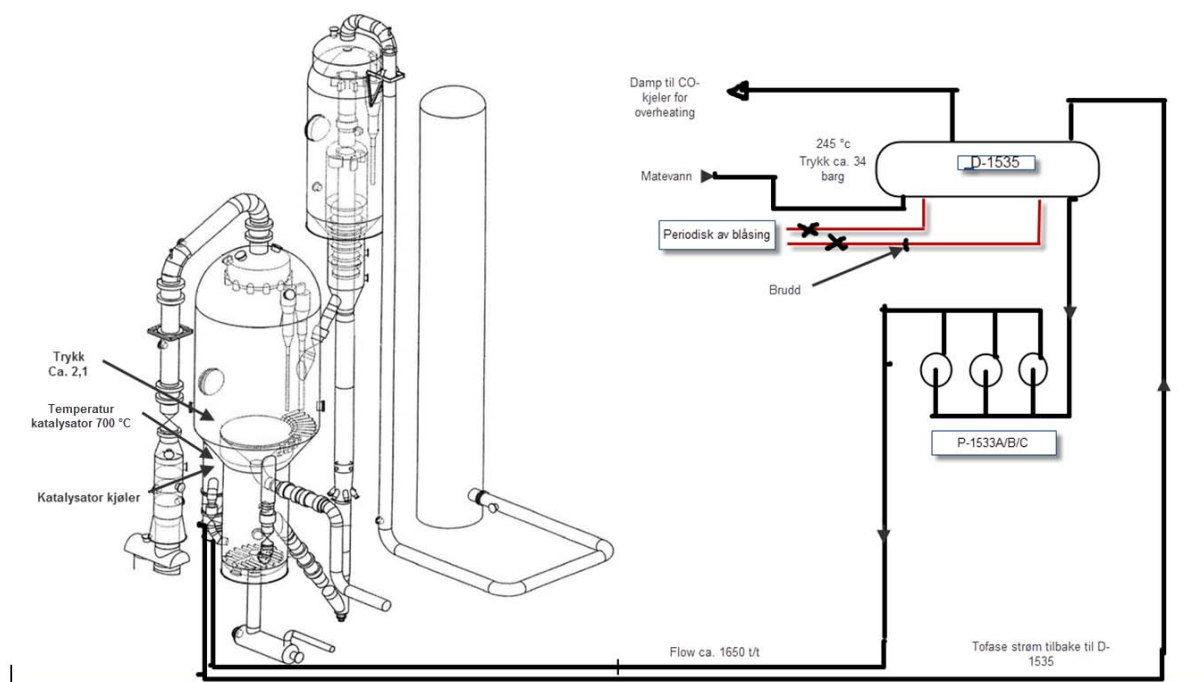
The cracker and the regenerator where coke is burnt off and steam produced are shown on the left, with the steam separation process illustrated to the right. Key: Pressure abt 2.1; Temperature catalyst 700°C; Catalyst cooler; Flow abt 1 650 t/h; Steam to CO cooler for overheating; Feedwater; Pressure abt 34 barg; Periodic blowoff; Fracture; Two-phase steam back to D-1535.

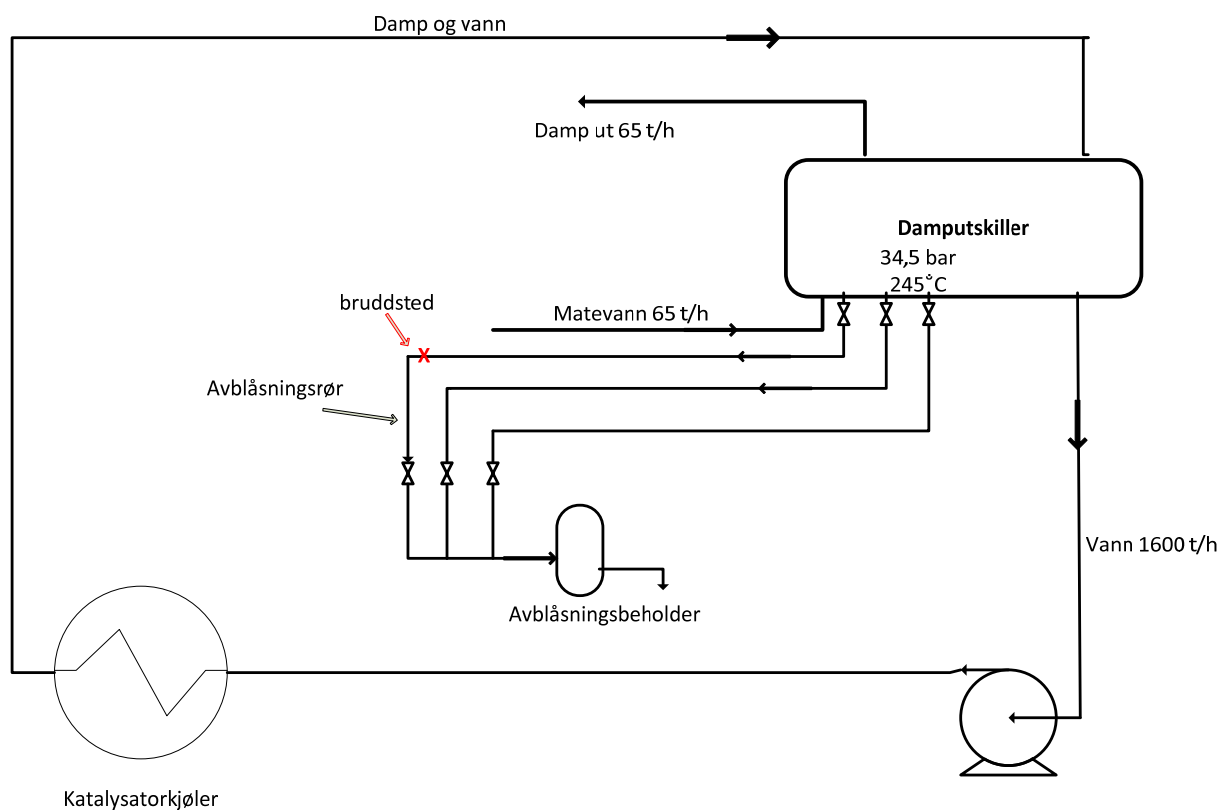
Two valves are installed on this pipe, one beneath the steam separator and the other at ground level. The steam separator is located about eight metres above ground. The upper valve is normally open, so that pressure in the pipe is constant, while the lower valve is the one used for periodic blowoff. With a diameter of two inches, the pipe runs back and forth under the separator and is about 30 metres long. The leak occurred in this blowdown pipe.

Key: Steam and water; Steam out 65 t/h; Steam separator; Feedwater; Fracture site; Blowoff pipe; Blowoff vessel; Water 1 600 t/h; Catalyst cooler.

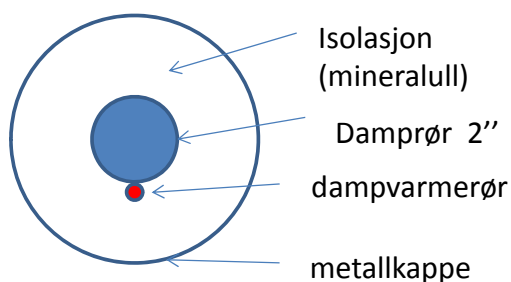
Extensive corrosion under the insulation was the cause of the leak. The external mantling (metal sheath) was substantially corroded over large areas and small holes were clearly visible. Only about 0.5 mm of an original material thickness of 3.9 mm remained in parts of the fracture zone on the steam pipe. Internal corrosion in the latter appeared to be limited. Insulation was wet around the whole pipe. The main reasons for the extensive external pipe corrosion are assumed to be long-standing moistness in the insulation as a result of the corroded and damaged mantling, and the fact that periodic blowoffs in the steam pipe have provided optimum temperatures for corrosion to develop. The leak may also have occurred from the steam tracing pipe.

Cross section of the blowoff pipe. Key: Insulation (mineral wool); Steam pipe two-inch; Steam tracing pipe; Mantling
