Investigation report

Report			
Report title		Activity number	
Investigation of lifting incident	Investigation of lifting incident with dropped object on Jotun B 044027505		
Security grading			
☑ Public	Restricted	Strictly confidential	
Not publicly available	Confidential		
Involved			
Team		Approved by/date	
T-3		Erik Hörnlund/10 September 2018	
Members of the investigation tceam		Investigation leader	
Sigmund Andreassen, Kenneth Skogen, Lars		Ola Heia	
Melkild (only on land)

1 Summary

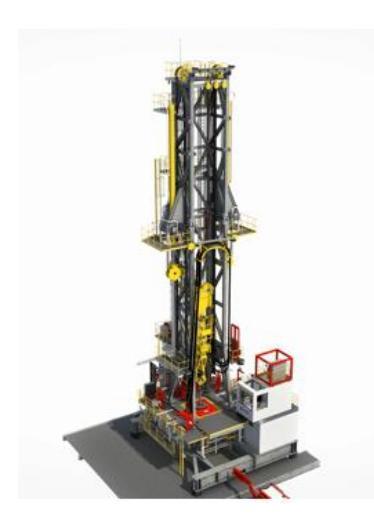
Optimus modular drilling rig.

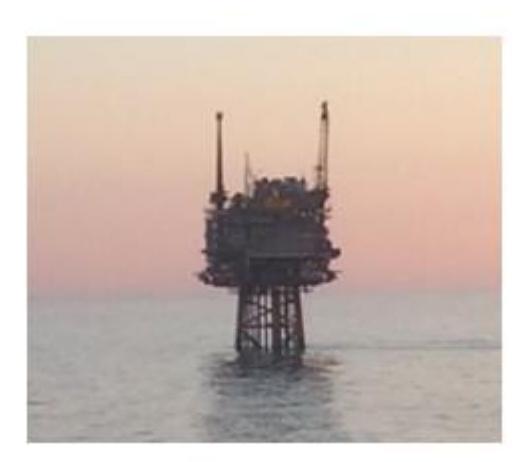
Jotun B.

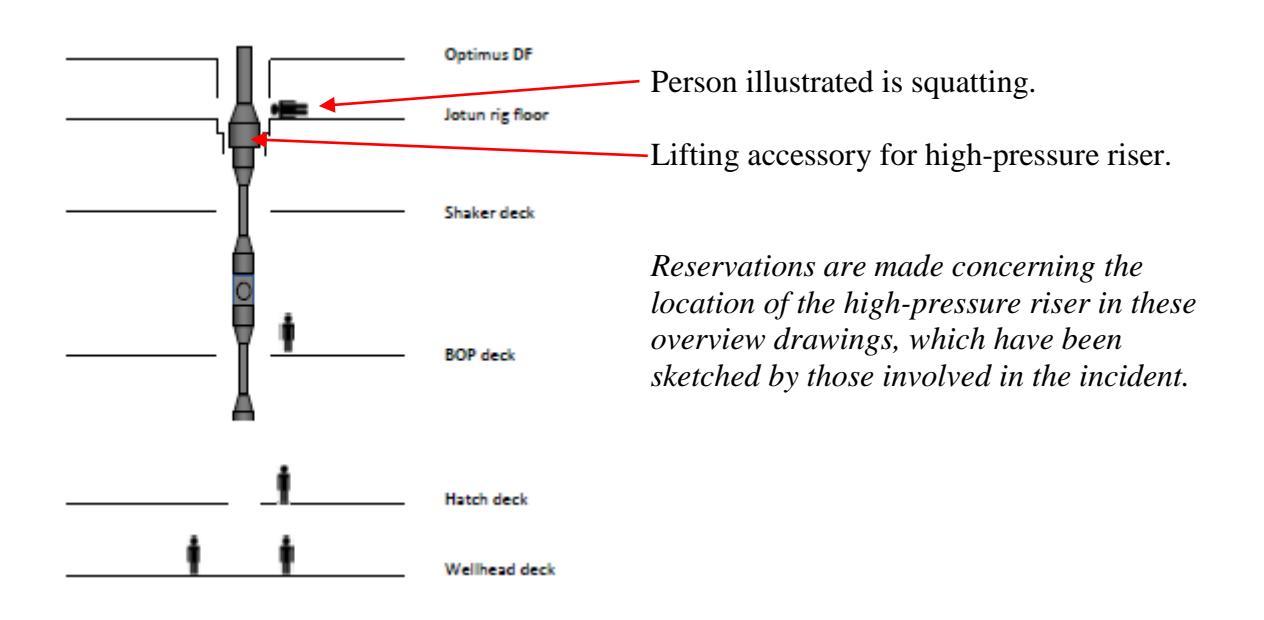
In order to help lead the string past the opening in the BOP deck, the person stationed on the facility's original rotary table descended to help lead/guide the string.

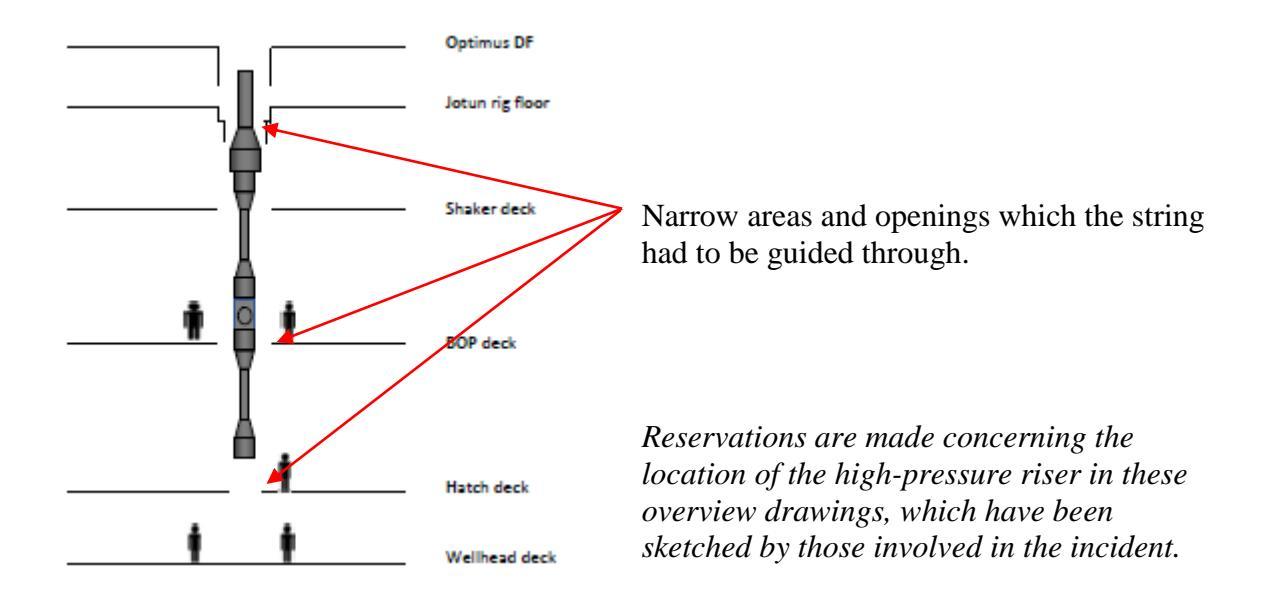
At the time the incident occurred, two people were posted down in the wellhead area, one was on the hatch deck, two were on the deck by the BOP room and one was in the driller's cabin on the drill floor. At about 23.23, the riser came loose and dropped about eight metres onto the wellhead. Given the riser's length of about 15 metres and weight of roughly 15.7 tonnes, this corresponded to some 1 232 136 joules in kinetic energy just before impact. The riser was left standing in an apparently correct position on the wellhead, at a slight angle from the vertical. No personal injuries were suffered, but the incident had the potential under slightly different circumstances to cause a fatal accident.
