Investigation report

Report	
Report title Report of the investigation into a naphtha leak at Slagentangen on 24 August 2020. Rev 2	Activity number 007931030

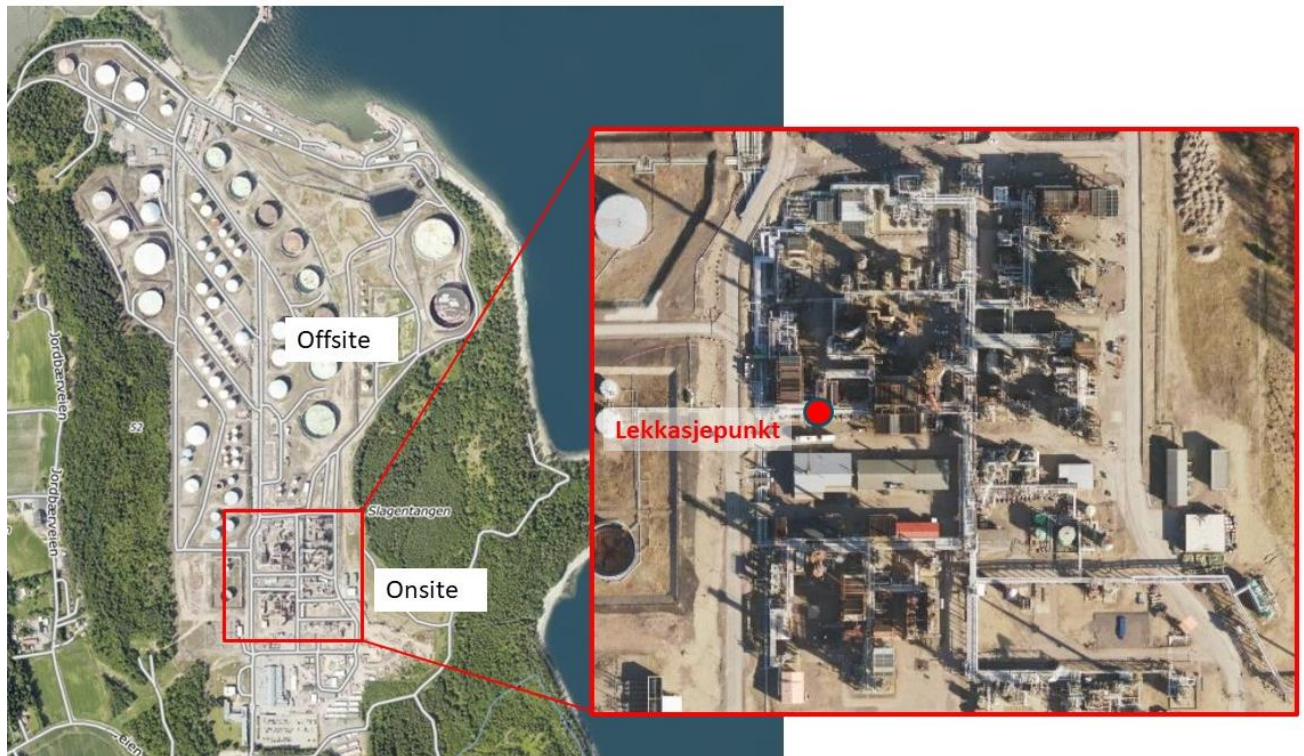
Figure 2 Overview of the Slagentangen refinery and the leak site. Photos: kart.finn.no
Key: Lekkasjepunkt: Leak point.

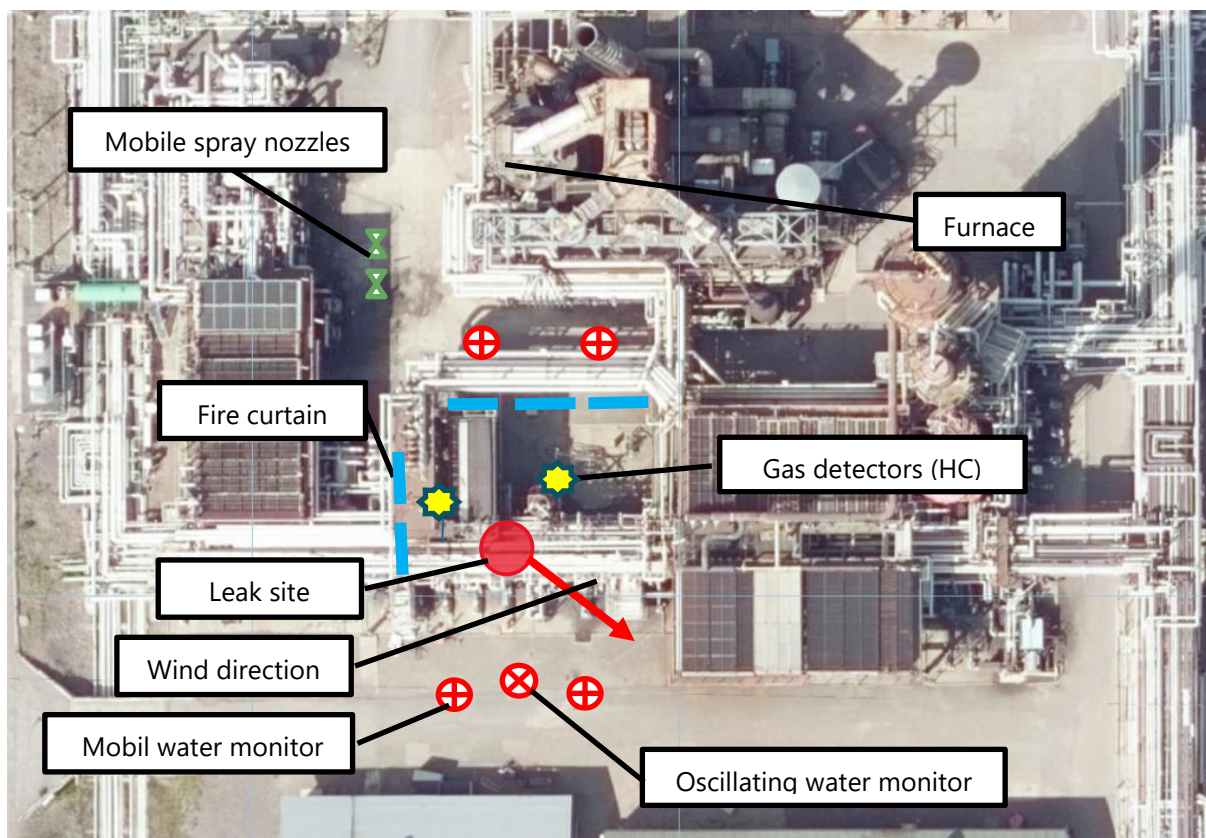
- notification of the incident
- check of the leak point (see also section 10.1.3)
- gas alarm with associated mustering of emergency response and non-essential personnel (see also section 10.1.4)
- mobilisation of fire-fighting personnel at the fire station, and laying foam in the area below and around the leak point
- technical support team mobilised to carry out the following activities
 - connecting fire hoses to nearby hydrants, mobile and oscillating water monitors
 - establishing the water curtain system against potential ignition sources (including furnaces) and HC gas detectors between the leak site and potential ignition sources.

Figure 11: Overview of the process plant with equipment and wind direction. North at the top. Photo: kart.finn.no
