Investigation report

Report	
Report title Report of an investigation – Equinor Mongstad – Person fallen from scaffolding	Activity number 001902065 Case 2023/116

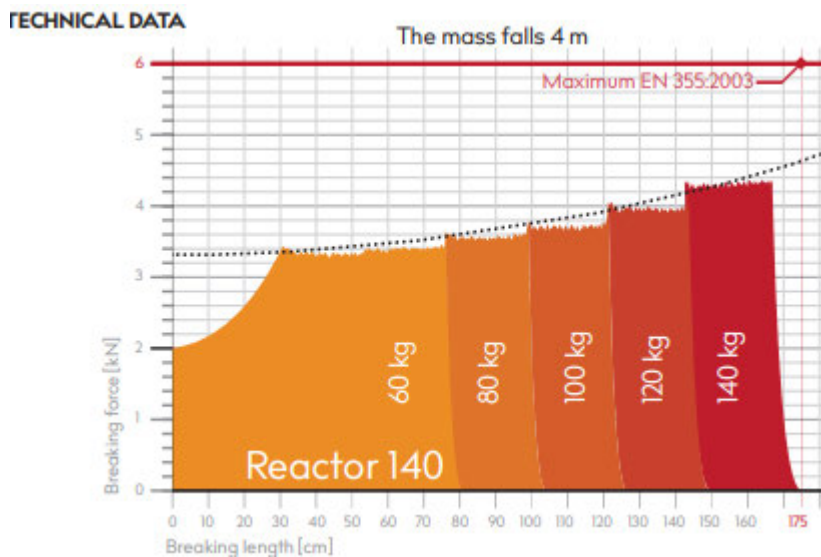
Figure 4. Source: Singing Rock W4400WW00

According to the table from Singing Rock, the total length of the Y lanyard with Reactor 140 shock absorber and large hook is 180 centimetres.

Maximum reaction length is 1.75 metres, with a maximum load of 140 kilograms.

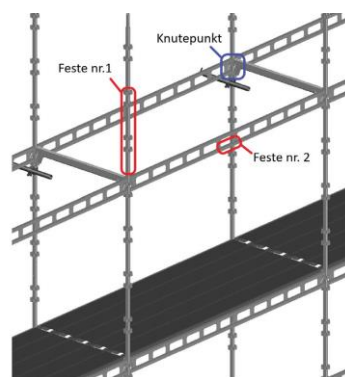
Figure 5. Example from Aluscaff

Fall-arrest equipment can be attached to scaffolding materials during assembly, use and dismantling, but the various scaffolding manufacturers differ somewhat in their guidelines on attaching such devices.

BBS says it has tested attachments on ledgers, and states that it can attach the Y lanyard hooks at all points on the lower part of the ledger. The investigation team requested documentation on testing attachment points for hooks which exceed the recommendations from the manufacturer, but this could not be produced.

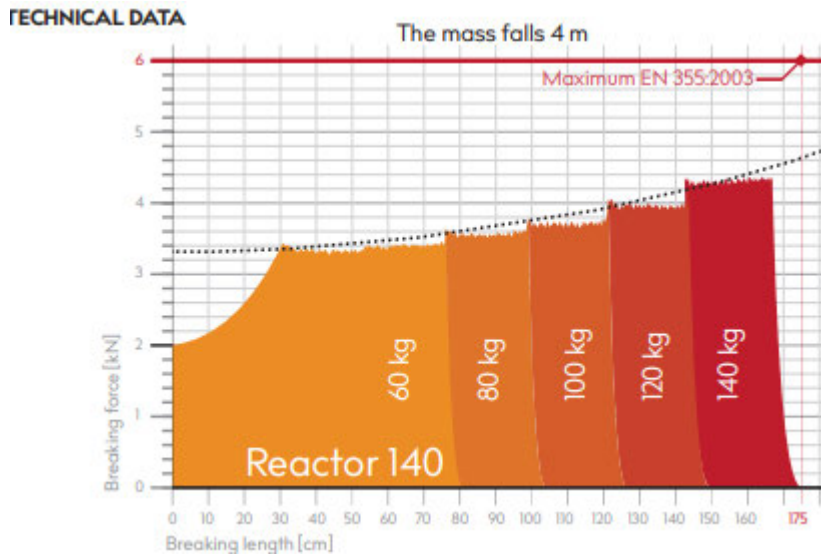
Figure 10. Source: Singing Rock W4400WW00

According to the table from Singing Rock, the total length of the Y lanyard with Reactor 140 shock absorber and large hook is 180 centimetres.

Maximum reaction length is 1.75 metres, with a maximum load of 140 kilograms.

The Reactor 140 shock absorber involved in the incident was function-tested at Equinor's FOS SMT MCT centre of expertise for materials and corrosion technology. See report MAT-2023021:
