Collaboration in Subsea Integrity, Inspection, Maintenance and Repair

Collaboration - FlexScan[®] Ultrasonic Riser Scanning

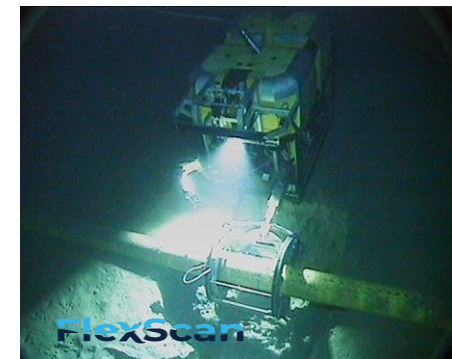
Oceaneering equipment
 - > Neptune
 - > ROV deployed
 - > 6" to 20" pipe diameter
 - > Rated to 3000m
 - > Trident
 - > Diver deployed
 - > World's first subsea phased array UT scanner

- > Suitable for larger diameter risers

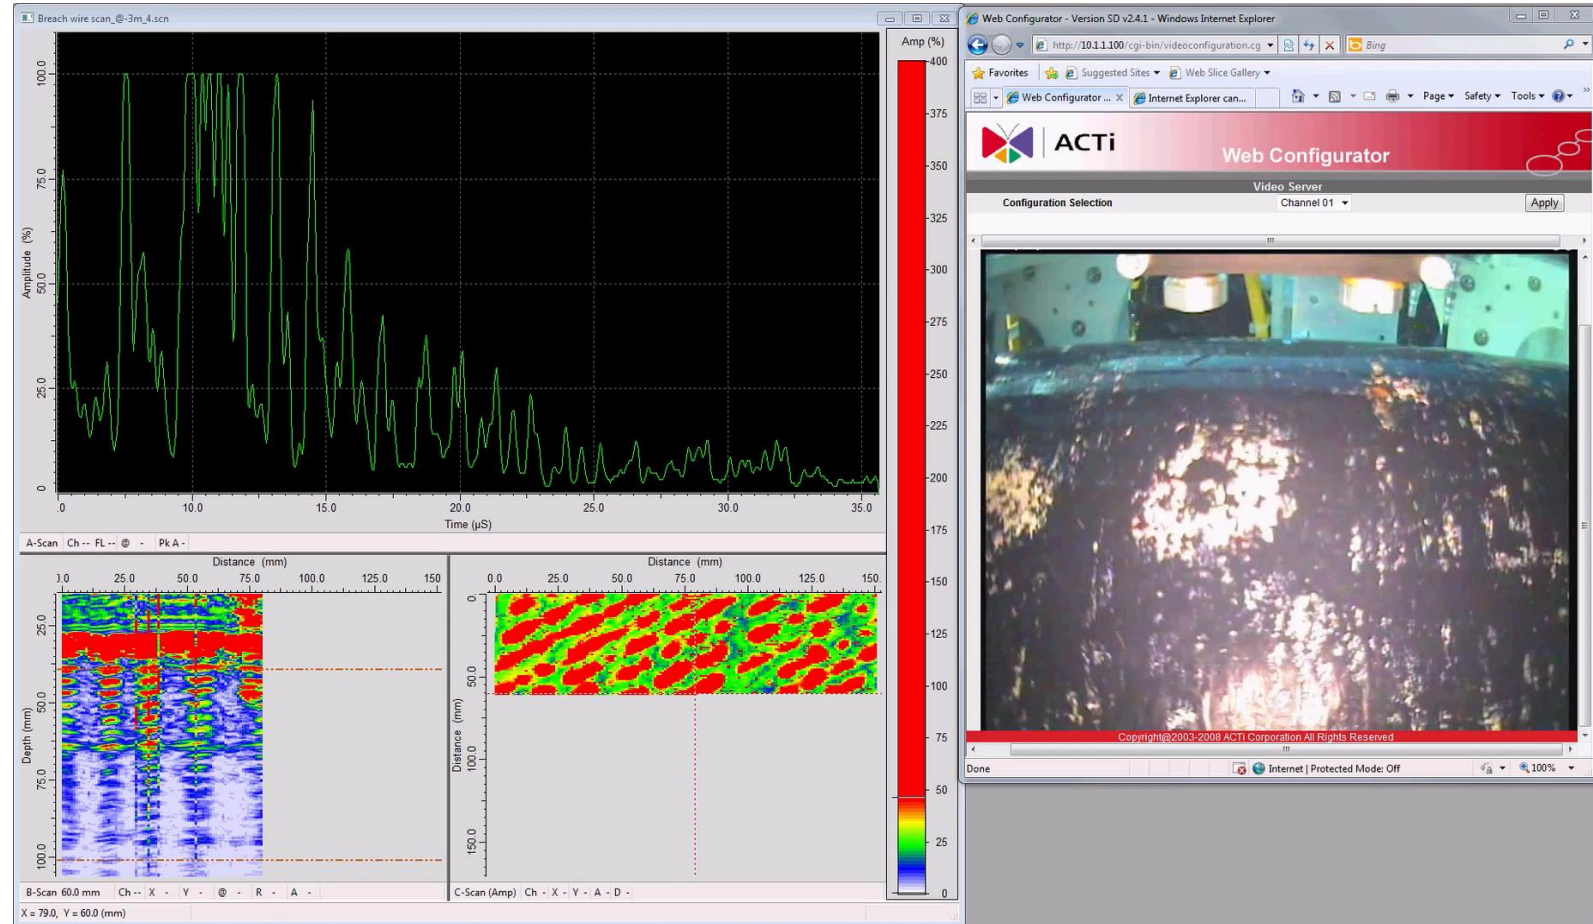
Example Case

- Annulus test only holding 0.6 bar
- Riser breached 6m below MSL
- Scan data directly over breach location indicates negligible general corrosion at breach area
- Flexlife life extension incorporates scan data
- Verified safe remaining operating
