Flexible Pipe Integrity; post-Sureflex & introducing the draft EI life extension guidance

Ian MacLeod, Global Assurance Lead,
Asset Performance & Optimisation

El Draft Guidance – Life Extension of Unbonded Pipe

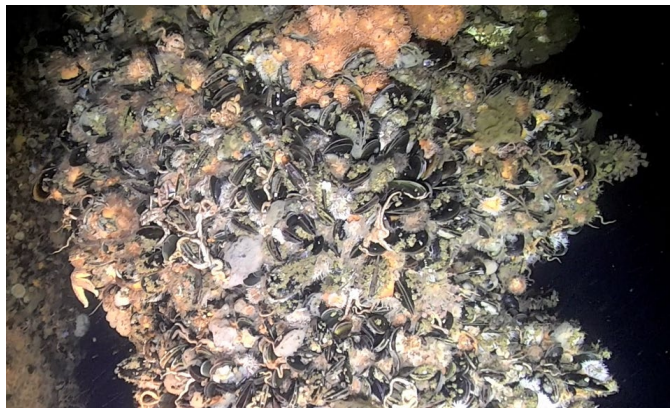
Bend Stiffener
Tip Inspection

- Lastly, updated guidance on inspection & monitoring
 - are initiating defects really identifiable through GVI?

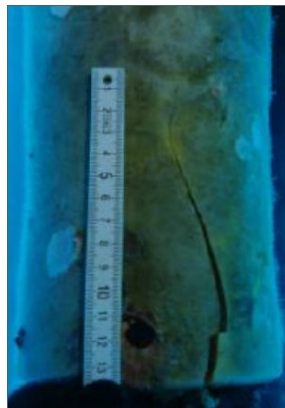
Stiffener
Tip Damage

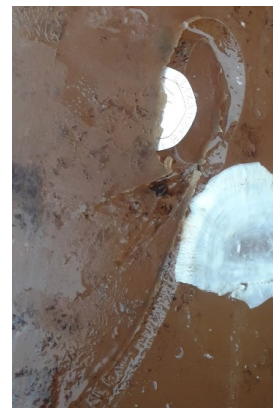
Cleaning Damage
In-situ Recovered
